SYNOPSIS

OPERATOR : AERO SURVEYS LTD
(STARBOW)

MODEL : ATR 72 - 212A

PLACE OF ACCIDENT : KOTOKA INTERNATIONAL AIRPORT
ACCRA, GHANA (DGAA)

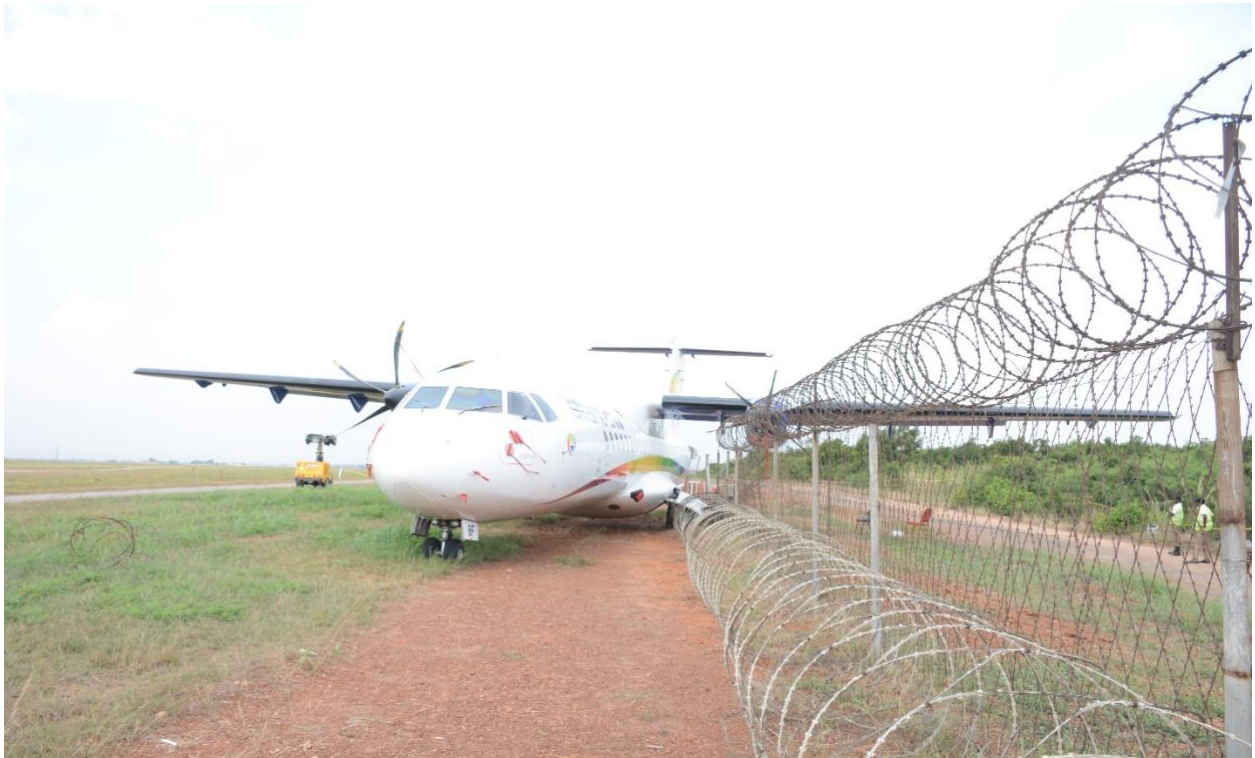
Figure 2: Aircraft at impact Site

the runway and finally came to a stop about 600m from the edge of the runway after impacting the airport inner perimeter fence. The airport emergency response was activated.

One passenger was seriously injured and four others sustained minor injuries. There was substantial damage to the aircraft propellers, undercarriage and fuselage. The Precision Approach Path Indicator (PAPI) and the inner perimeter fence were also damaged.

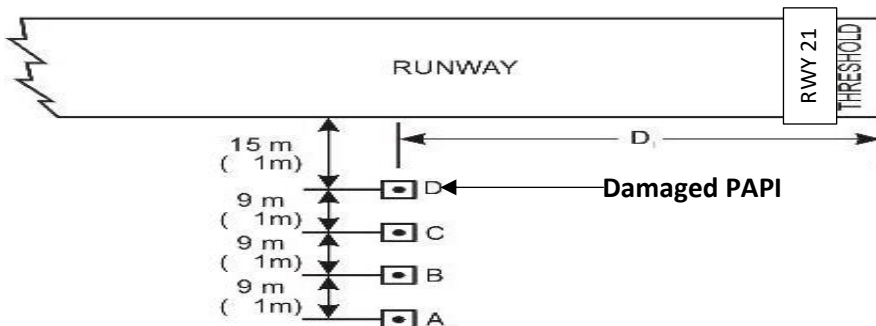
Figure 4: PAPI diagram

The aircraft's right main landing gear ran over the inner PAPI light (lettered D in figure 4) destroying it completely. In addition, about 30 meters of the aerodrome inner perimeter fence was also damaged.

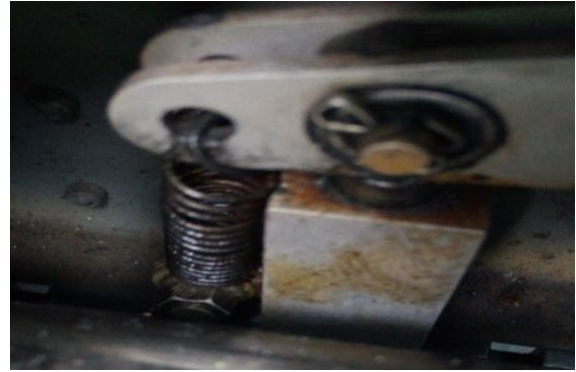
Figure 19: Normal Spring

- b. Both alignment washers (packers) were not in place on the captain's seat. (*Refer to figure 20*)
4. In the case of the co-pilot's seat, all springs and washers were intact. Also, while all other springs looked black (*refer to figure 19*), that on the captain's seat looked ash in colour (*refer to figure 18*), an indication that the broken spring may have been replaced during maintenance.

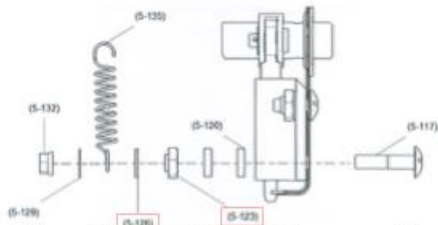
Figure 12 : Pre-mod spring fitting assembly

The right spring has been fitted between the hollow nut (5-123) and the thin washer (5-129), with the washer (5-126) on the incorrect side of the hollow nut (Figures 12 & 13).

The hollow nut was found to have remnants of wire within it.

This incorrect assembly may have contributed to a partial clamping of the spring attachment and thus to its failure.

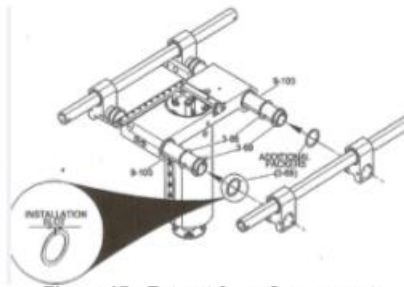
Figure 17 : Extract from Component Maintenance Manual

Component Maintenance Manual 25-11-21 requires fore/aft and lateral movement checks and asks to add packers until there is no more free movement (Figure 17). On the accidented seat, packers are missing on both the fore/aft and lateral tubes.

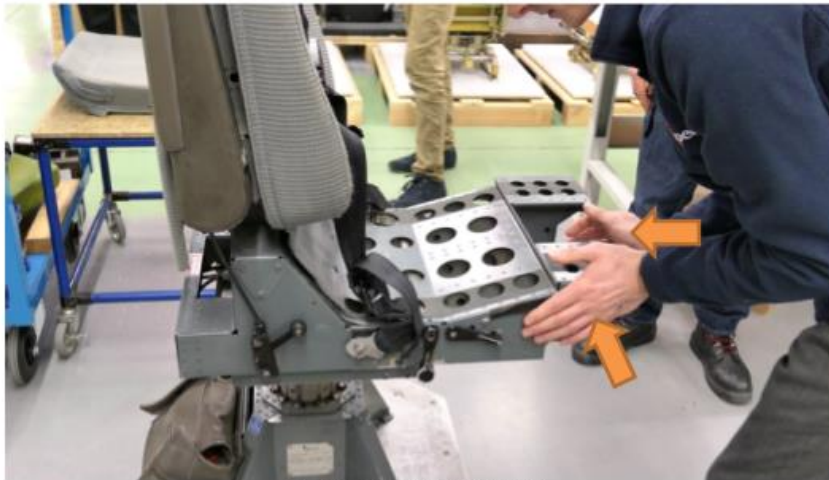
Figure 18 : "Roll back" test

When pushed rightward and backward (see Figure 19) from an unlocked position (pins not locked into the rails), the seat moves all the way back and sideward to the lateral position (see orange arrow on figure 3). This operation will be referred as the "roll back" test in this document.

The "roll back" test is performed with a weight of 96 pounds on the seat. The same results is achieved.
