Client Devon Canada	Date of Inspection 08/13/2012 - 08/17-20'	Report Number RB - 120817 -001
Facility Maple Glen Gas Plant	Time of Inspection 17:00	W.O. Number 20015628
Attention Cam Busby	NDE Procedure UT-0001	P.O. Number NA

Equipment ID Condensate Storage Bullets	Surface Condition Painted, Acceptable
Material Type and Thickness SA 612	Surface Temperature Ambient

We were asked to perform Phased Array inspection of 100% of the welds on the following two Condensate Storage Bullets located at the Maple Glen Gas Plant (16-36-036-16W4). A0151944 and A0151945. This is an in-service client information inspection only.

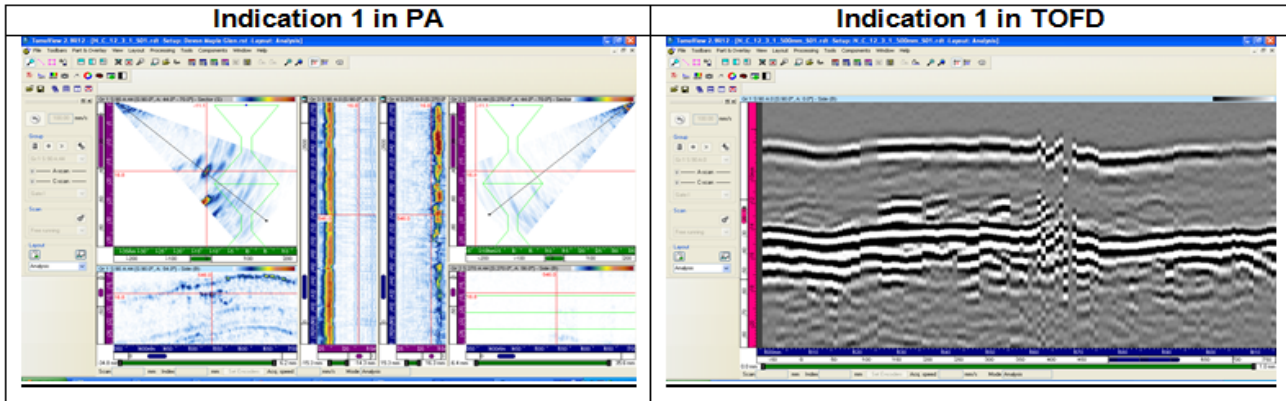
The following pages contain the images of both the PAUT and TOFD for the 19 relevant indications detected during the inspection.
