Performance of Buildings With Shear Walls in Earthquakes of the Last Thirty Years

Mark Fintel, P.E.

The author describes observations of shear wall performance in severe earthquakes in which modern reinforced concrete buildings stood the test of violent shaking, starting with the Chilean earthquake of May 1960 through most of the subsequent strong earthquakes, up until the Armenian earthquake of December 1988. Despite the excellent behavior of shear wall-type concrete structures as compared to concrete frame-type structures, building codes continued, up until the last decade, to give preference to concrete ductile frame structures (which are subject to higher distortions) while placing a substantial penalty on the use of shear walls. This code approach was due to the lack of experimental and analytical background information on shear wall behavior. While a large body of information on shear walls accumulated during the 1980s, still more experimental and analytical studies are needed to create a solid basis for a rational seismic design approach. The availability of such information should encourage a wider use of shear walls for earthquake resistance.

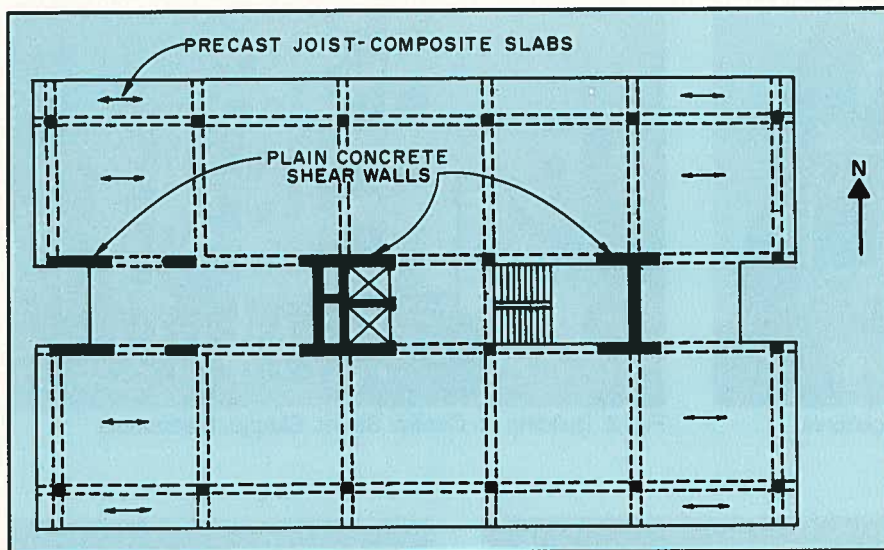
Fig. 5. Floor plan of Party Headquarters, Skopje, Macedonia.

The 14-story Party Headquarters Building (see Fig. 4) had a structural system for lateral resistance consisting of a shear wall frame interaction. The three unreinforced concrete cores interacted with the frame of two-way slabs resting on beams (see Fig. 5). The building swayed considerably during the earthquake; desks were thrown from one end of rooms to the other. However, the building itself withstood the earthquake without damage, not even broken windows. The elevators had jammed but in several days they were repaired and put back into operation.

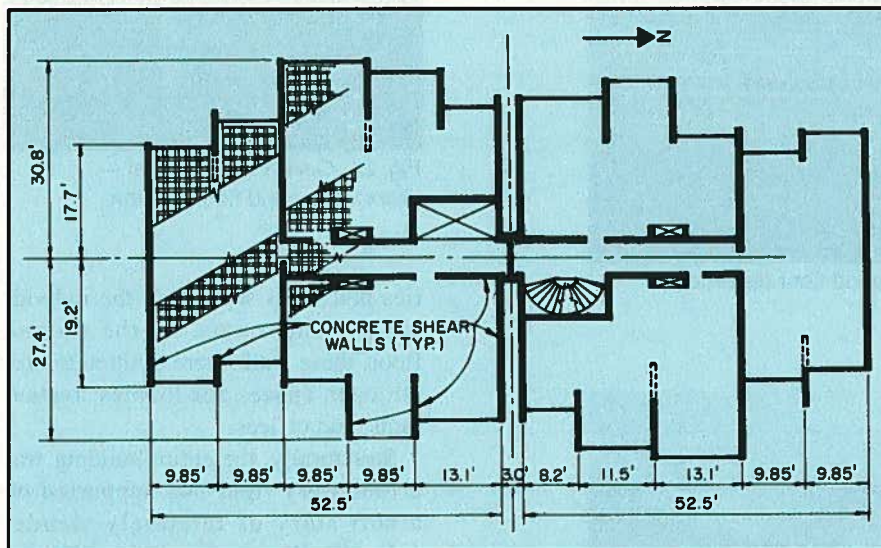
Fig. 16. Floor plan of Plaza One Building, Caracas, Venezuela.

There was only one building in Caracas of a different structural configuration. The 16-story Plaza One Building (see Figs. 15 and 16) was a shear wall building, using bearing walls instead of columns in each of the two orthogonal directions. The American owners initially had planned a 20-story building; however, the Uniform Building Code (which was the code being followed at that time) did not permit more than 16 stories in concrete and this is why the decision for 16 stories was made.

The building was located in an area of heavy damage. A 10-story building in front of Plaza One collapsed and most of its neighboring structures suffered heavy non-structural damage. Plaza One went through the earth-

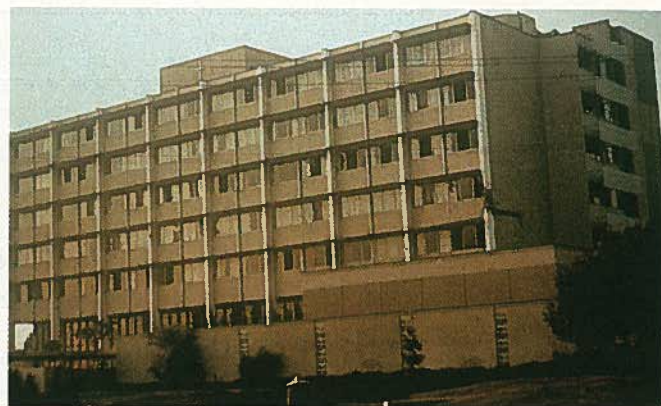
Fig. 23. Holy Cross Hospital, San Fernando, California.

The six-story neighboring Holy Cross Hospital (see Fig. 23), which had a concrete frame structural system, suffered severe structural damage (see Fig. 24) and had to be torn down.

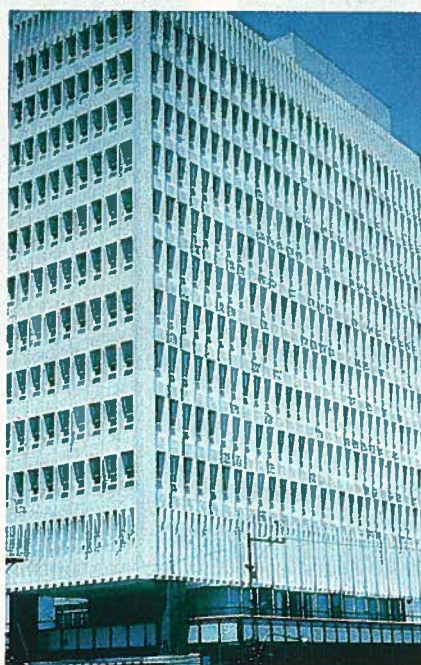
Fig. 26. Banco Central.

The 14-story Banco Central (see Fig. 26) was a one-bay frame. The lateral resistance was provided by two small concrete elevator cores and a masonry infill wall, all located at the east end of the building (see Fig. 27). During the earthquake, this cluster of resistances acted as a pivot around which the entire structure rotated. In the assessment of the damage, it was found there was only limited structural damage, primarily tearing between the

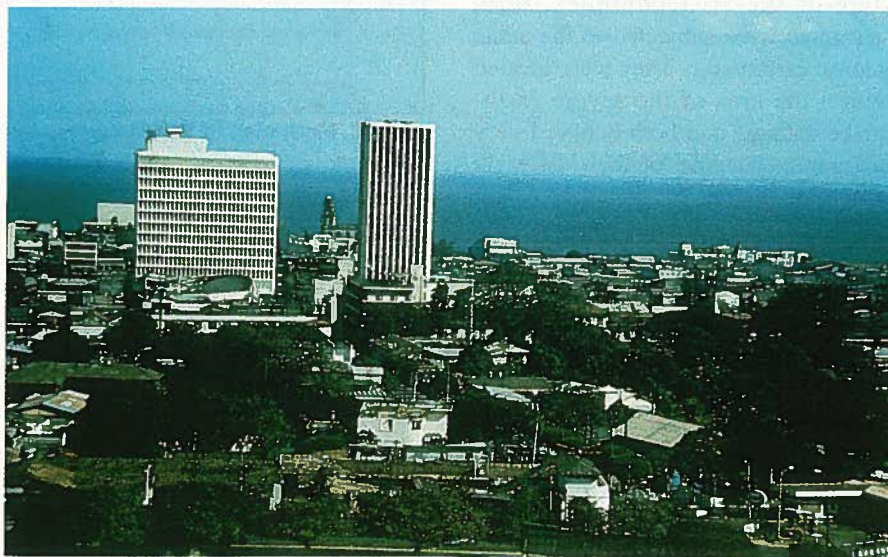
Fig. 25. Banco Central and Banco de America, Managua, Nicaragua.

Of specific interest are two modern bank buildings constructed in the early 1960s (see Fig. 25). The buildings were located across from each other. Both banks were very carefully constructed with the best quality construction available, using current state-of-the-art techniques. Both structures were subjected to the same intense earthquake. They were located within the area of the severe earthquake damage and both behaved very differently because of their different structural systems.

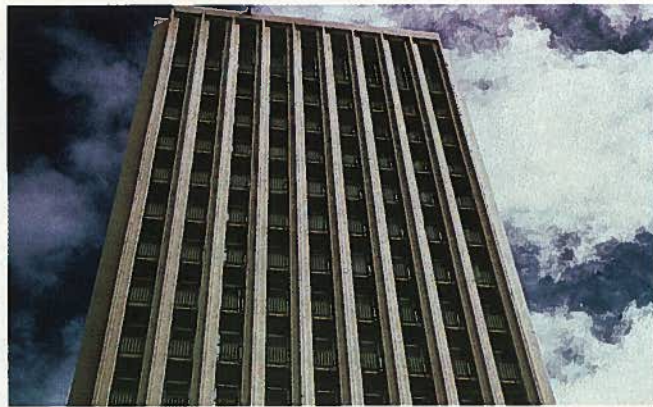
Fig. 29. Banco de America.

The 18-story Banco de America (see Fig. 29) responded to the earthquake in a completely different way. In the plan (see Fig. 30), a closely spaced peripheral column grid interacted with four centrally located elevator and stair cores to resist lateral forces. The cores were tied together with coupling beams on every floor level. The result was a rigid shear wall frame interactive system. There was neither non-structural nor structural damage, except for one coupling beam that failed in shear on the sixth floor (see Fig. 31). This was caused by over reinforcing in flexure of the short coupling beam with a large duct opening.

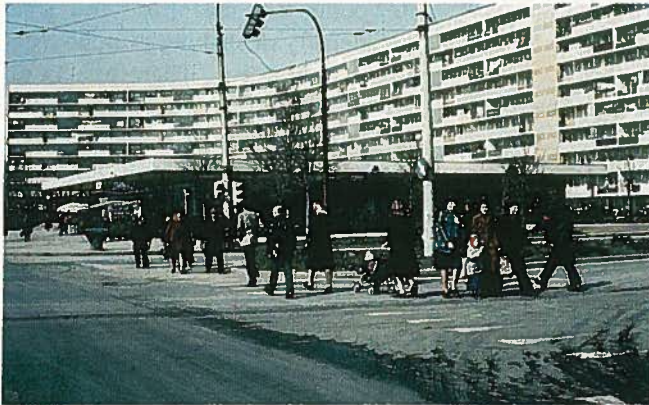
Fig. 34. Modern structures in Bucharest, Romania.

There were 300,000 new dwellings constructed in Bucharest after World War II, and out of these, 70,000 were built using precast concrete. It was the first time that a large number of precast concrete buildings were tested in an earthquake. The precast concrete buildings built in Romania after

World War II were initially four stories in height. Subsequently 7-, 9-, 13-, and 15-story buildings were built (see Fig. 34).

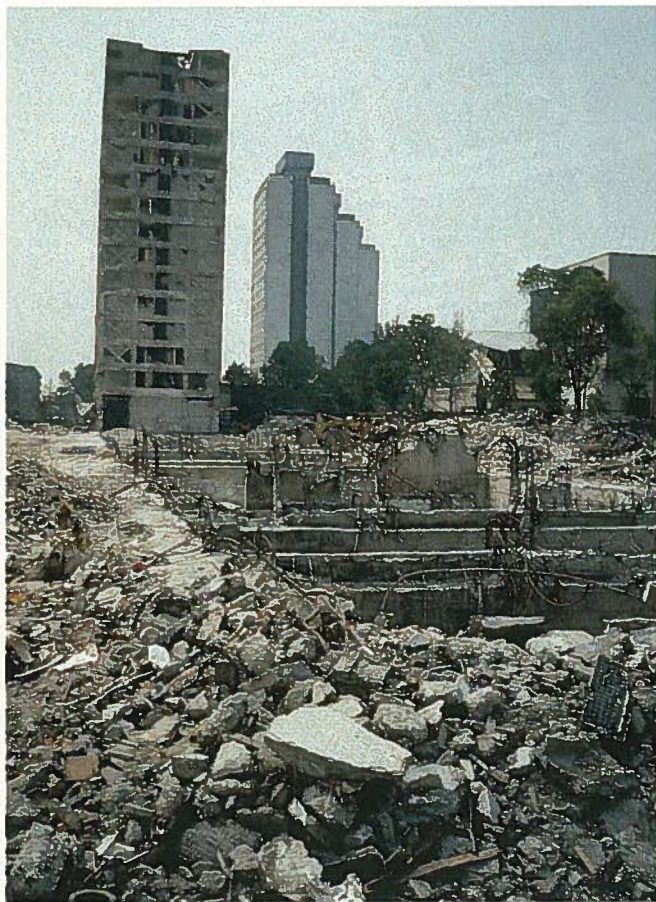
Fig. 45. Nuevo Leon Building, Mexico City, Mexico.

A noteworthy case study was that of Nuevo Leon, a suburb of Mexico City constructed in the 1960s, in which about 750,000 people lived. There were a number of 14-story buildings, each consisting of three sections separated by expansion joints. Fig. 45 shows one remaining section standing while the other two collapsed. The primary resistance to lateral forces in these buildings was provided by rigid walls at each end; the rigidity of the walls was created by X-bracing.

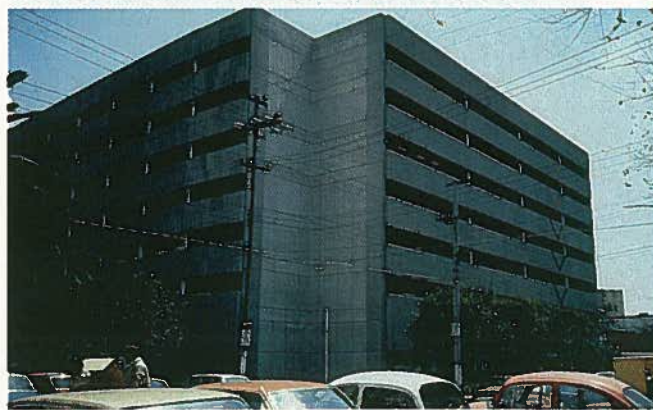
Fig. 47. Undamaged parking structure, Mexico City, Mexico.

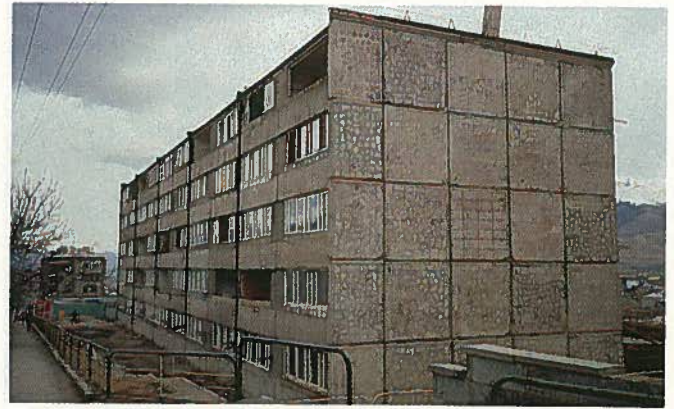
Spitak, a city of 24,000 inhabitants located in the epicentral region, received an almost direct hit from this shallow earthquake. The city was almost completely devastated (see Fig. 49); all of its schools, hospitals, public facilities and most of the housing was destroyed. Loadbearing masonry and masonry with frames up to five stories were the predominant residential construction types in the city. About 90 percent of these structures collapsed — none escaped damage. Of the residential buildings in the city, only a five-story large precast concrete panel building survived the earthquake undamaged (see Fig. 50).

Fig. 50. Undamaged shear wall structure, Spitak, Armenia.

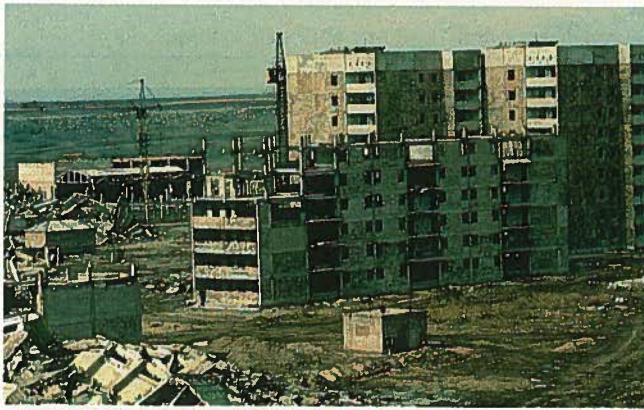
Fig. 51. Nine-story precast frames, Leninakan, Armenia.

Leninakan, a city of 290,000 inhabitants located 20 miles (32 km) from the epicenter, suffered an enormous amount of casualties in collapsed modern residential high rise buildings (mostly nine-story precast concrete frame structures; see Fig. 51), schools,

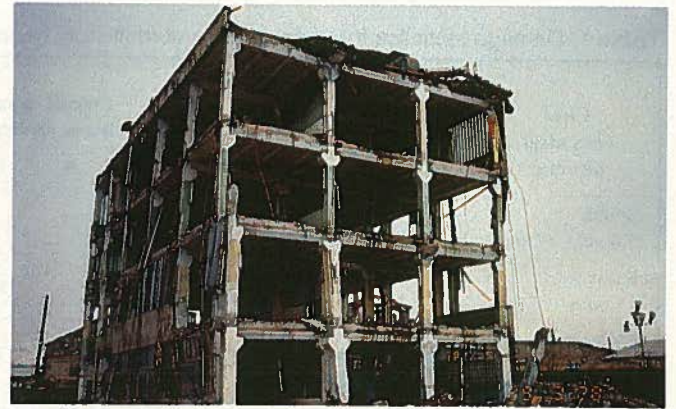
Fig. 52. Precast concrete industrial building, Leninakan, Armenia.

institutional, and industrial buildings (see Fig. 52). Some new residential sections of the city consisting of many high rise buildings were devastated. Many churches and other historical monuments were destroyed. The Technical University suffered a partial collapse of a major building, burying in the debris a large number of students. The 16 high rise precast concrete large panel structures remained undamaged (see Fig. 53).
