#PI0703B: Service Rear Axle Message Displayed on Driver Information Center (DIC), DTC C0407 with Symptom Code 64 or C0403 Symptom Code 62 Set - (Feb 25, 2013)

Models: 2010-2012 Buick LaCrosse
2010-2012 Cadillac SRX
Equipped with All-Wheel Drive (AWD)

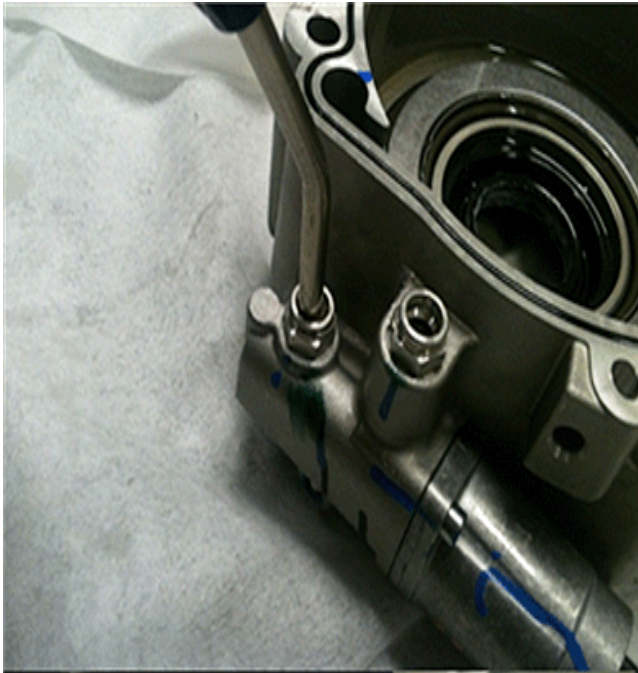
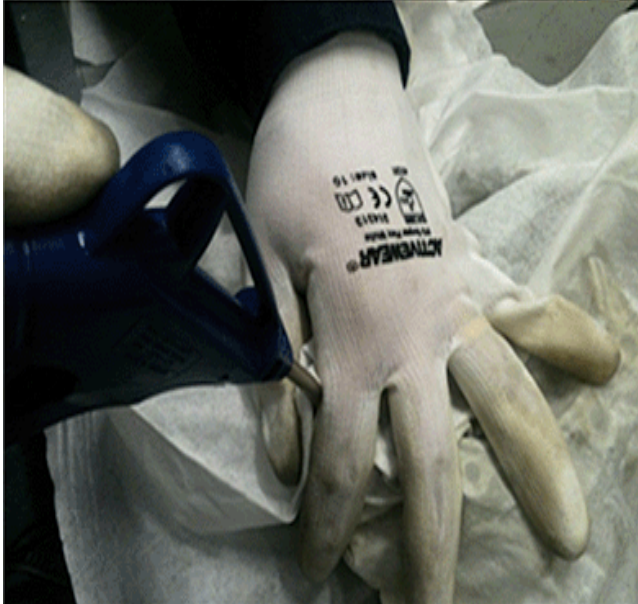
3. If the rear differential fluid level is too high and either a or b exists, then the eLSD clutch oil is leaking past the eLSD clutch internal piston seals (6 or 7) into the rear differential. The service fix is to replace the eLSD clutch piston only using the following procedure.

11. Apply compressed air to the low pressure pipe connector port to release the piston from the differential clutch housing.
12. Remove the eLSD clutch piston from the housing.
