# **Pipers Row Car Park, Wolverhampton**

## **Quantitative Study of the Causes of the**

## **Partial Collapse on 20<sup>th</sup> March 1997**

**Jonathan G M Wood**

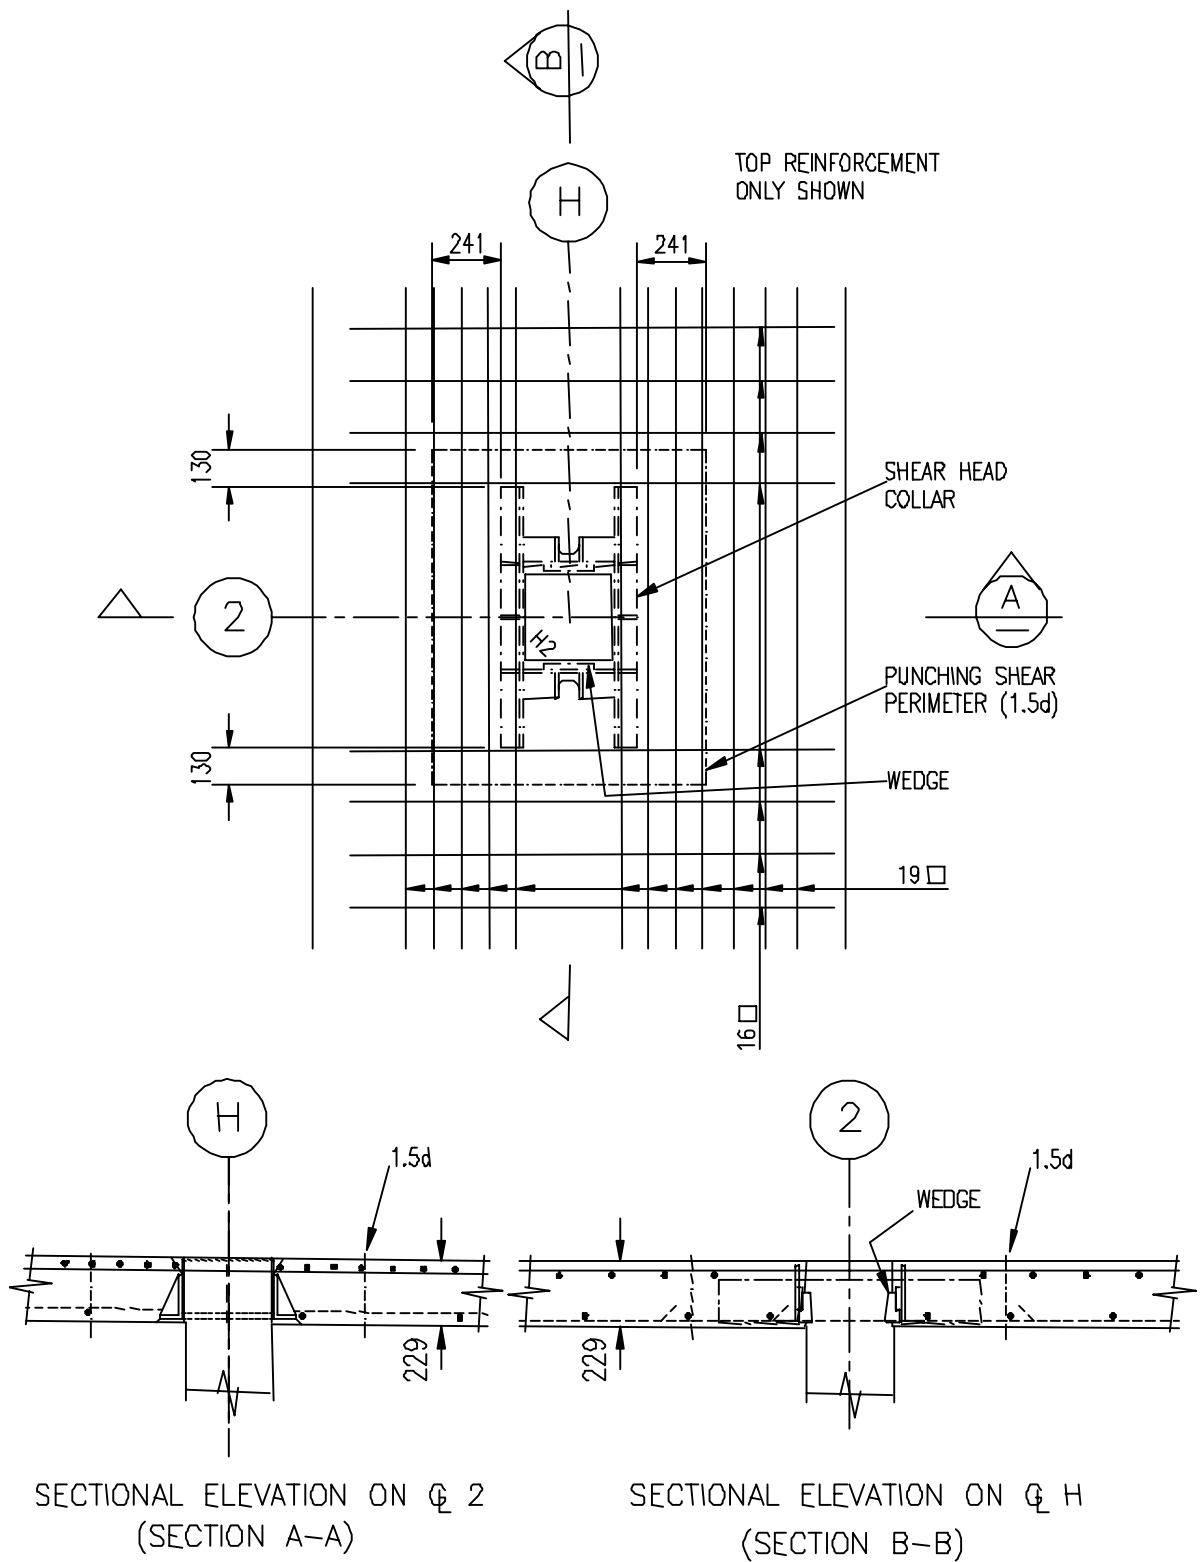
The particular features of the shear head design at H2, I2 and J2 and their relationship to the reinforcement are shown on Figures 4.2 - 1 to - 3. At H2 and I2 the long projecting angles of the shear head 'collar' resulted in the displacement of the top reinforcement T1 bars and T2 bars more widely, away from the column. At all locations the underside of the angle was ½" (12mm) above the soffit with the slab supported on the upper surface 22mm above the soffit. The ½" below the angle was filled with mortar to provide fire protection. The support wedges engaged into the short angle and can be seen in Figure 8.2.7 - 1 of the sectioned I2 column head. At J2 the shear head lacks the projecting angles and the irregular disposition of reinforcement and the holes for lifting and drainage complicated the shear behaviour.

Figure 4.2 – 1 Reinforcement and shear head 'collar' at H2

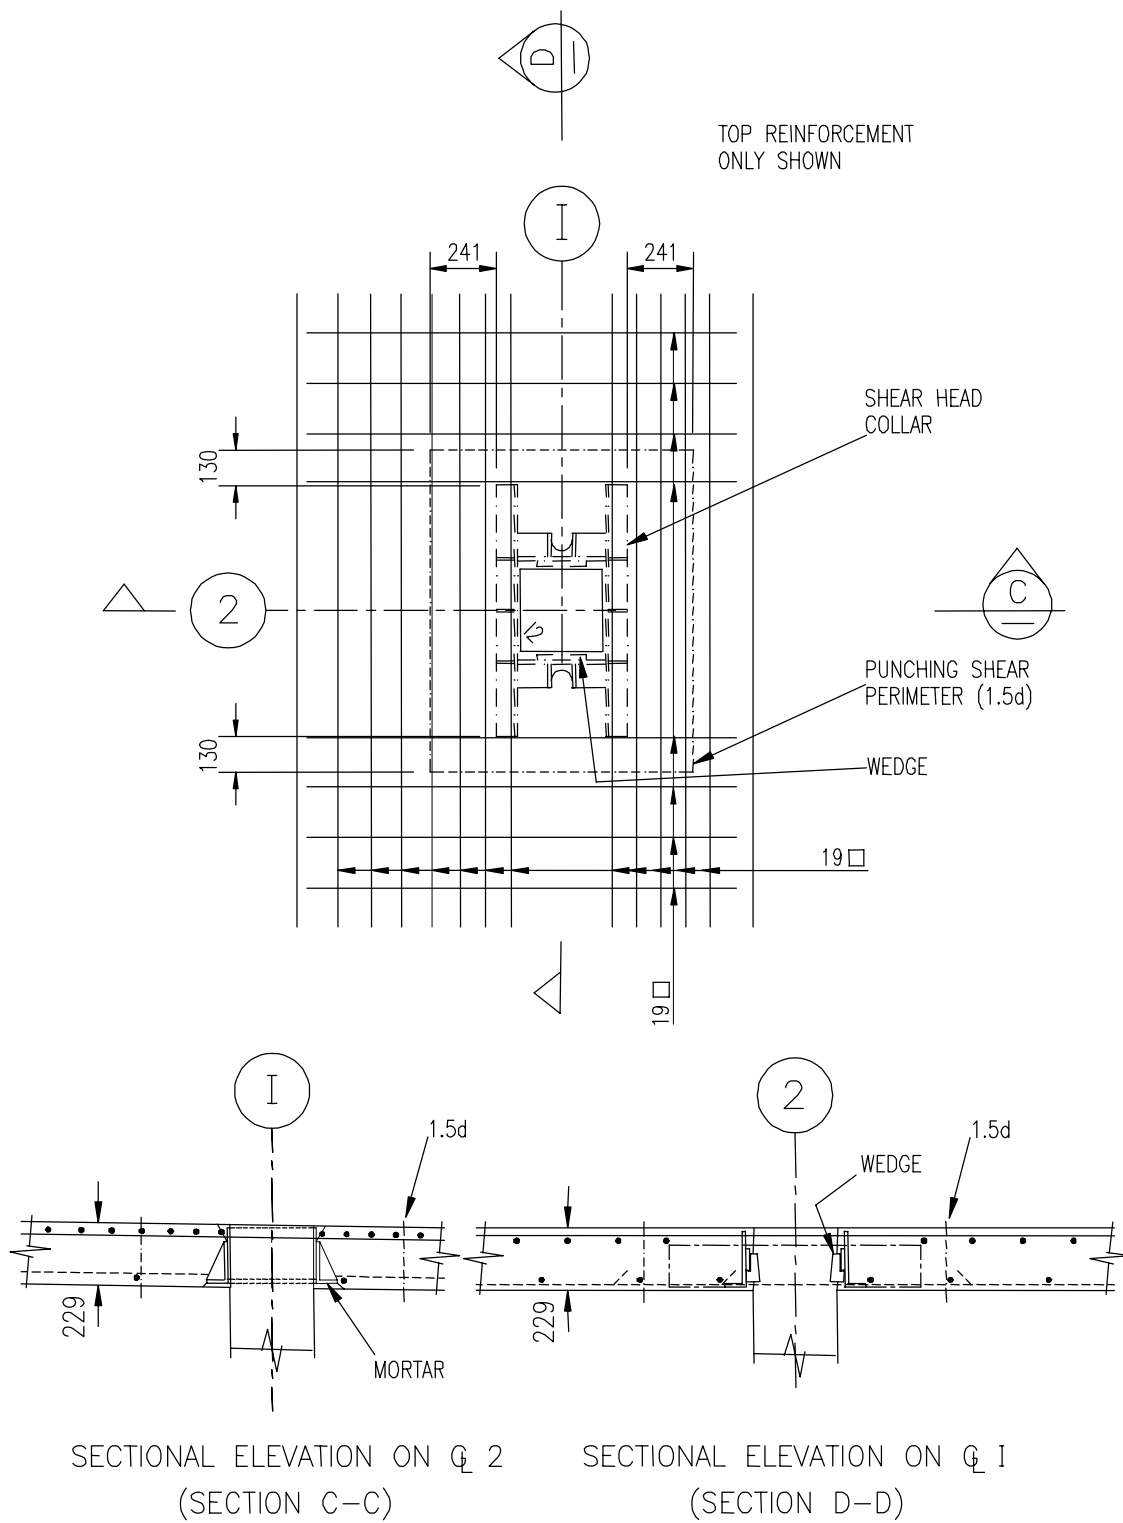
**Figure 4.2 - 2 Reinforcement and shear head 'collar' at I2.**

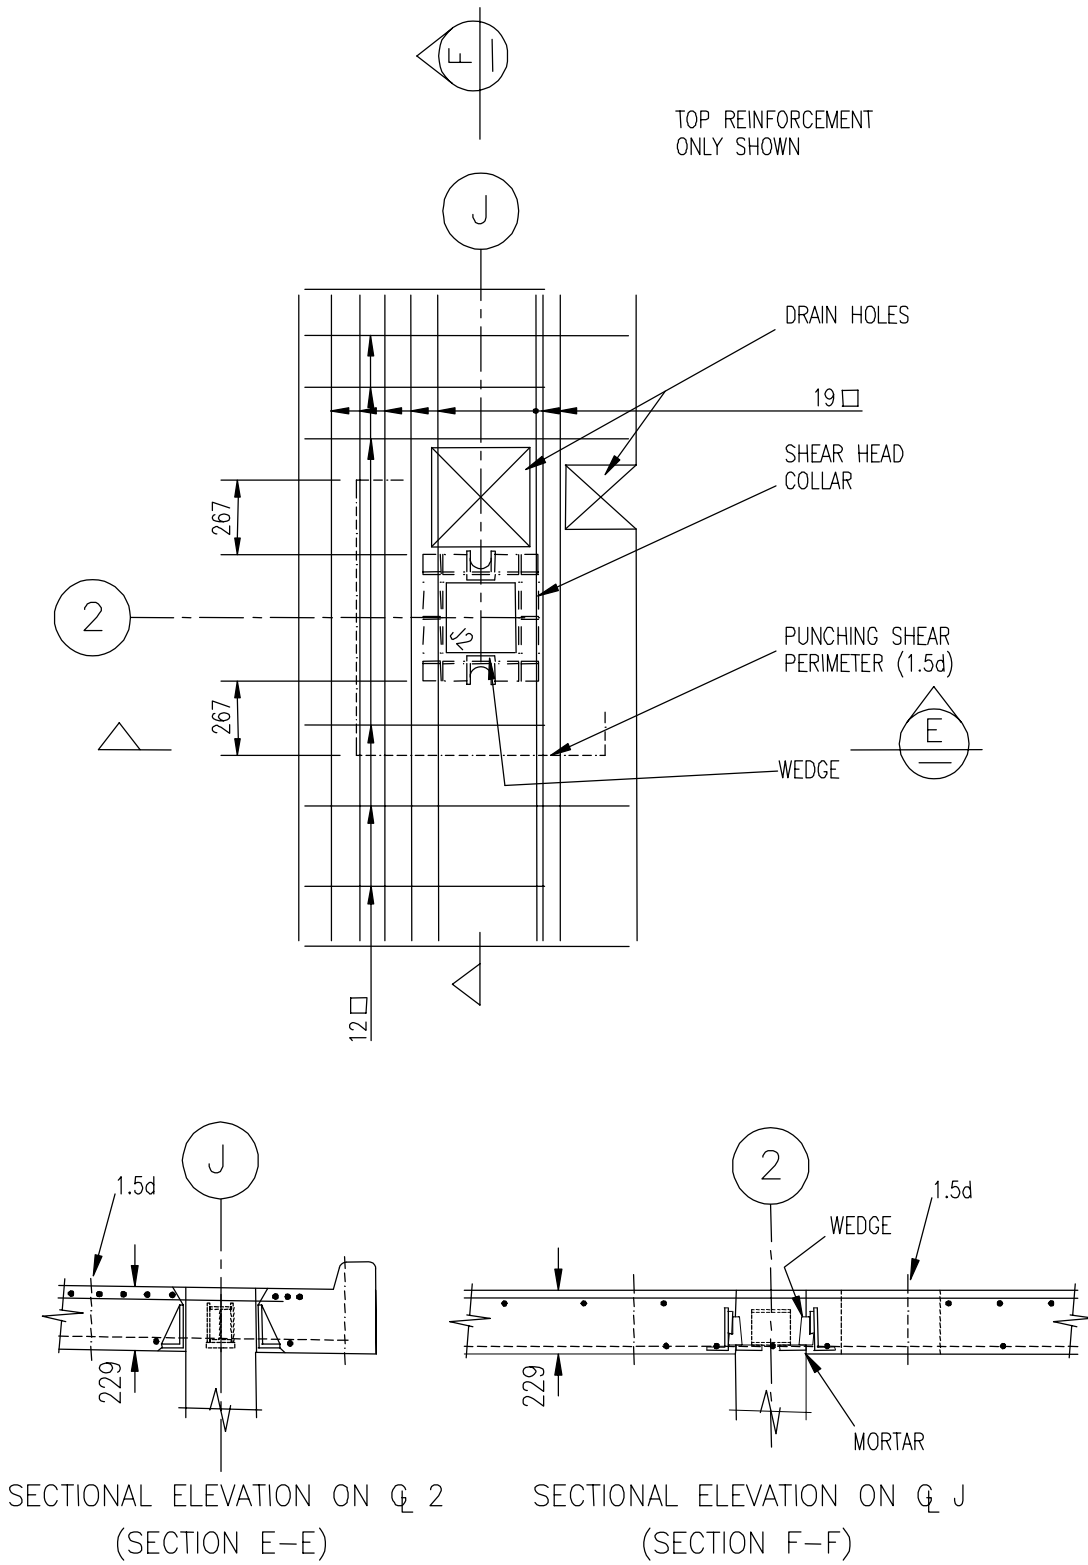
**Figure 4.2 - 3 Reinforcement and shear head 'collar' at J2.**

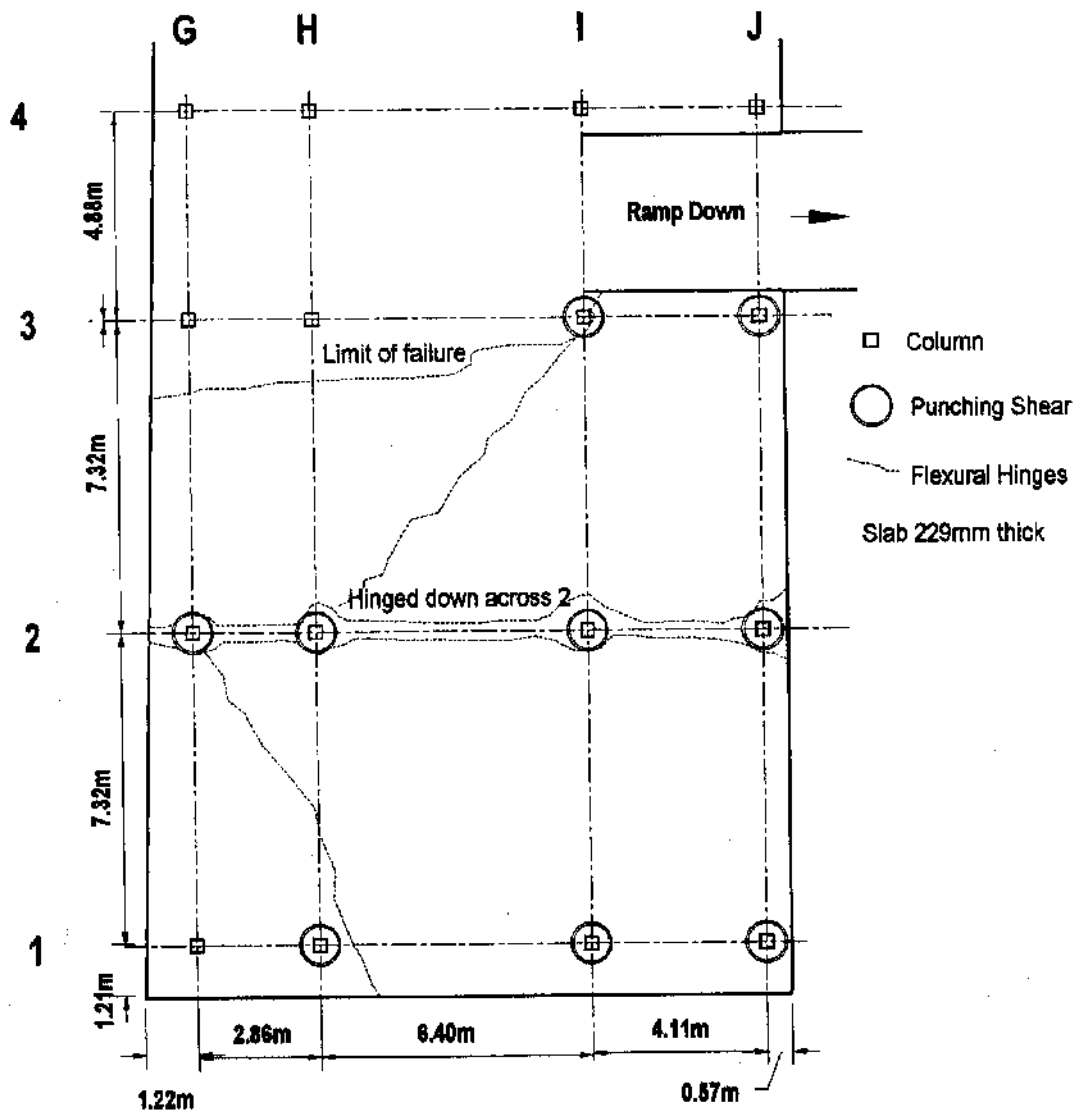
At about 3.20 am on the morning of 20th March 1997 the top floor slab supported by columns G1, G2, H1, H2, I1, I2, J1 and J2, an area ~15m by ~15m weighing about 120 tonnes, collapsed onto the 3rd floor slab below. The view from above after the collapse is shown in Figure 7.1 - 1. There was no load other than self weight on the failed slab at that time.

Figure 7.1 - 2 Layout of collapsed slab

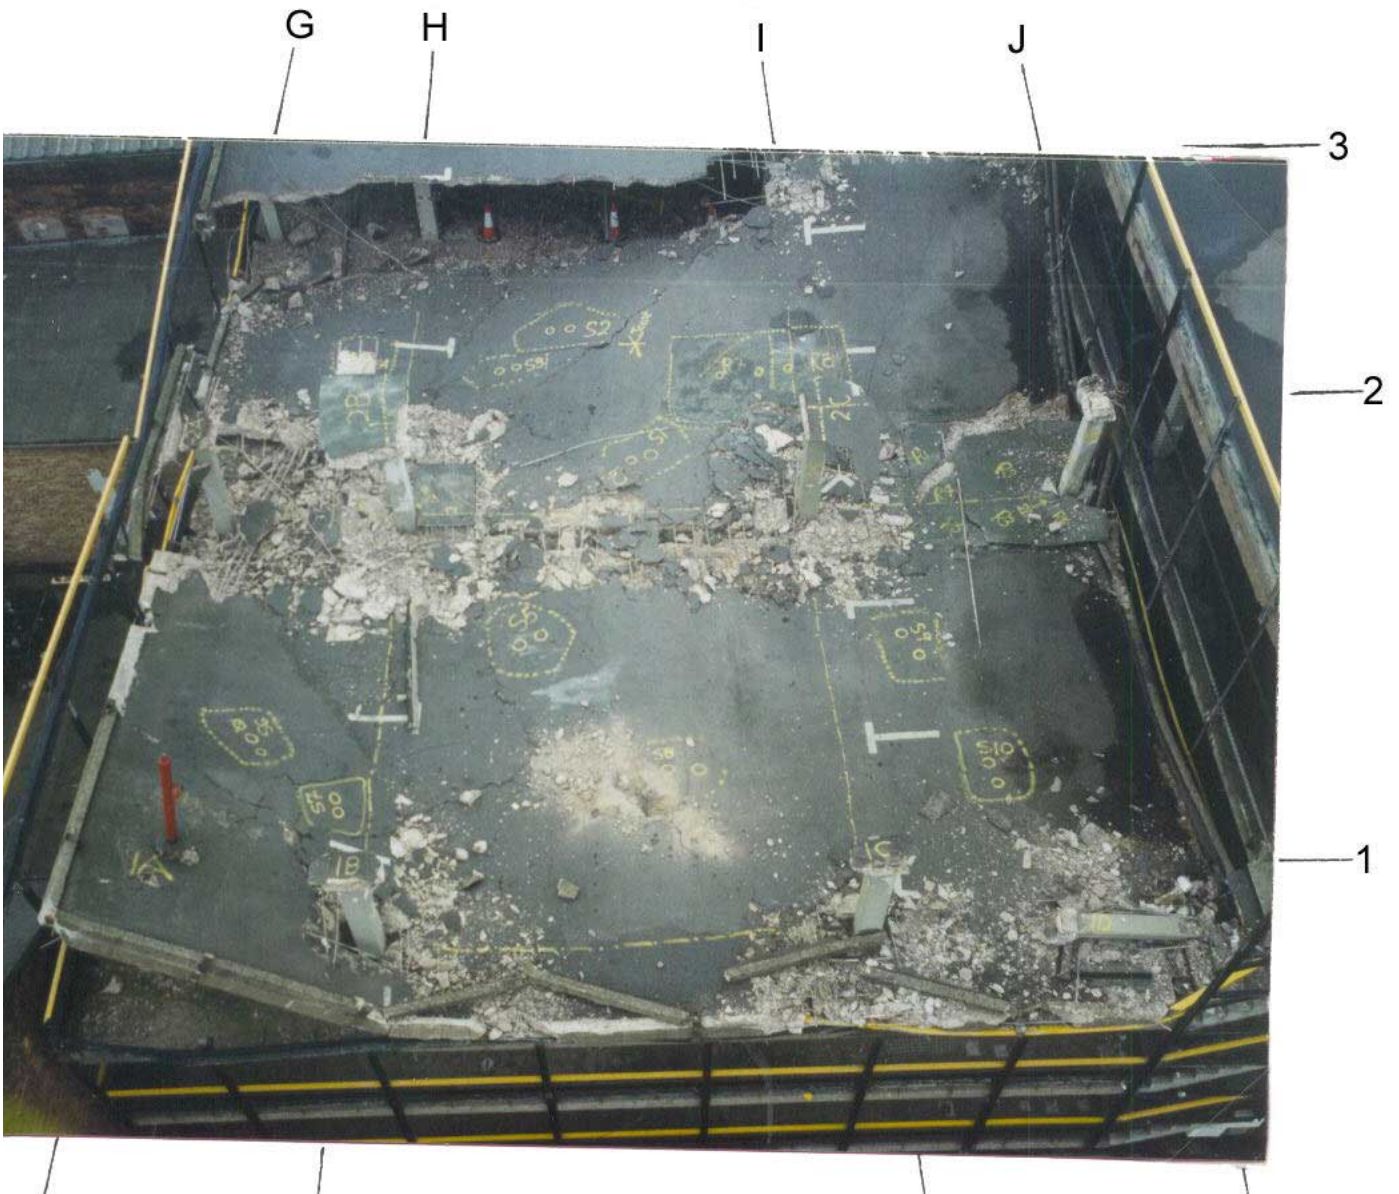
On the basis of the joint inspection on 25<sup>th</sup> March HSE, H&S and SS&D identified various large sections of the 4<sup>th</sup> floor slab and column for careful removal prior to and during demolition. These are shown marked on the slab in Figure 7.2 - 1. While some sections were too fragmented to be cut out and lifted down during demolition, a good representative set, including samples of repair material and a section of the 3rd floor slab S20 were obtained and moved for storage under cover at the NCP car park at Horse Fair in Birmingham, Figure 7.2 - 2. These large retained samples are listed on Figure 7.2 - 3 with their locations shown on Figure 7.2 - 4 based on the HSE Sketch 1 [H133].

Figure 7.2 - 1 Marked locations for retained slab samples.

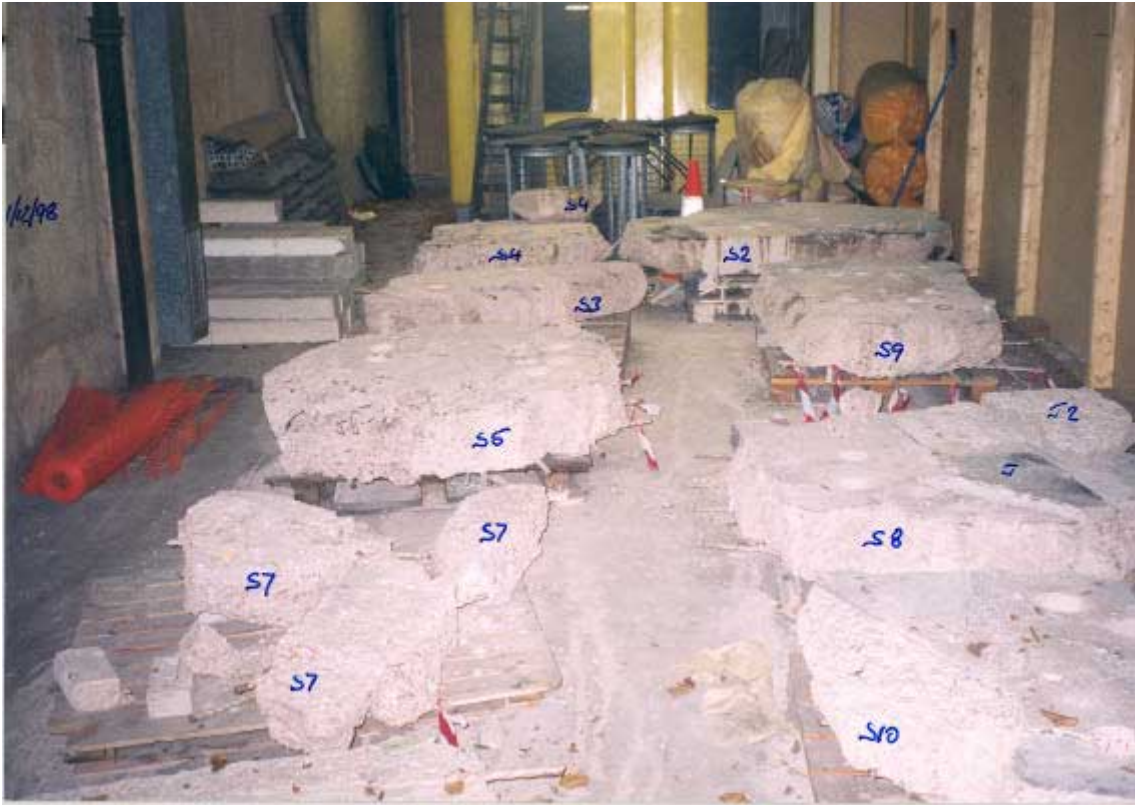
Figure 7.2 - 2 Retained samples in store Birmingham

At the start of the contract work in September 1999 the retained large samples of slabs and columns (as shown in Figure 7.2. - 2 and listed in Figure 7.2- 3) had been in store inside a partitioned off section of Horse Fair car park in Birmingham since the sampling carried out by Sandberg in 1997. The conditions would have allowed some drying of the slabs. The drying would have increased the rate of carbonation from that in the site conditions. Carbonation would have been developing from the date of fracture on all the surfaces exposed at the time of the collapse, during the demolition shortly afterwards and during Sandbergs sampling.

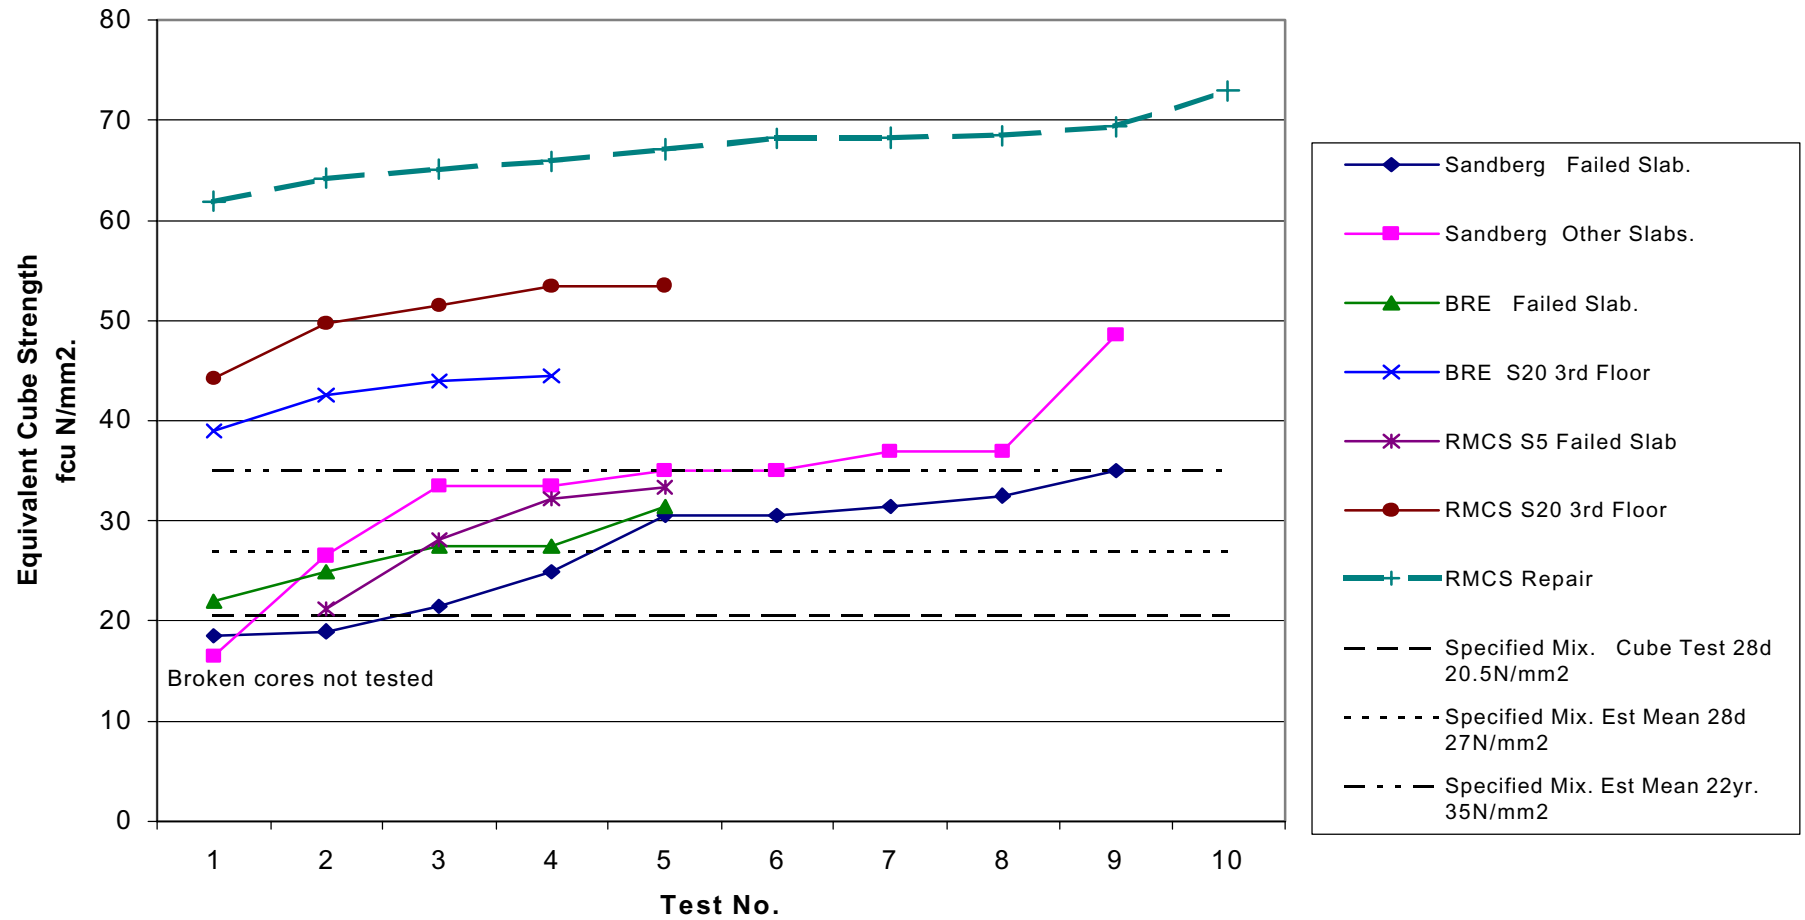
This demonstrates the unreliability of the normal practice of taking 6 to 8 cores at random from a structure to establish an as built characteristic or 'least credible' strength for structural appraisal. This type of testing was adopted by H&S to check other car parks immediately after the Pipers Row collapse. Had an inspection and testing survey been carried out before the collapse, random sampling would have been unlikely to have picked up the localised areas of particularly low strength concrete which contributed to the failure at Pipers Row.

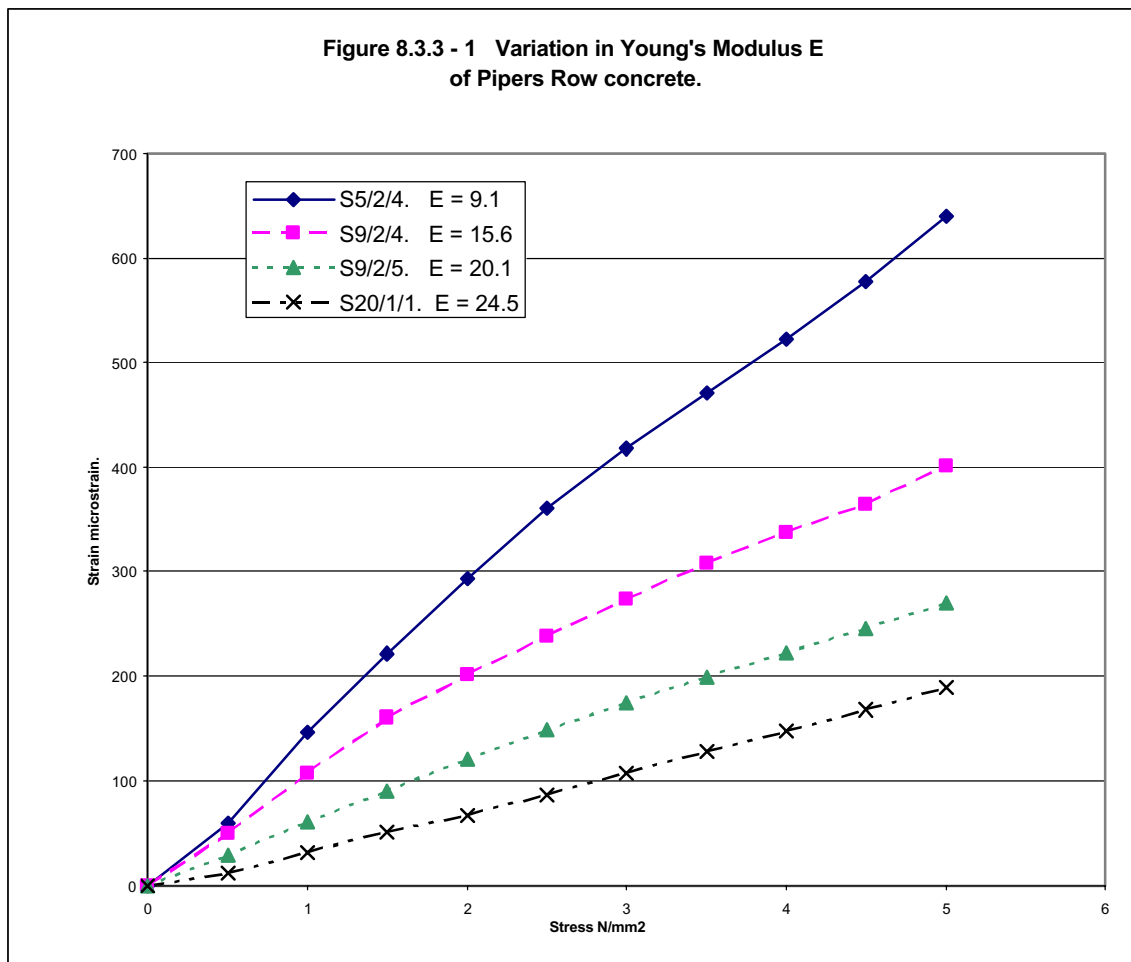
The greater deformations from the low E would have been a significant factor in the development of ponding, which led to slab degradation, despite the generous falls provided in the initial design.

The average E for the repair when tested by RMCS was 31N/mm<sup>2</sup> short term, similar to the best concrete from Pipers Row.

**Figure 8.3.3 - 1 Variation in Young's Modulus E of Pipers Row concrete.**

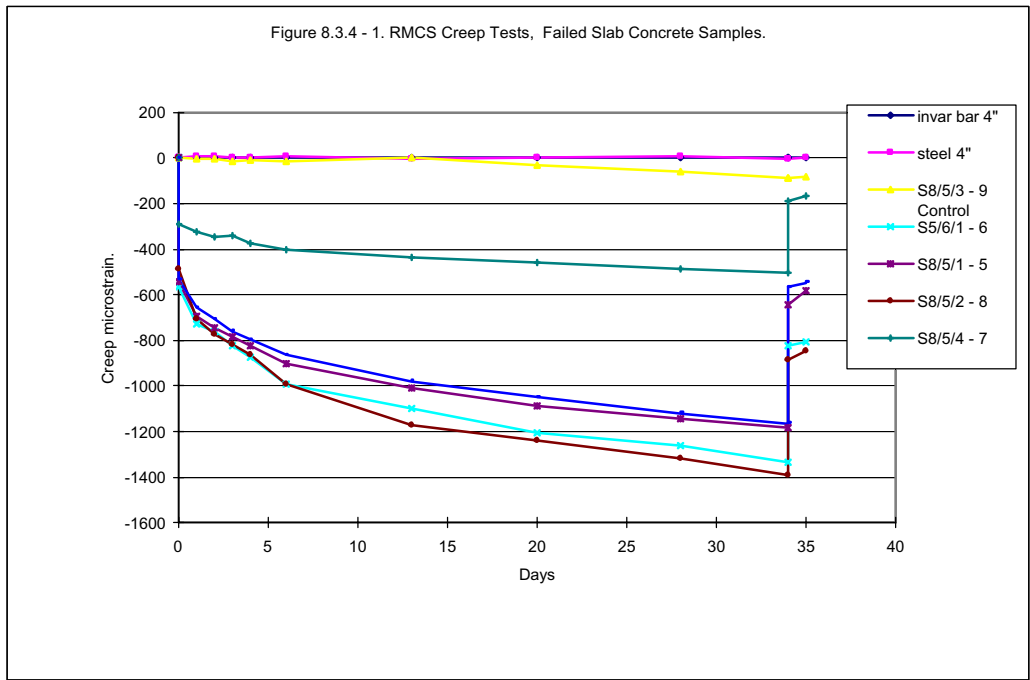
The creep strains are plotted in Figures 8.3.4 - 1 for the failed slab concrete samples. They show that sample S8/5/4 4 - 7 is similar to that expected for a reasonable quality >20N/mm<sup>2</sup> concrete with a good E Young's Modulus of 35kN/mm<sup>2</sup> and a maximum strain after 5 weeks of 500 microstrain. The other four concrete samples were of low quality with lower E and total strains at 5 weeks in the range 1100 to 1300 microstrain, which would have substantially increased long term deflections in the structure. The creep factors (long term strain/short term strain) were 1.75 for 'reasonable' concrete and 2.25 for 'low quality' concrete.

**Figure 8.3.4 - 1. RMCS Creep Tests, Failed Slab Concrete Samples**

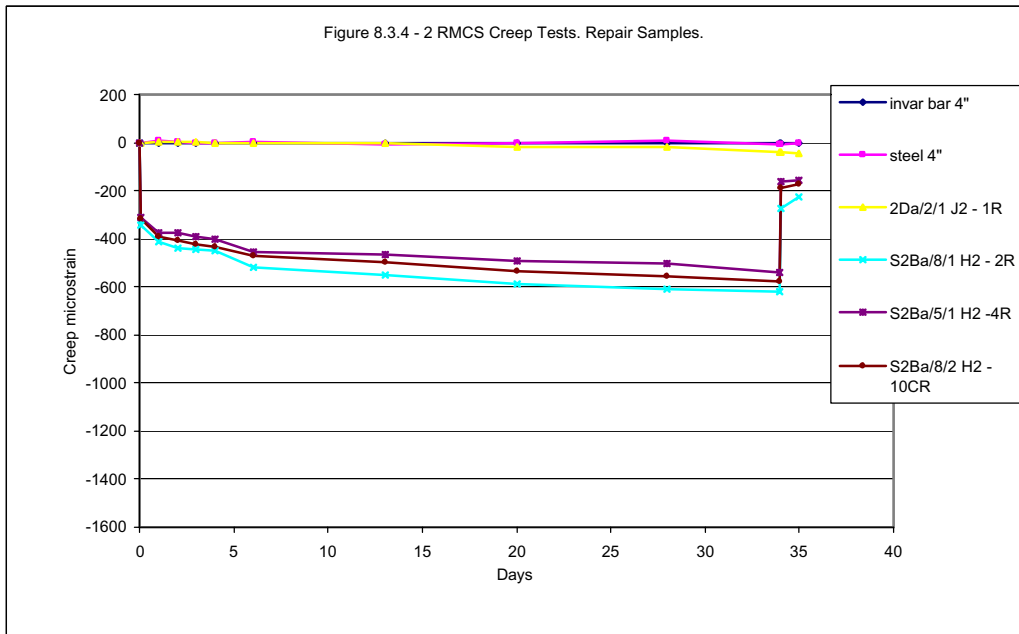
Figures 8.3.4 - 2 shows the creep strains for the repair samples which are similar to the S8/5/4 4 - 7 concrete with total strains at 5 weeks in the range 540 to 620 microstrain well matched to good concrete.

**Figure 8.3.4 - 2. RMCS Creep Tests, Repair Samples**

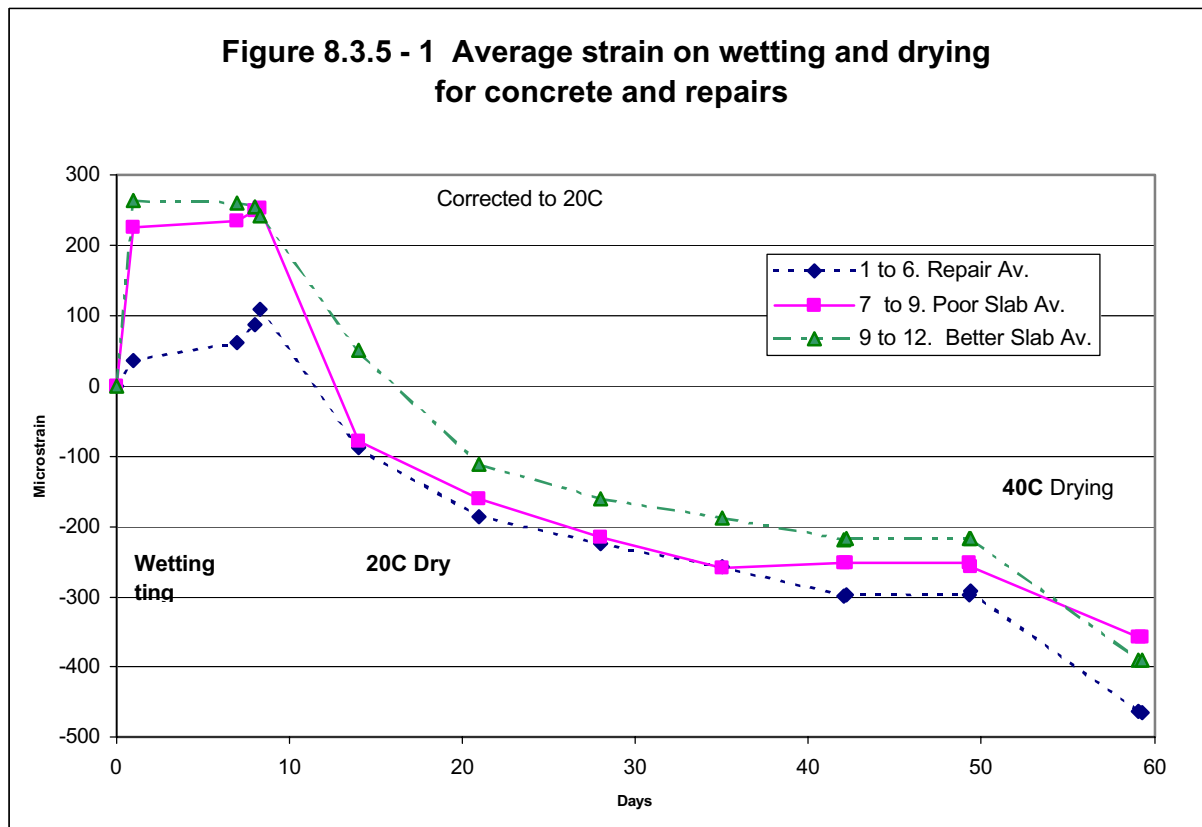
All the samples of concrete had coefficients in the range 10.8 to 12.3, average 11.3microstrain per °C The repair material had coefficients in the range 10.3 to 12.1, average 11.5microstrain per °C These are close to the standard value of 12microstrain per °C used in analysis and there is no differential between the repair and original concrete.

**Figure 8.3.5 - 1 Average strain on wetting and drying for concrete and repairs**

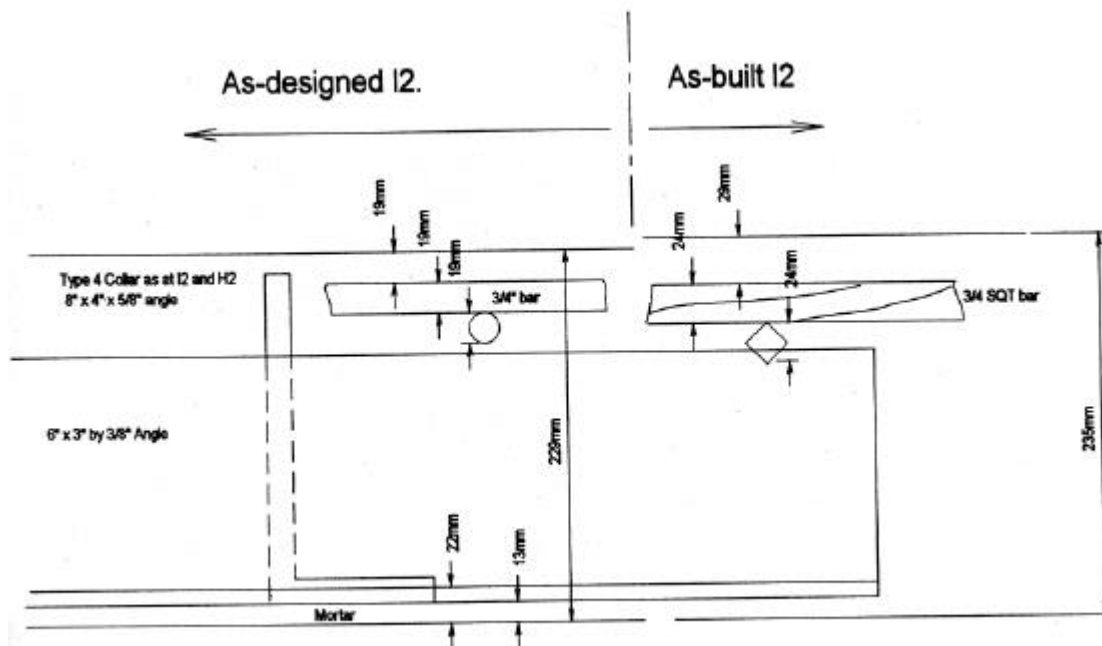
Figure 8.3.9 - 2 As-designed and as-built cover to top reinforcement

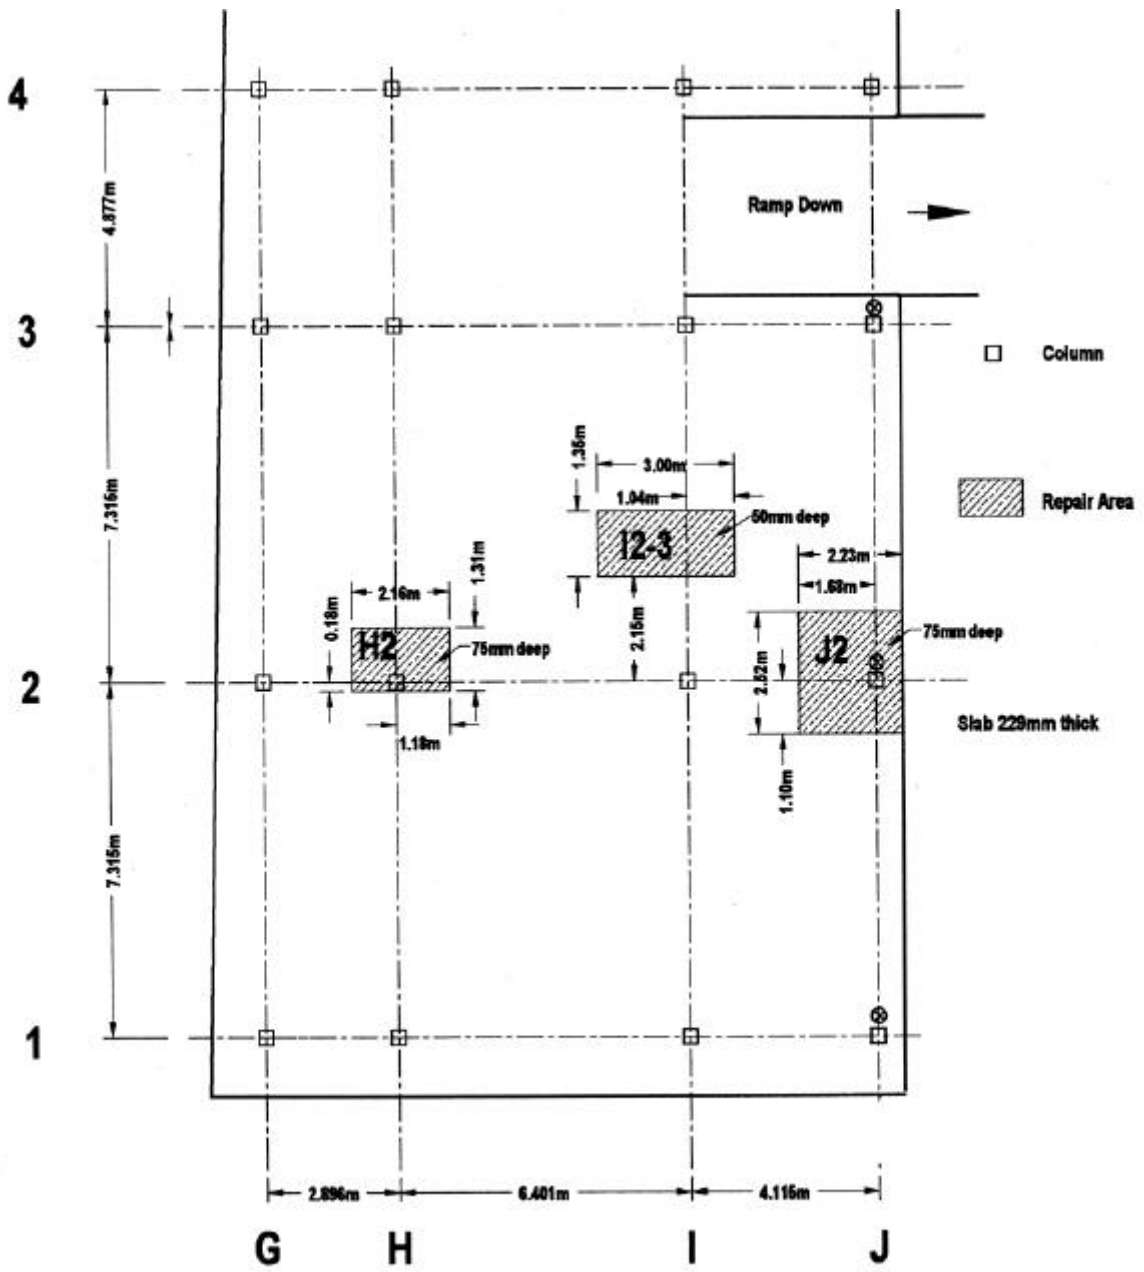
Ref.	From	Size mm	Thickness Range	Thickness Average
S2Ba	H2 Repair Large	1320 x 850	50 to 90	73
S2Bb	H2 Repair Small	1300 x 750	50 to 70	55
2Da	J2 Repair	650 x 400	70 to 90	79
2Db	J2 Repair	460 x 420	50 to 85	66
2Dc	J2 Repair	460 x 320	45 to 65	58

Figure 8.3.10 - 1 Location of repairs

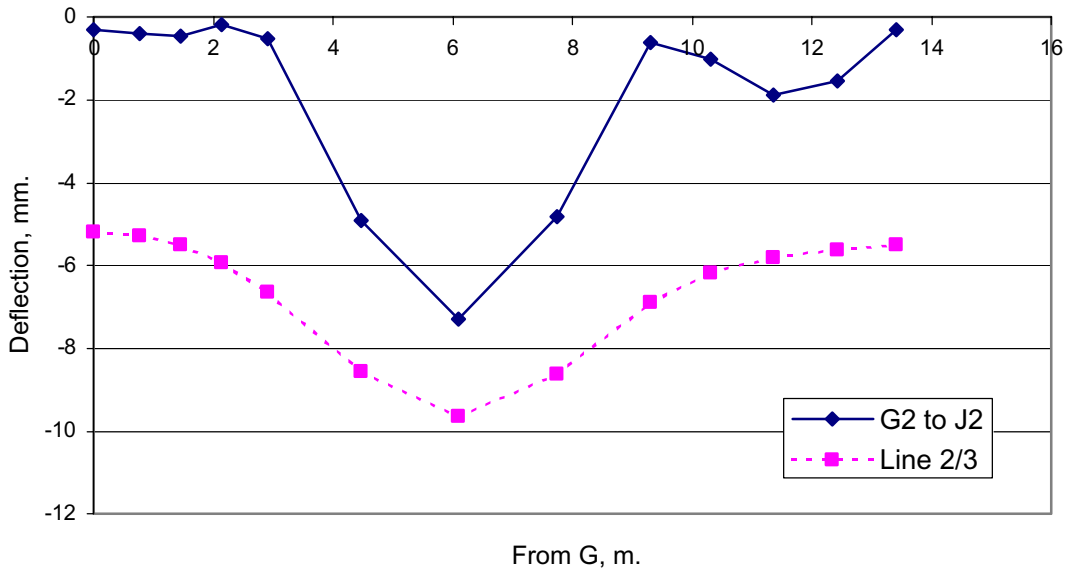
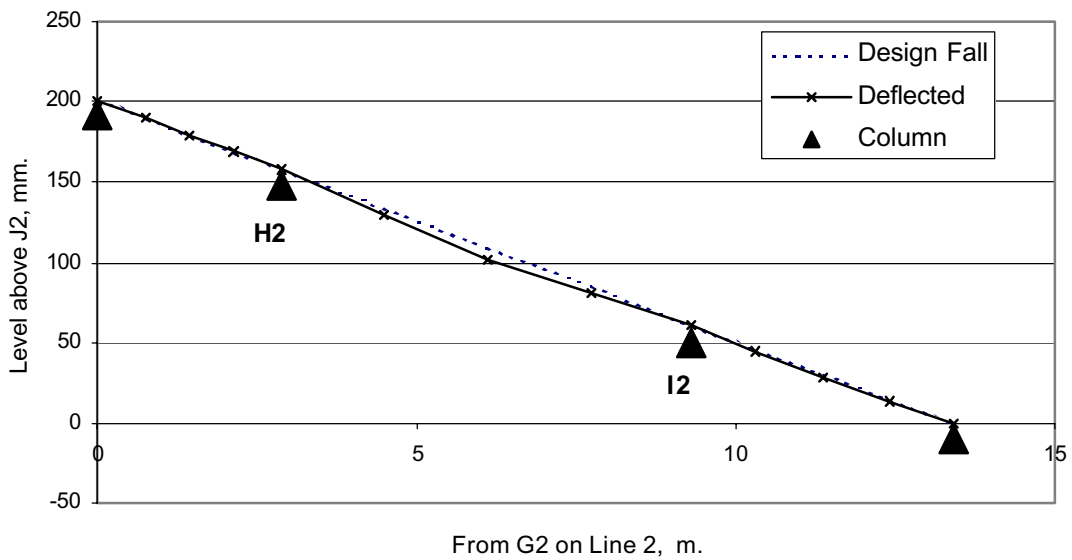
Figure 9.3.1 -1 shows the deflected profiles along the line through column centres from G2 to J2 and the parallel line at midspan between Lines 2 and 3. These are replotted relative to the design fall along Line 2. The design fall from G2 to J2 (201mm in 13.4m i.e. 1 in 67) should have been more than sufficient to prevent ponding on the slab. However actual sagging of the slab did create areas of ponding.

**Figure 9.3.1 - 1 Deflections and Deflected Profile  
from AV ANSYS Cracked Slab run under *RefDL* 5.4kN/m<sup>2</sup>**
