Plank Road/Trail Assessment and Alternatives Report

Date of Assessment: 01/08/2016

Prepared for: Minneapolis Parks and Recreation Board

WSB & Associates, Inc.
701 Xenia Avenue South
Suite 300
Minneapolis, MN 55416

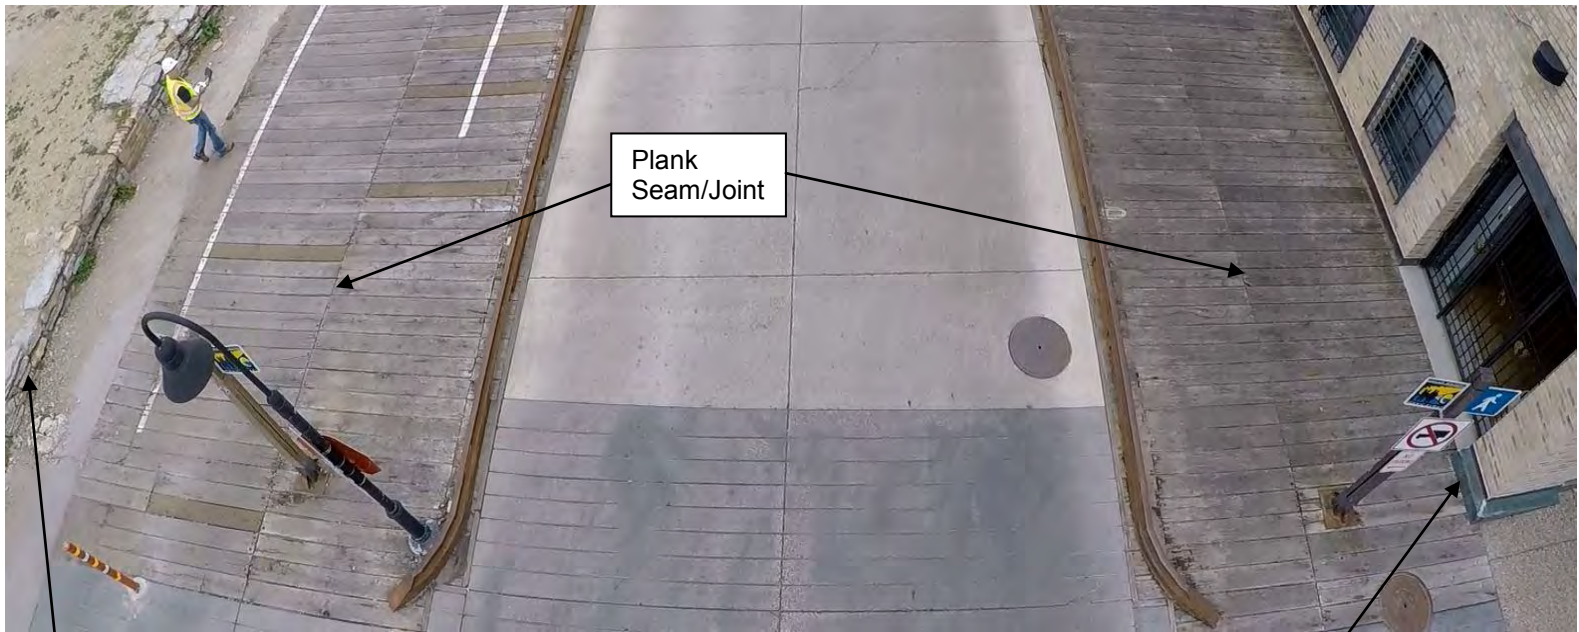
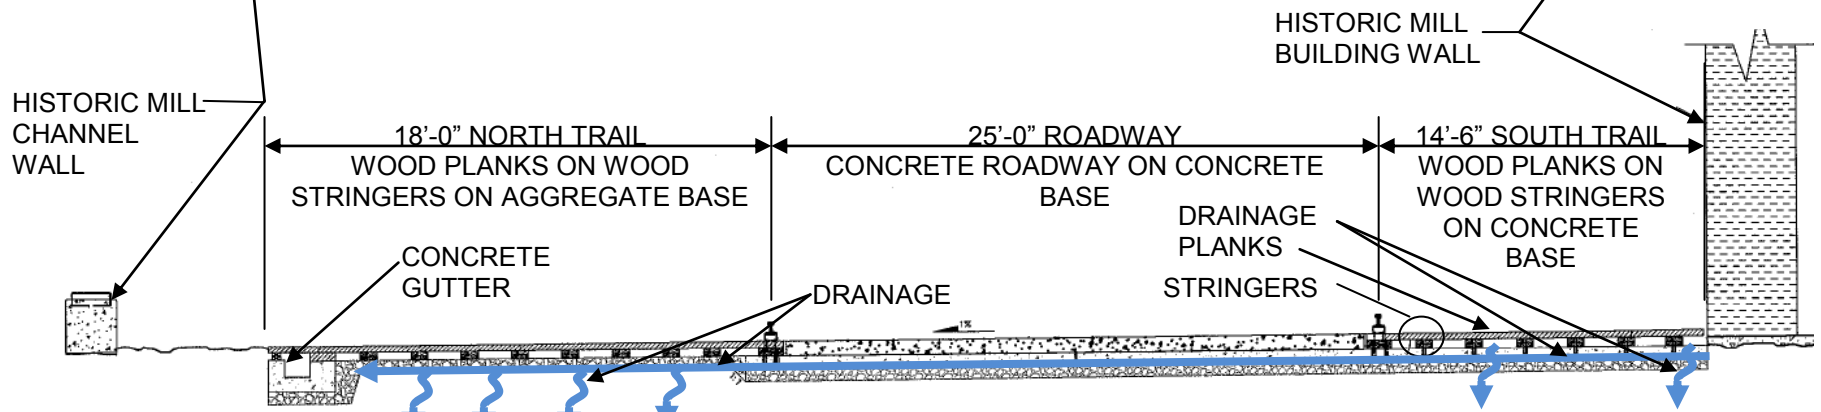
Figure 5: Plank Road/Trail Cross-Section (Looking East)

The remaining portions of original the plank road trail consist of 3"x10" white oak planking (untreated) with a substructure of two 2"x8" (treated) Southern Yellow Pine stringers stacked on top of each other. Below the substructure/stringers on the south side is a six inch concrete slab, while on the north side the stringers bear on 1 foot deep aggregate fill. The wooden planking is held in place with lag bolts and the pine stringers are held in place with anchor bolts to the concrete slab. Below the concrete subgrade lies the historic waterpower canal, which has been filled with sand to protect it.

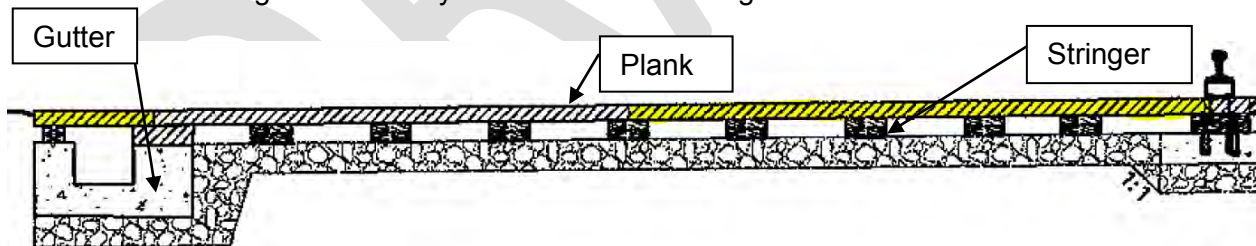
Figure 21: Typical Section Alternative 2
(Yellow highlight indicates typical areas of removal/replacement)

Materials:	\$5,000 (\$5/LFT x 800 LFT + Hardware)
Labor:	\$10,000
Total:	\$15,000/year

- Pros
 - Can be done as budget and time allow
 - Low cost
 - Historical context is maintained
 - Cost effective solution until stringers need replacement
 - Trails do not need to be closed for long duration
- Cons
 - Not a long term solution (roughly 10-20 years)
 - Repairs or modifications to the subgrade can't be performed
 - Will get more costly as trail continues to age

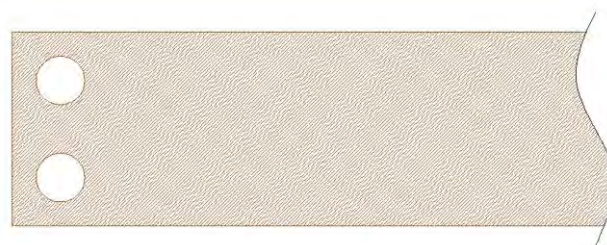
Figure 22: Plank with Anchorage in Each Corner

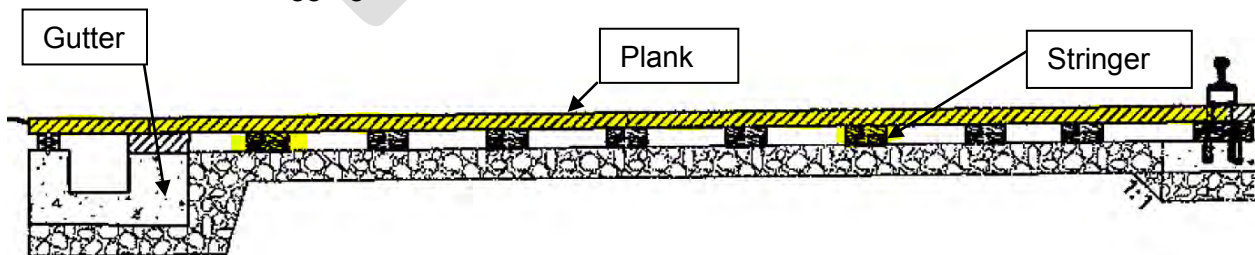
Figure 23: Typical Section of Alternative 3
(Yellow highlight indicates typical areas of removal/replacement)

Materials Cost:	\$130,000 (\$5/LFT X 22,000 LFT + Hardware)
Labor Cost:	\$230,000
Total Cost:	\$360,000

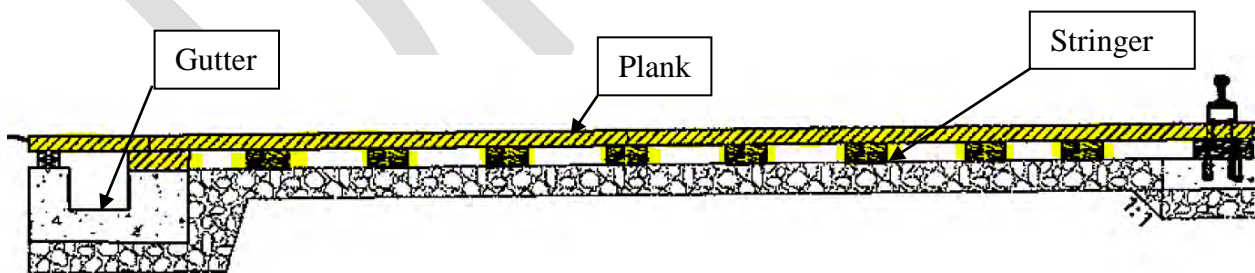
Figure 24: Typical Section of Alternative 4a
(Yellow highlight indicates typical areas of removal/replacement)

Materials Cost:	\$200,000 (\$6/LFT X 28,000 LFT + Hardware)
Labor Cost:	\$380,000
Total Cost:	\$580,000

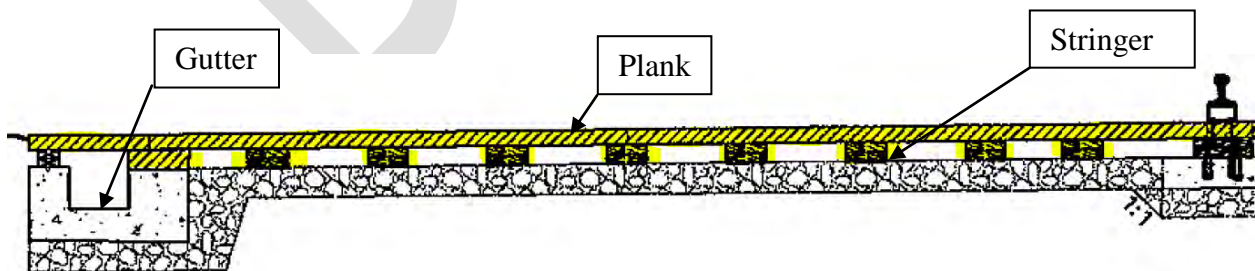
Figure 25: Typical Section of Alternative 4b
(Yellow highlight indicates typical areas of removal/replacement)

Materials Cost:	\$420,000 (\$20/ SFT Concrete/Composite Base & Stringers with Timber Planks)
Labor Cost:	\$400,000
Total Cost:	\$820,000

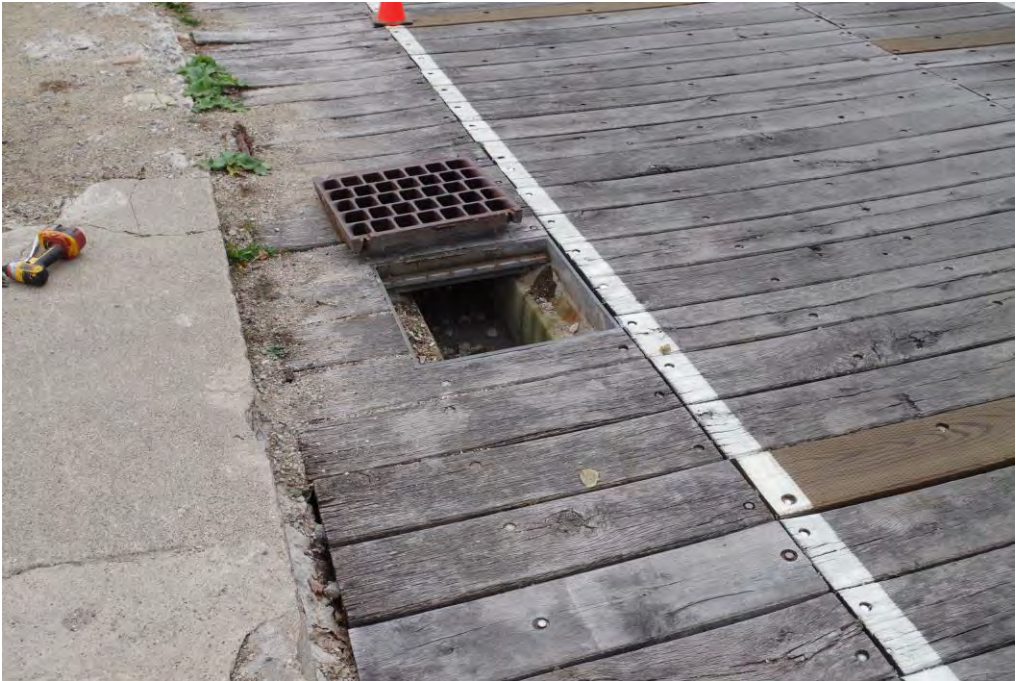
Figure B-1: Drainage Grate on North Trail

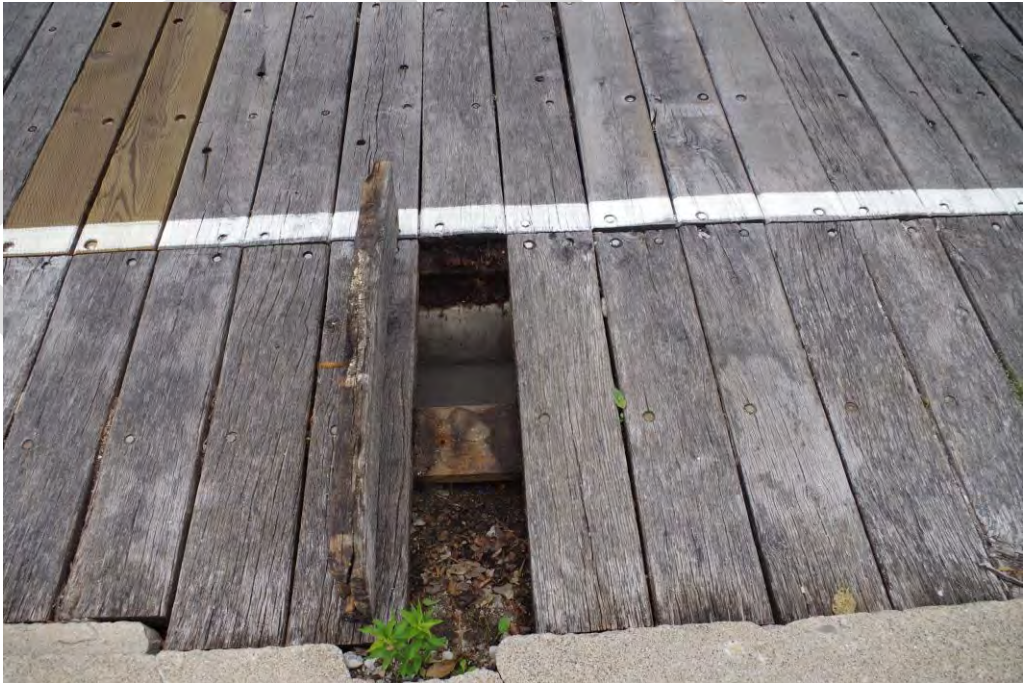
The day after a rain event WSB visited the plank road and observed that the concrete gutter system along the north end of the north trail appeared to be unused. The cleanliness of the concrete gutter after 10 years is evidence that it is not being used. The storm water is likely draining directly into the groundwater through the north trail's aggregate base. Figure 14 shows the gutter one day after a rain event.

Figure B-2: Top View of Gutter at North Trail

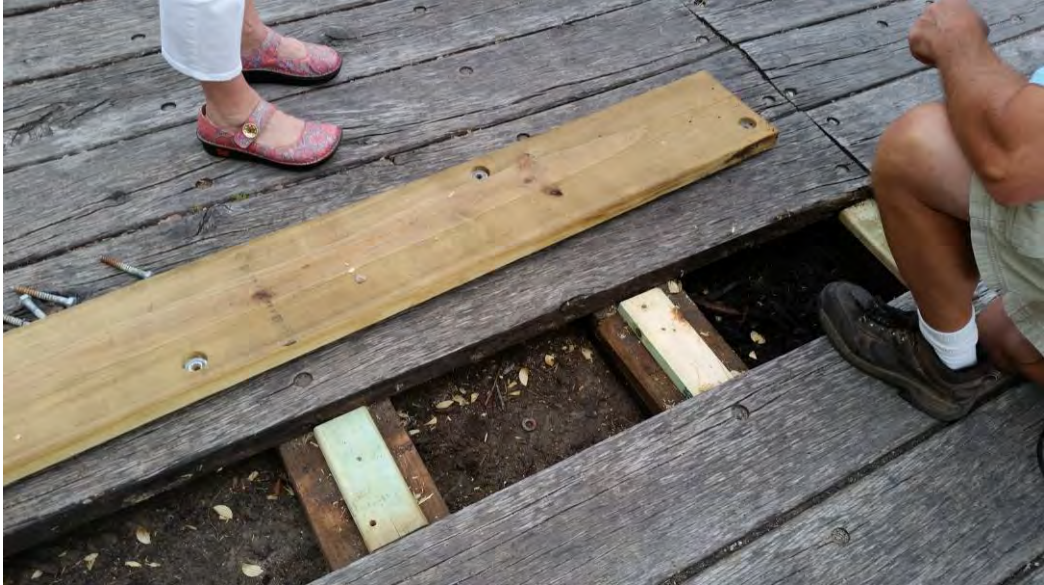
Figure B-5: Replacement Plank at South Trail (Concrete Base)

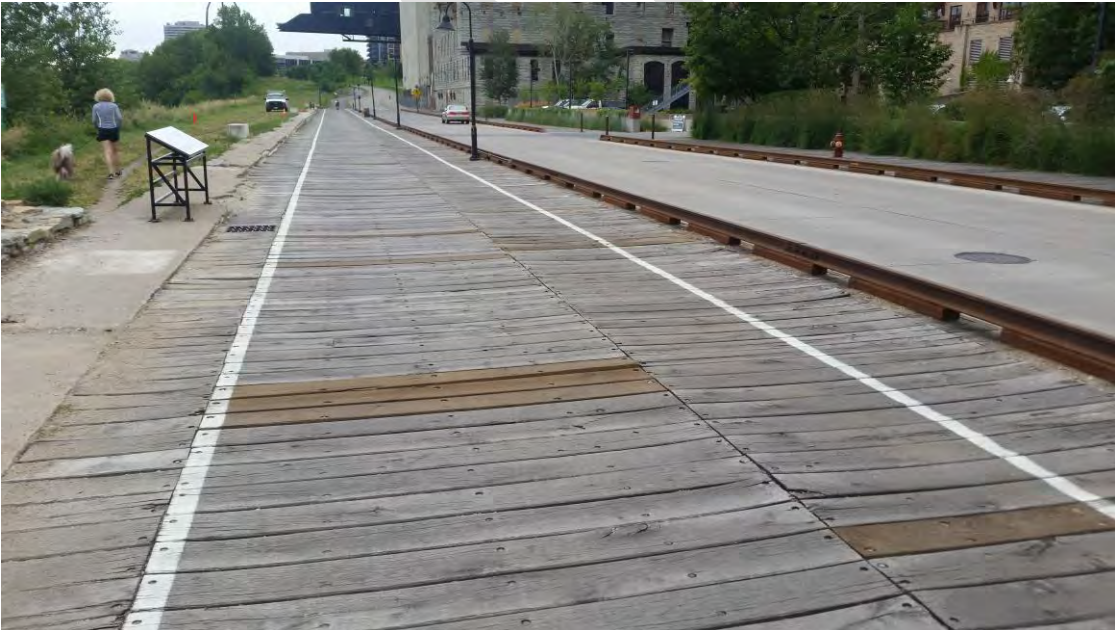
Figure B-9: View from the North Trail Looking East

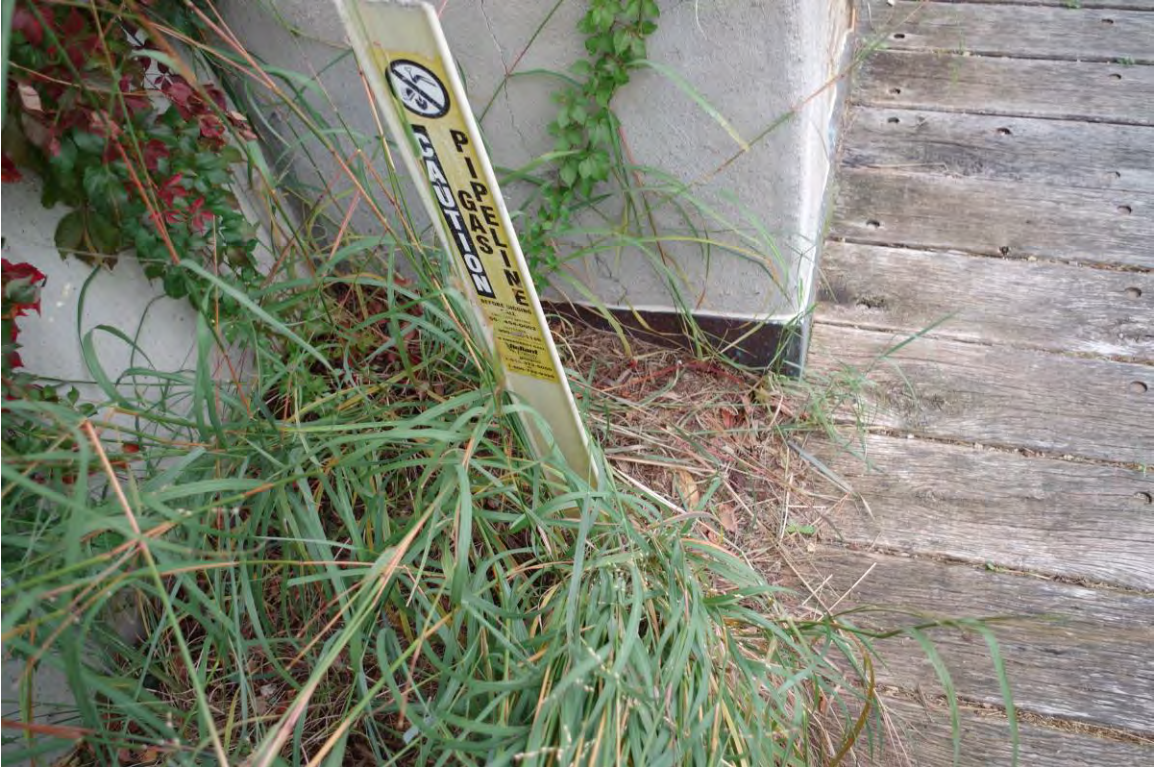
Figure B-10: Gas Pipeline on the South Trail

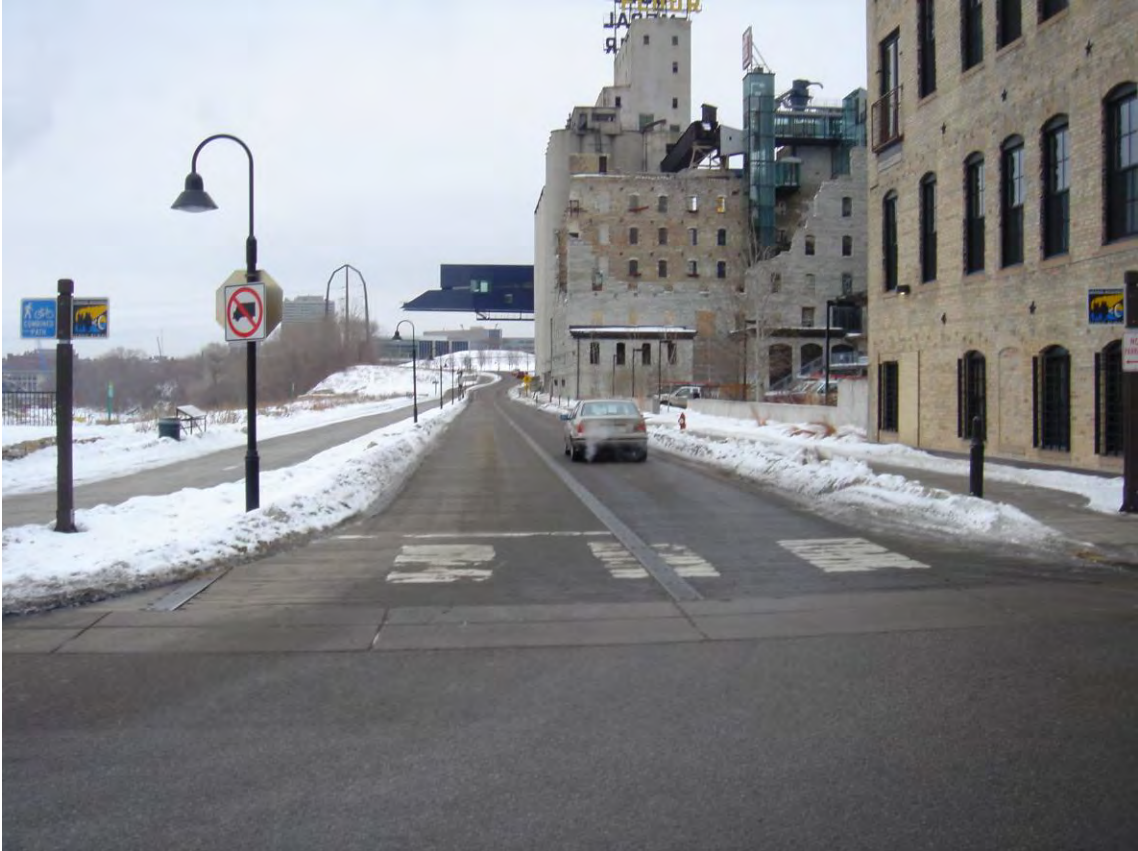
Figure B-12: Plank Road in winter before Road was Rebuilt (Circa 2010)
