PREPARATORY SURVEY REPORT
ON
THE PROJECT FOR
REHABILITATION OF METEOROLOGICAL RADAR SYSTEM
IN
GUIUAN
IN
THE REPUBLIC OF THE PHILIPPINES

May 2014

JAPAN INTERNATIONAL COOPERATION AGENCY

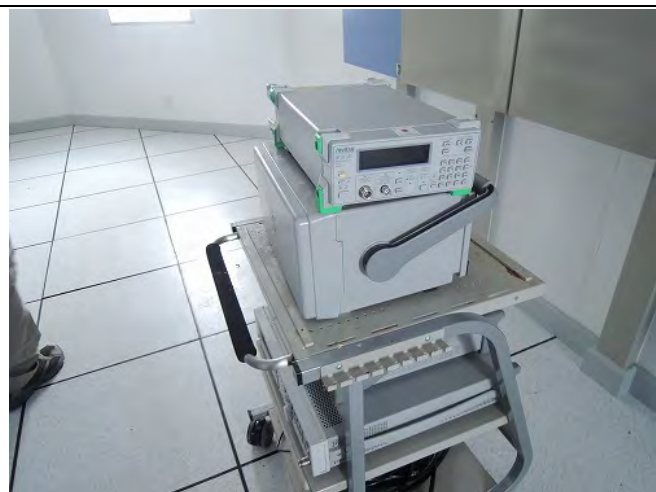
M4F Radar Equipment Room (Measurement Equipment)

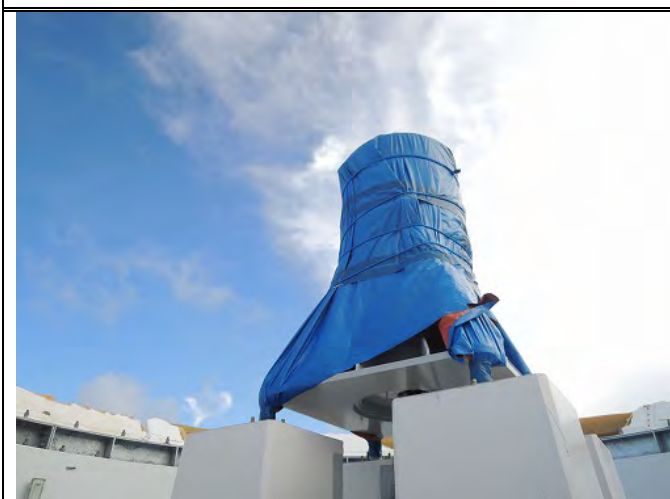
6F Radome Room (Antenna Pedestal)

Radar Antenna (Pedestal)	Destroyed	Replacement	Equivalent to the existing one

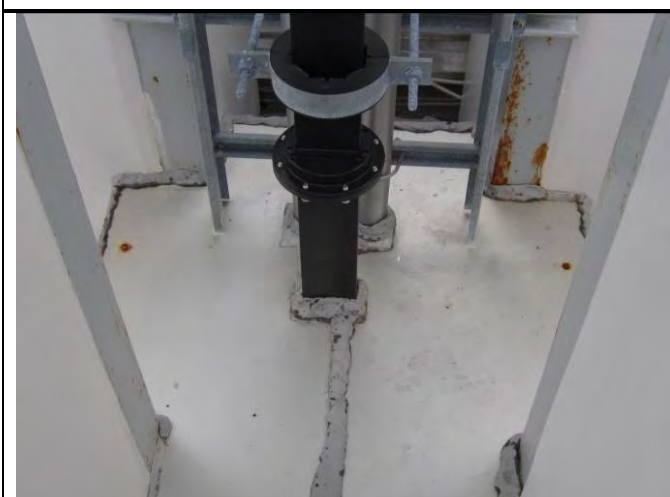
6F Radome Room
(Cover of the Cable Duct)

Cable Duct	Damaged	Replacement/ Reinforcement/ Repair	<ul style="list-style-type: none"> ■ Attach the tough cable duct inspection door which is created in Japan. ■ Reinforce with the Stainless angle ■ To install 3 water leakage protection at the top of the cable duct in the radome room and inside duct.

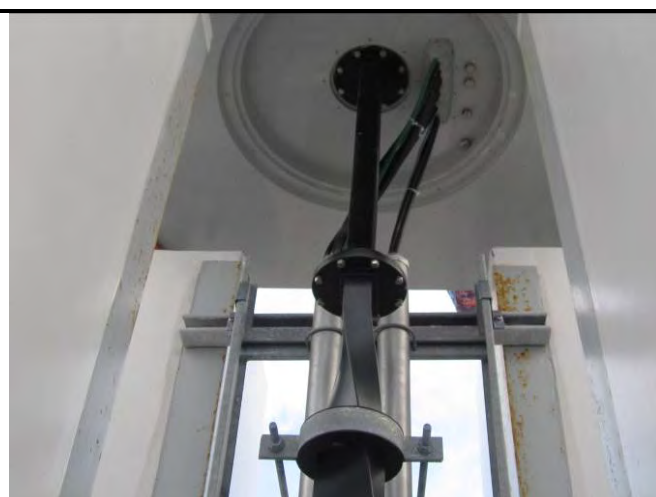
6F Radome Room
(Wave-Guide Configuration of the Pedestal Bottom)

Wave-guide Configuration	Damaged	Replacement	Equivalent to the existing one

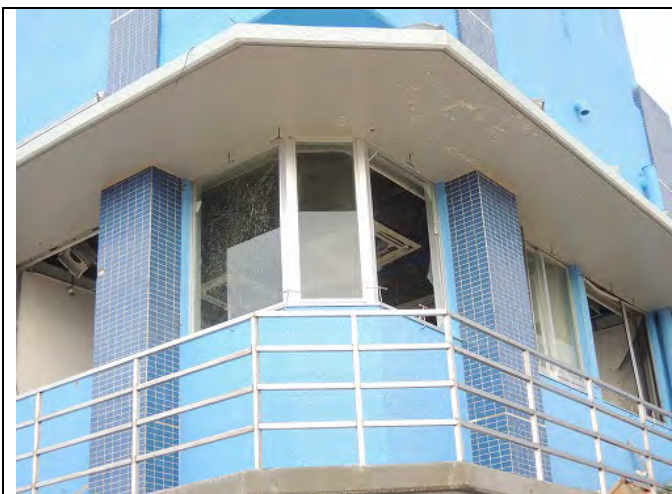
Observation Room from the Southeast Side of the Facility

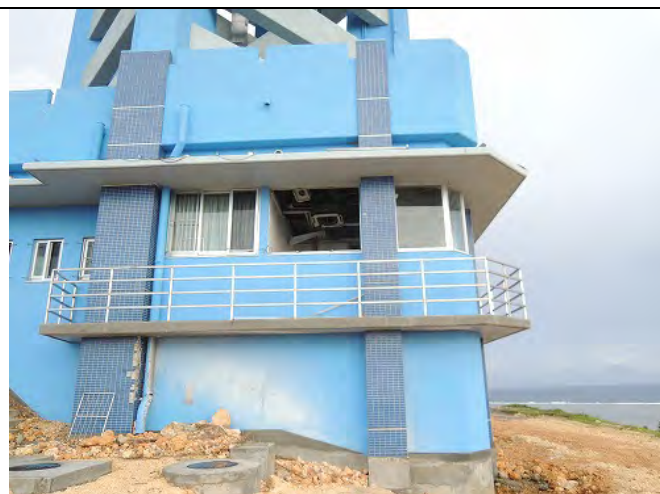
Observation Room from the South Side of the Facility

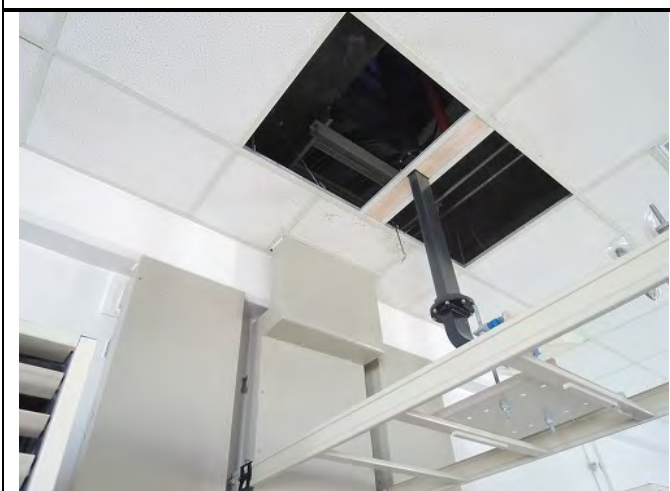
M4F Radar Equipment Room
(Ceiling of the 5F Cable Duct Bottom)
