Put Your Report Title Here

Infra-Red Imaging Documentation

Infrared Moisture Survey Report

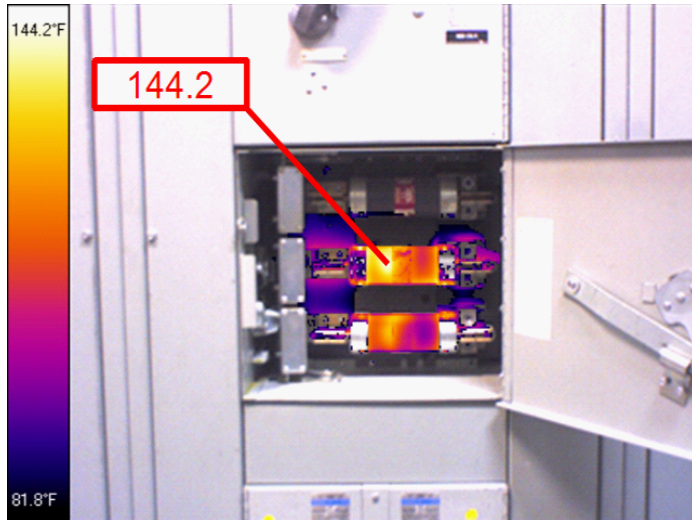
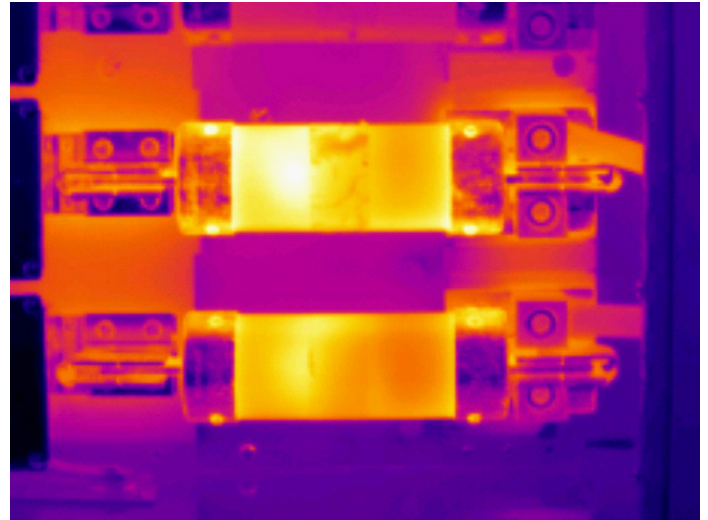
Image Information						
Temperature Information			Camera Information			
High	Low	Average	Company	ISI		
144.2°F	81.8°F	143.3°F	Model	FLXP320F		
Calibration Range	BkGround Temp	Emmissivity	Lens Type			
-4.0°F .. 212.0°F	68.0°F	98	Sensor Size	Width - 320	Height - 240	
Concerns						
-

Suggestions						
-
