PV Module and System Fault Analysis

VijyantMahajan

Thesis Supervisor: Dr. David Parlevliet

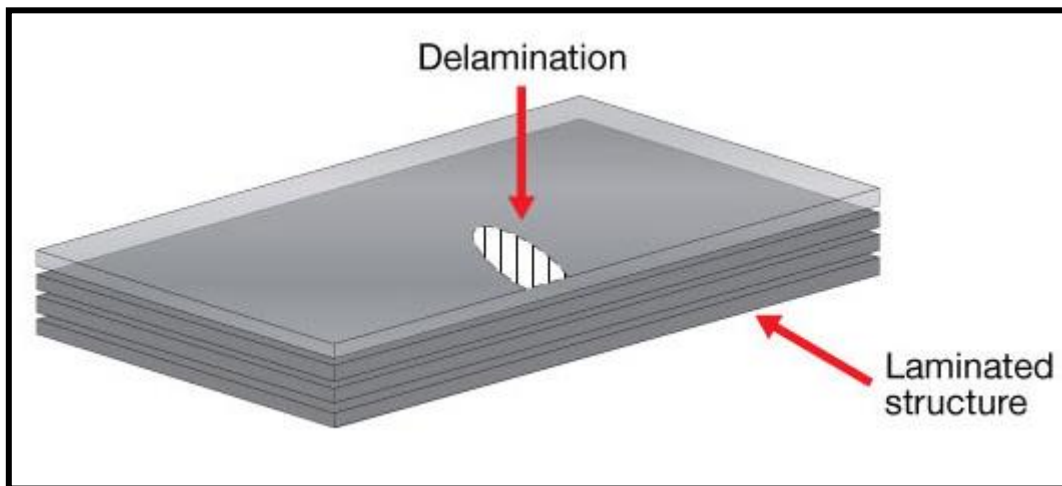
Delamination is the detachment of the layer of a PV module from its panel. It is mainly caused by humidity and moisture ingress. (Roest, Top 3 quality issues in solar panels, 2013)

This will affect the performance of the cell. If the cell is used continuously after its delamination, moisture may get into the cells causing corrosion and other on-going damage to the module. (Clean Energy Investment, 2014)

Figure 31: Delamination of PV module (Source: (Olympus, 2014))

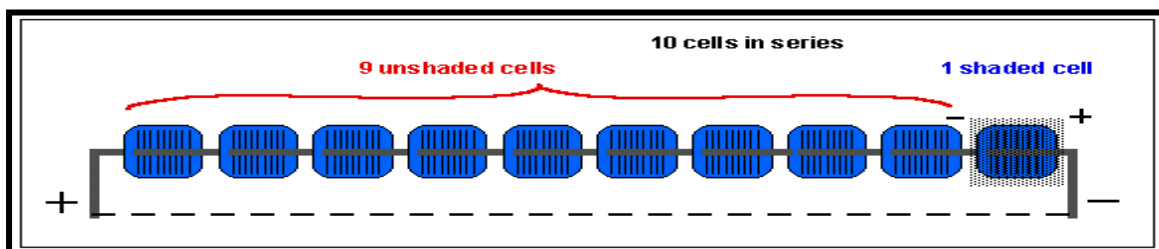
Most common cause of hot spot is the resistive heating of the shaded cells. This usually happens in the case of faulty bypass diode and defective soldier joints. (Daniel W. Cunningham, 2011)

Figure 39- Hot Spot Phenomena Case (Source: (Christiana Honsberg, 2014))

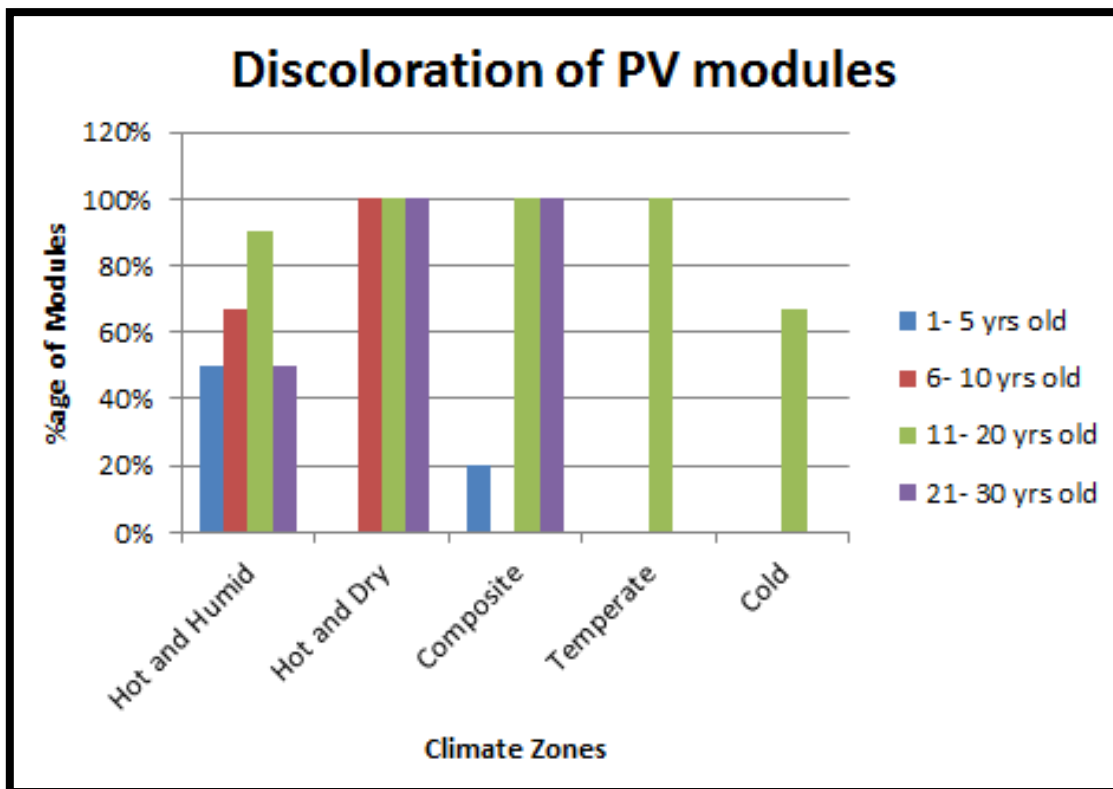
Figure 59 demonstrates the percentage of the PV modules in different climate zones which shows the discoloration in the front of the module. It is shown that in hot and dry climate, every module shows discoloration of the front encapsulant after 5 years of operation in the field. In Hot and Humid Climate, 90% of the modules which shows the discoloration are 11-20 years old. 50% of the PV modules in hot and humid climate show discoloration in their first 5 years of operation in the field. In composite climate zone, 20% of the modules got front discoloration in their first 5 years; however 100% of the modules show discoloration after their 11 years of the operation in the field. In temperate climate zone, 100% of the modules got discoloration after 11 years and 65% of the modules in cold region show front discoloration after 11 years of the use in the field. (Rajiv Dubey, 2014)

Figure 59- Discoloration of PV modules/ encapsulant with different climate zones. (Illustration: (Rajiv Dubey, 2014)

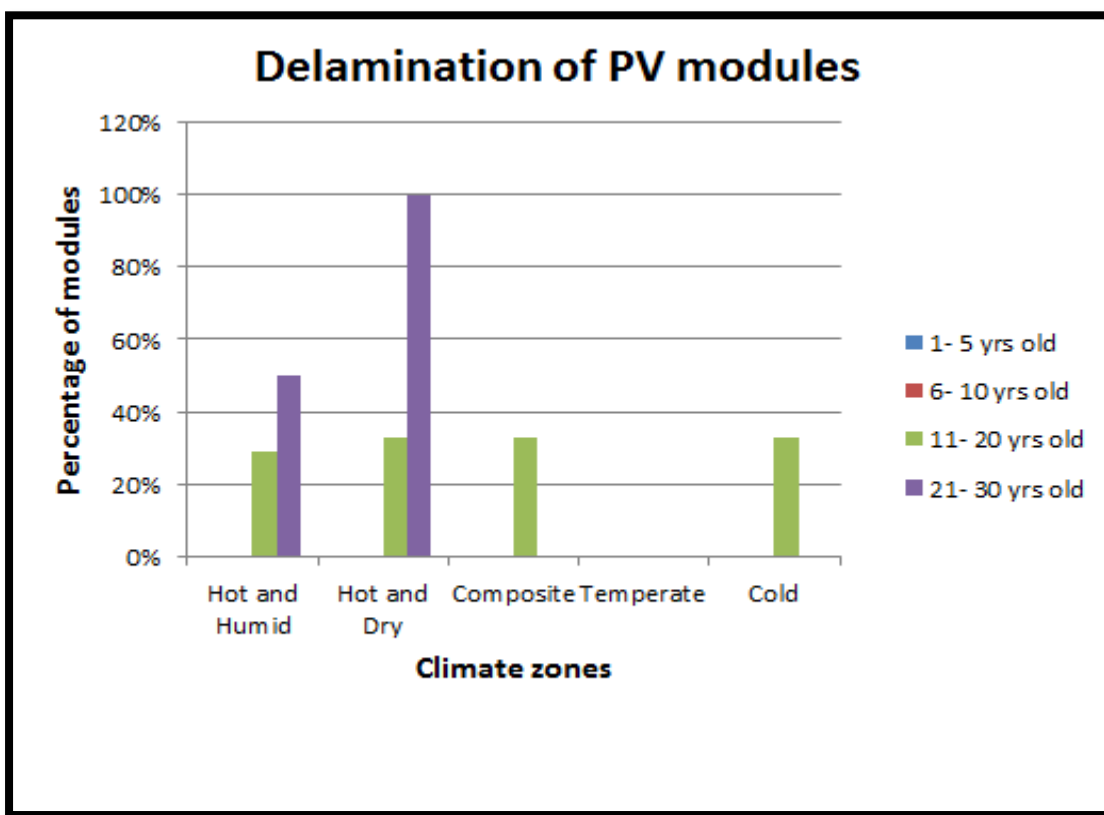
Figure 60 shows the percentage of the PV modules in different climate zones that got the delamination of the modules. It is clearly shown that 100% of the modules which are more than 21 years old show the sign of delamination in Hot and Dry climate, and 50% of the modules which are 21 years old got delamination in Hot and Humid climate. About 30% of the 11-20 years old modules show delamination of PV modules in all the climate zones except temperate climate zone. No delamination of PV module is recorded in the temperate zone. (Rajiv Dubey, 2014)

Figure 60- Delamination of PV modules with different Climate zones. (Illustration: (Rajiv Dubey, 2014)

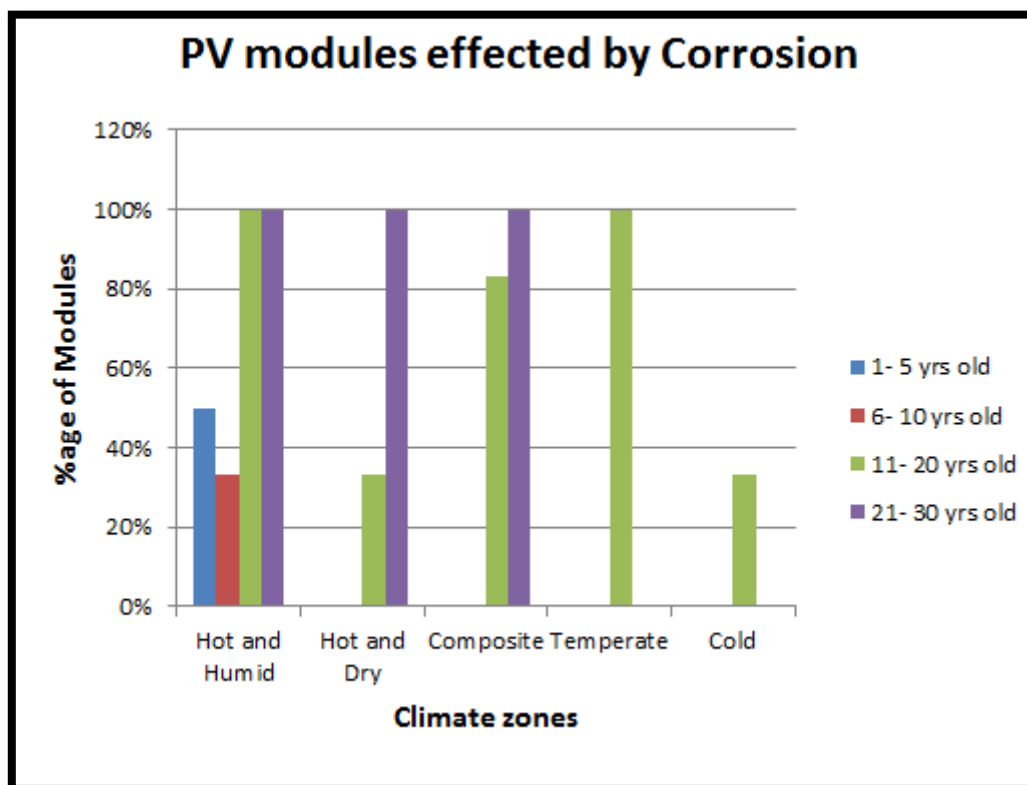
Figure 61 represents the percentage of the PV modules which are affected by the corrosion of the PV modules. It shows that in hot and humid climate, 100% of the modules got corrosion which are 11-20 years old and 21-30 years old. 30% of the modules which are 6-10 years old show corrosion and 50% of the modules which are less than 5 years old shows corrosion. In hot and dry climate, 100% of the 21-30 years old modules are corroded, 35% of the 11-20 years old modules and none of the modules which are less than 10 years old shows the sign of corrosion. In composite climate, more than 80% of the 11-20 years old modules show corrosion and 100% of the 21-30 years old modules shows corrosion. In temperate zone, 100% of the 11-20 years old modules are affected by the corrosion. No other data is recorded for the other modules in the field. In cold climate, 30% of the 11-20 years old modules are affected by corrosion. No other data is recorded for the other modules in the field. (Rajiv Dubey, 2014)

Figure 61- PV modules affected by Corrosion with different Climate zones. (Illustration: (Rajiv Dubey, 2014)

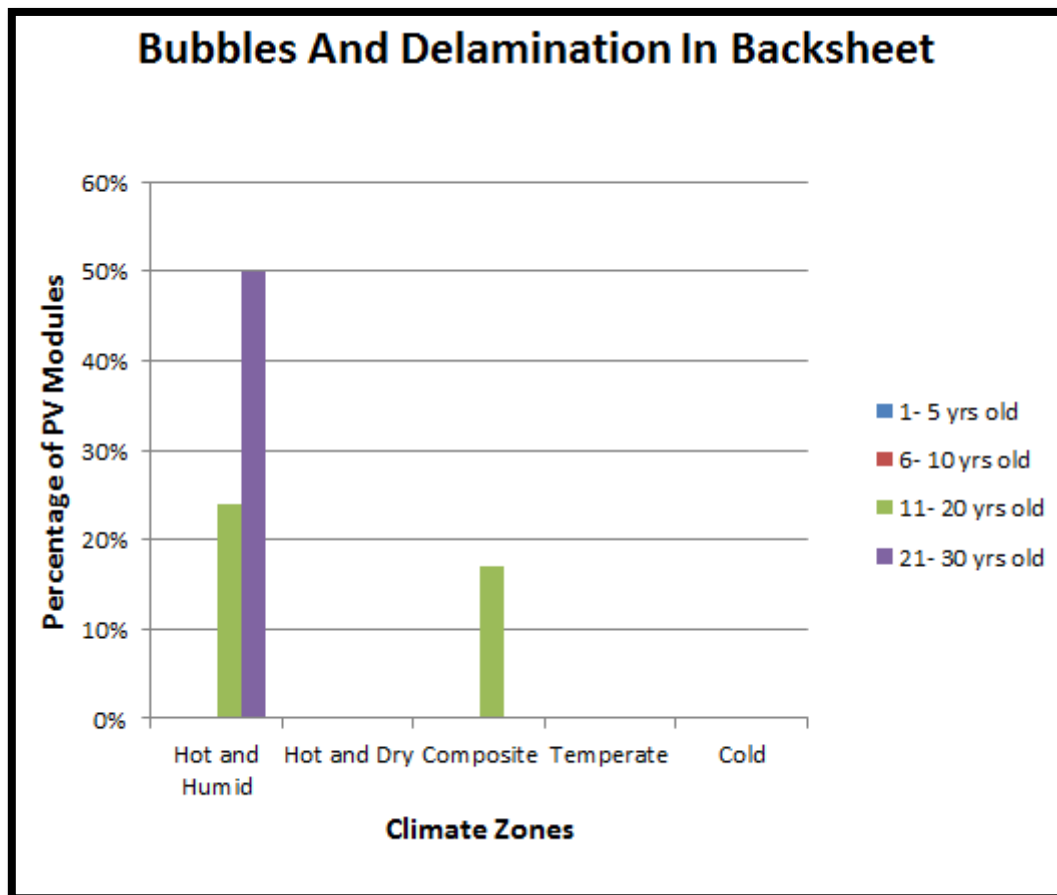
Figure 62 shows the percentage of the PV modules which shows the visible signs of bubbles and delamination on the back sheet of the PV module. The graph shows that in hot and humid climate, 50% of the 21- 30 years old modules shows that bubbles and delamination of the back sheet and 24% of the 11- 20 years old PV modules shows the same signs. 18% of the 11-20 years of the PV modules in composite climate zone shows this issue in the PV modules. No other data is recorded for other climate regions regarding this fault in the modules. (Rajiv Dubey, 2014)

Figure 62- PV modules with bubbles and delamination in the back sheet. (Illustration: (Rajiv Dubey, 2014)

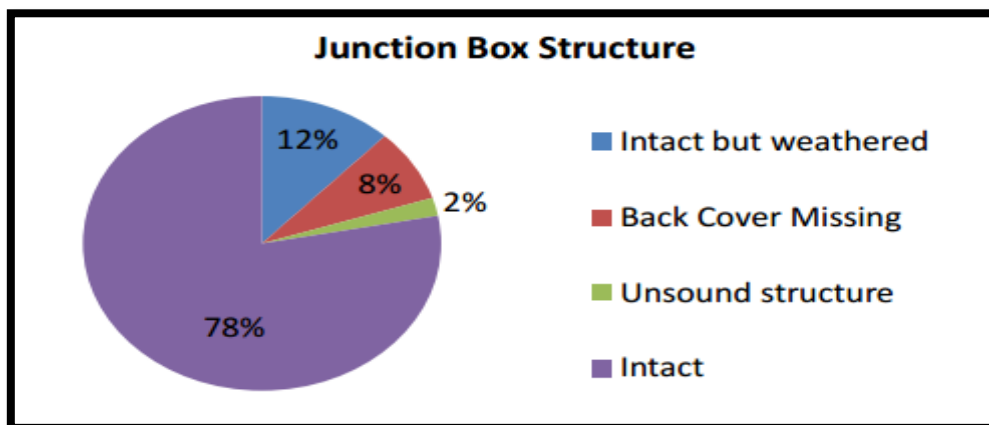
Figure 63 represents the results from the survey which shows the structure of the junction box. It is shown that 78% of the junction boxes are undamaged. 12% of the junction boxes are undamaged but weathered due to the environmental conditions. 8% of the junction boxes got their back cover missing, and 2 % of the junction boxes got structural damage.

Figure 63- Condition of the Junction Box. (Illustration: (Rajiv Dubey, 2014))

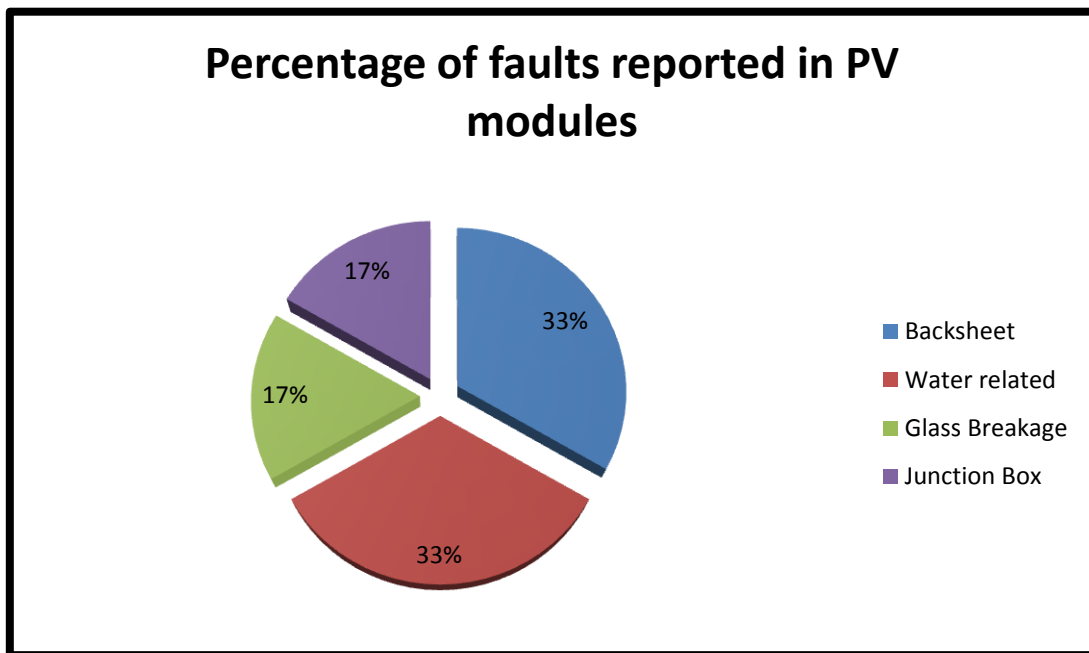
Figure 90- Faults reported with PV module Panels in the PV module system

The chart below (Figure 90) shows the types of faults reported to the PV module panel in the Photovoltaic module system. 33% of the faults are related to the back sheet of the PV modules and 33% are the moisture related faults. These two areas are the areas of major concern. Water ingress normally happens in the regions of high rainfall. Majority of the Australian population lives in the Temperate zone where good amount of rainfall is received during the rainy season and throughout the year except summers.

17% of the faults are reported which are related to the Glass breakage of the panel and another 17% of the faults are related to the junction box which is located behind the panel on the back sheet of the PV module.

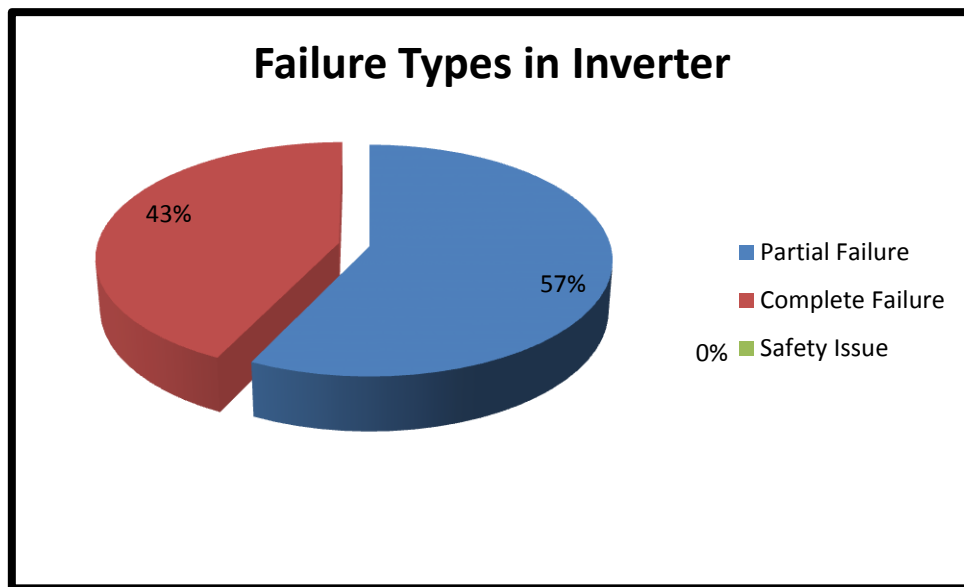
Figure 91- Types of Inverter faults reported

Inverter related faults are on the top of the list of the various components in the Photovoltaic module system where faults are reported. In this survey, 48% of the faults are reported which are related to the inverter of the Photovoltaic Module system. Faults in the inverter will produce a direct impact on the system performance. It often lead to the partial and complete failure of the system.

In this survey, as shown in Figure 91 respondents provide the information which represents that in 43% of the cases of the inverter problems, system fails completely. While in 57% of the cases, partial failure of the system is reported.

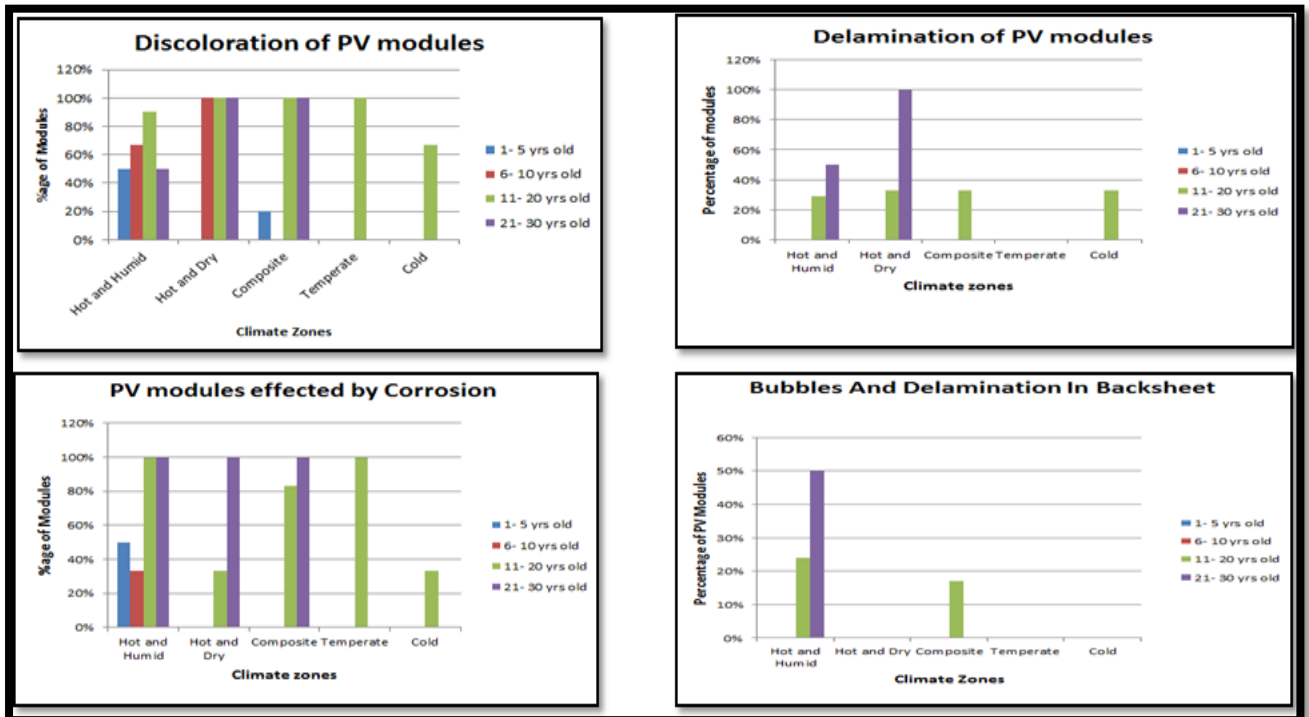
Figure 93- Visible faults in PV modules represented with their age and climate zone location (Source: (Rajiv Dubey, 2014))

All India Survey of PV degradation (Refer section 5.3.5.2 for detail) also shows that these visible faults are more likely to appear quickly in hot and humid climate and then in hot and dry climate as compared to the cold climate, shown in Figure 93.

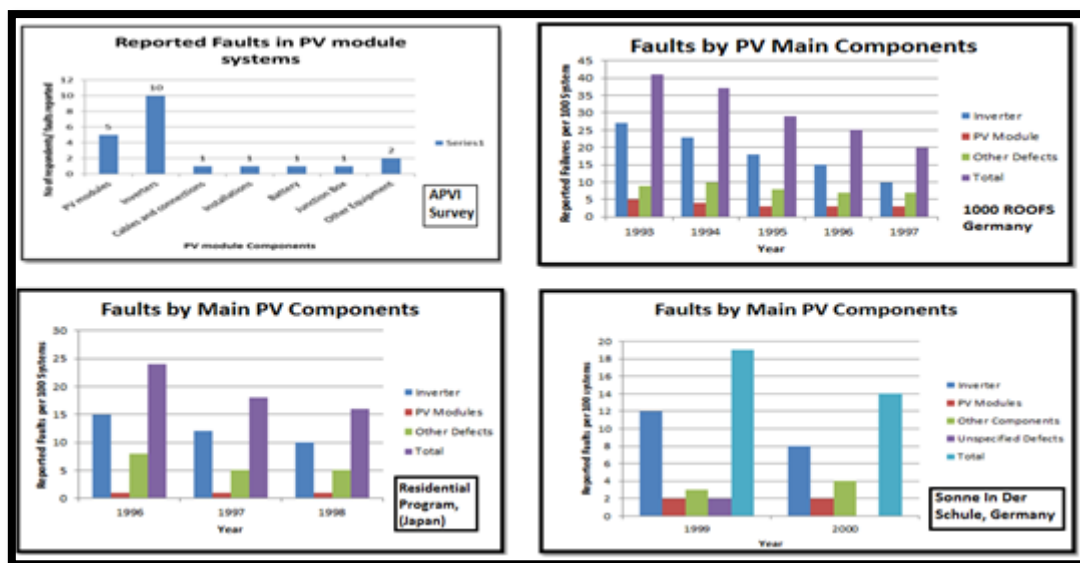
Figure 95- Some results which shows the faulty components in the PV module system (Illustration: (Laukamp, 2002))

APVI survey results (section 6.4.1.6) also shows that the inverter is the most common component in the PV module system. About 50% of the total faults reported are related to the inverter of the PV module system. Other surveys including 1000 roofs Germany, Residential program Japan and Sonne der schule Germany as discussed in the section 5.3.12 shows the similar results where most of the faults are related to the inverter of the PV module system as shown in Figure 95. Graphs in Figure 95 also shows the information from the other 3 surveys which suggests that the total number of faults are decreasing with the time every year. So, it suggests that continuous improvements have been made in designing the PV modules during those years.
