REPORT OF APOLLO 13 REVIEW BOARD

NATIONAL AERONAUTICS AND SPACE ADMINISTRATION

June 15, 1970

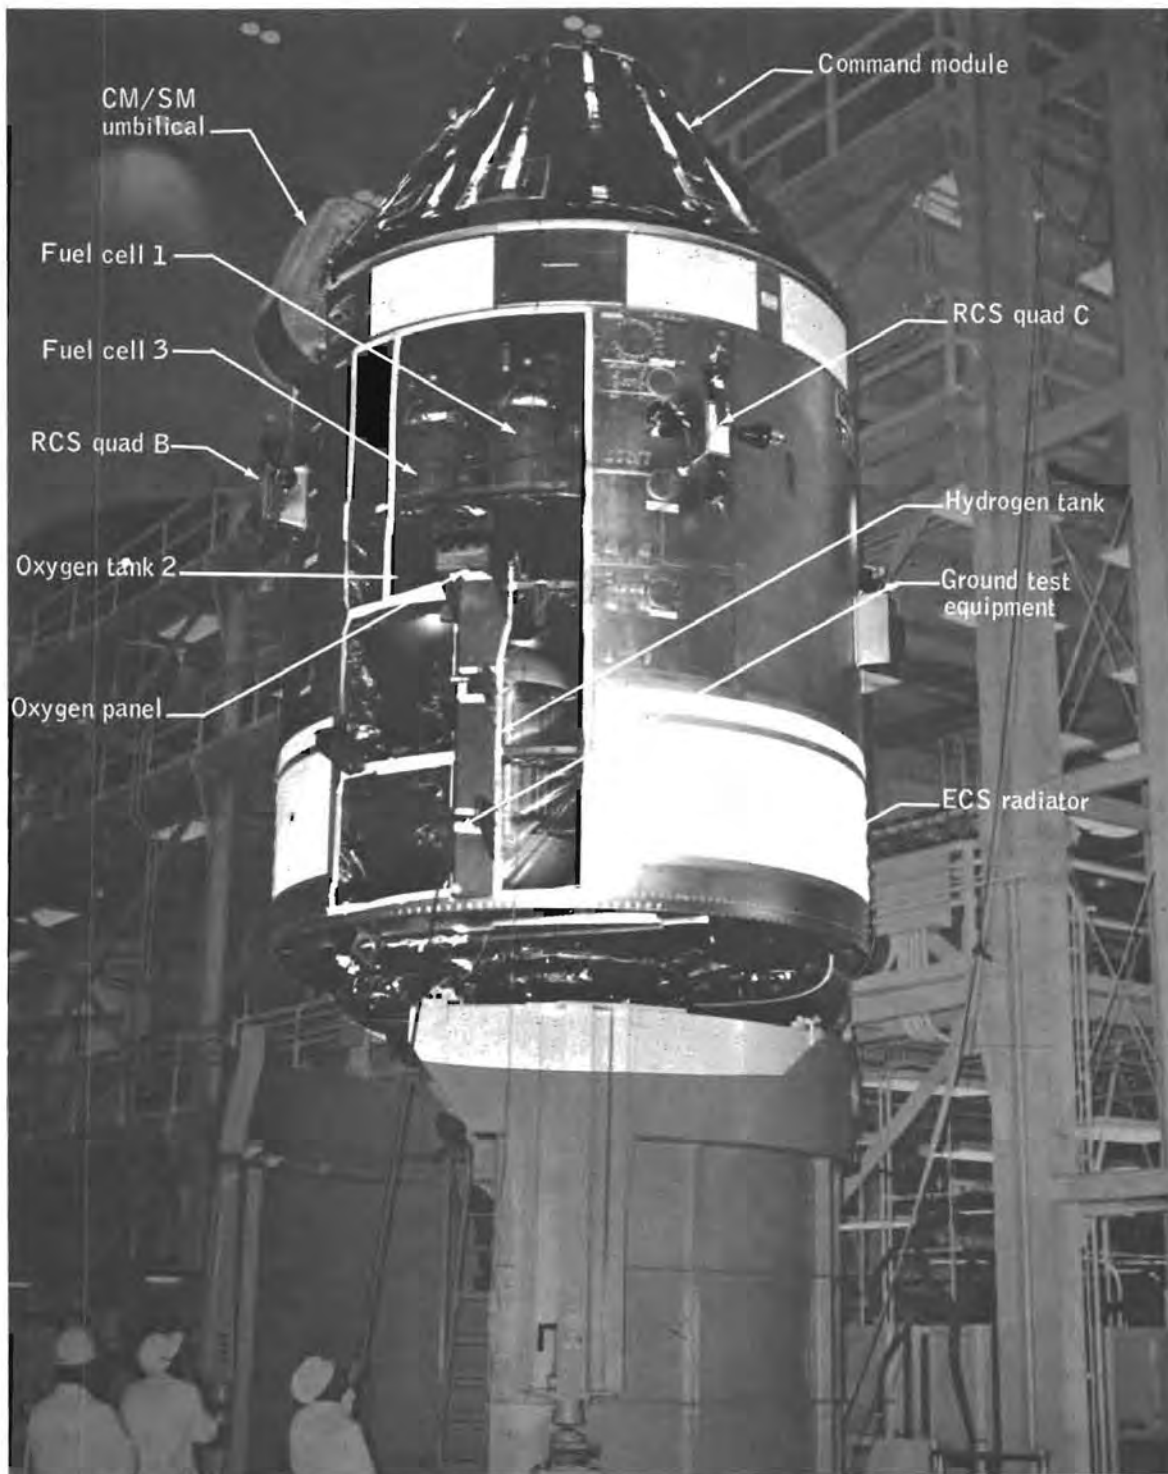
CSM in ground test with bay 4 panel removed.

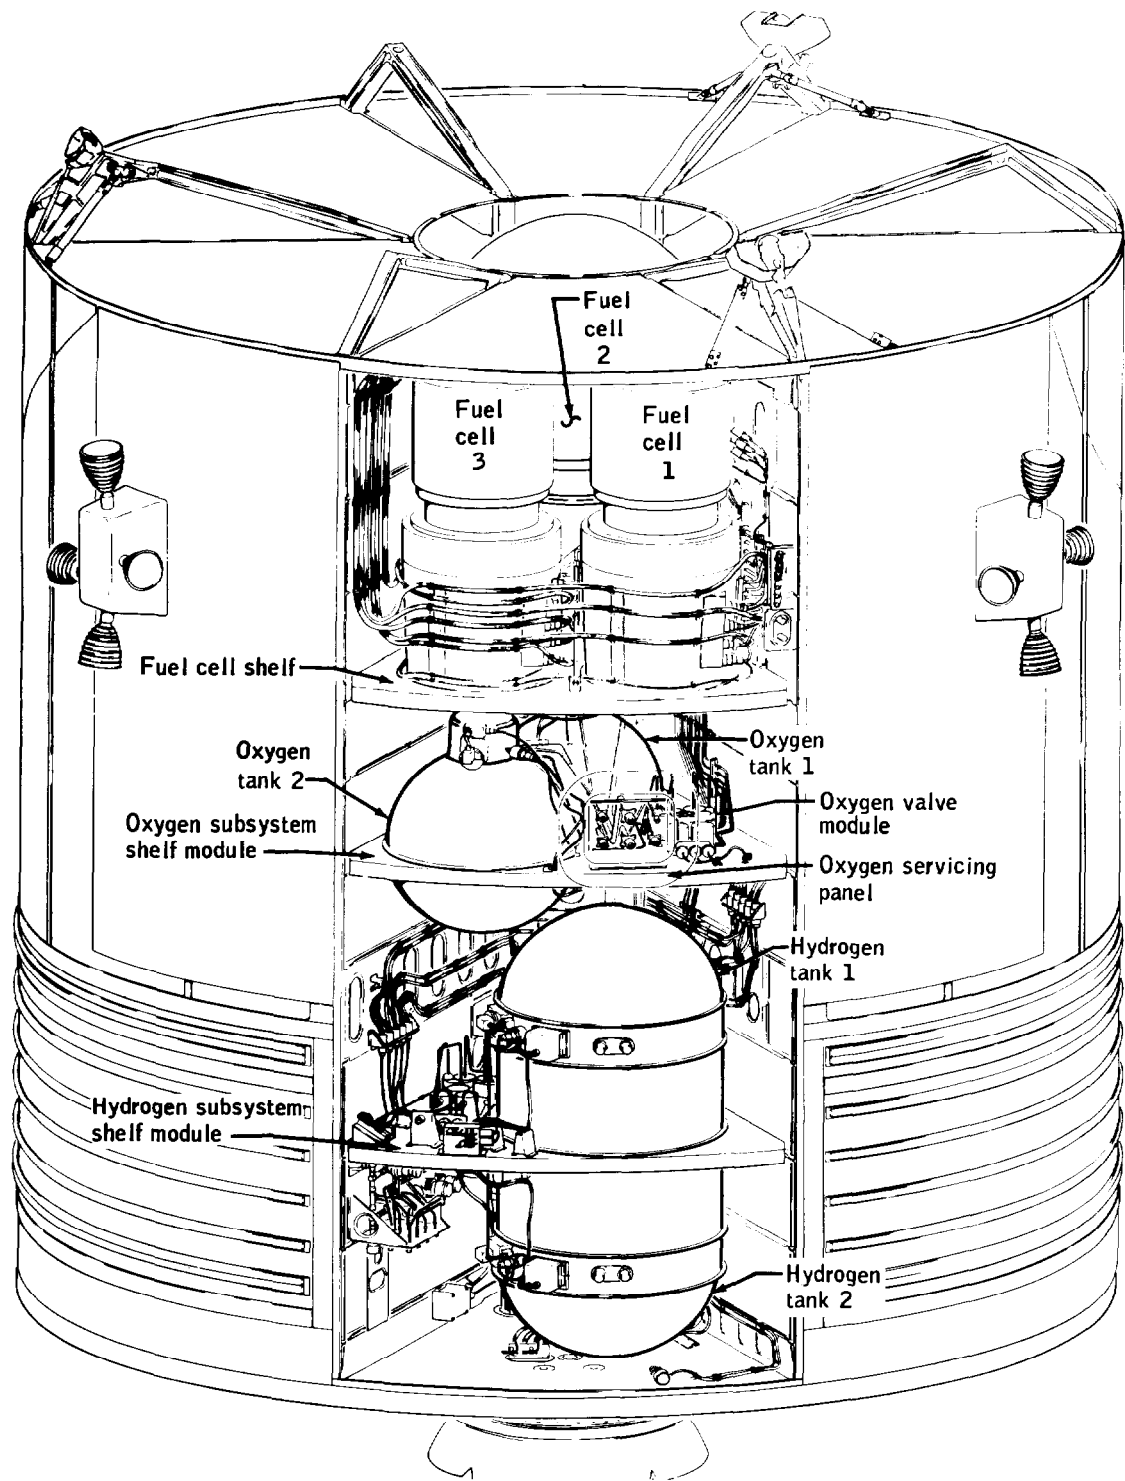
Figure 4-4.- Arrangement of fuel cells and cryogenic systems in bay 4.

Two oxygen tanks are mounted on a shelf in bay 4 of the SM, as shown in figure 4-4. Figures 4-5 through 4-8 are photographs of portions

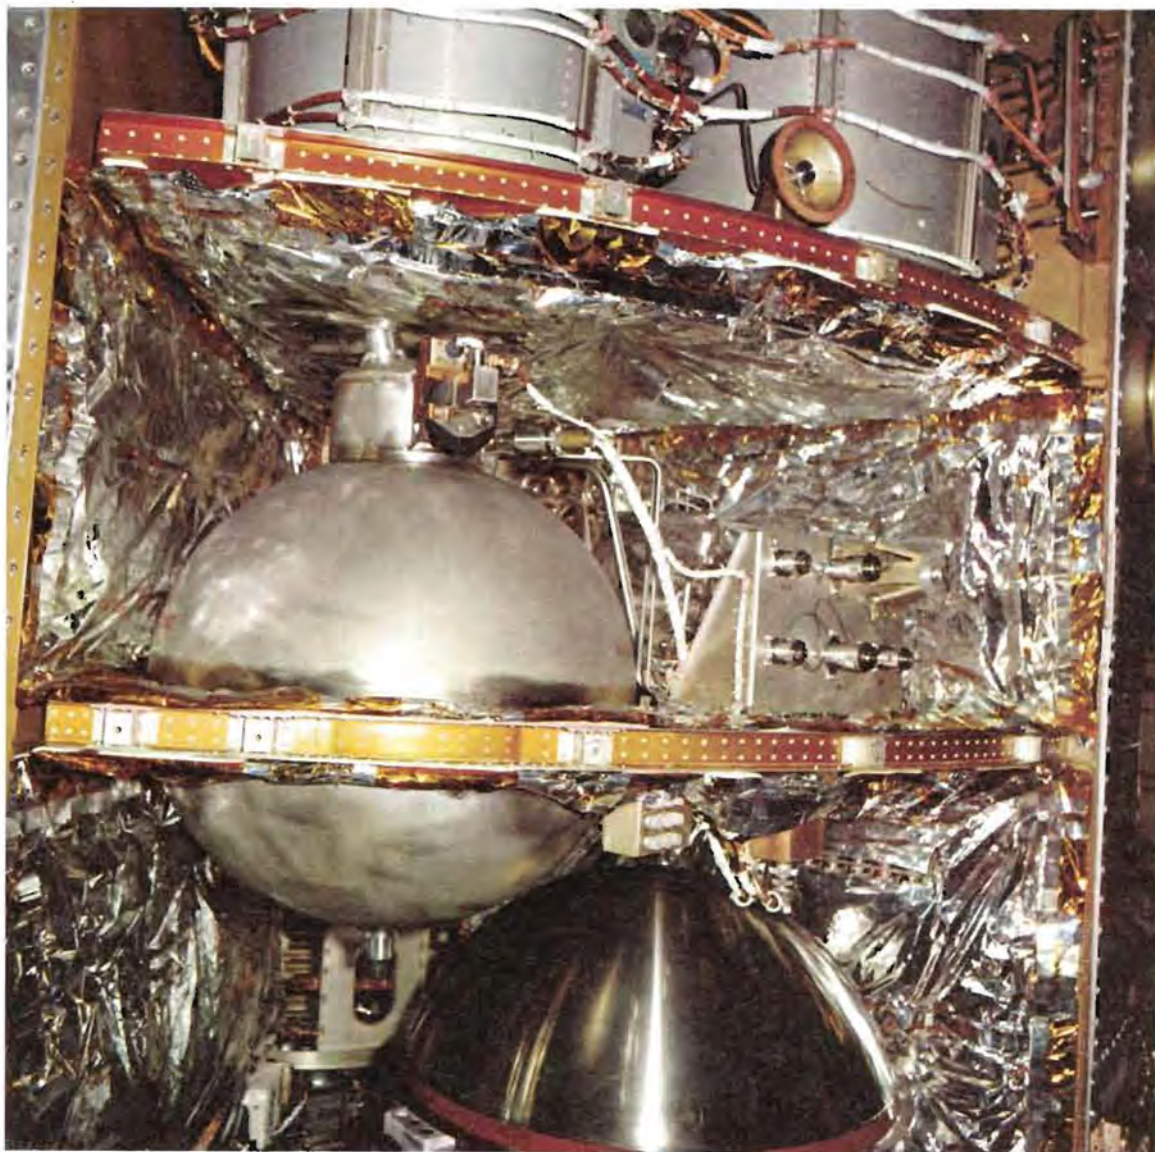
Figure 4-6.- Oxygen tank shelf.

of the Apollo 13 service module (SM 109) at the North American Rockwell plant prior to shipment to KSC. Figure 4-5 shows the fuel cell shelf, with fuel cell 1 on the right, fuel cell 3 on the left, and fuel cell 2 behind cells 1 and 3. The top of oxygen tank no. 2 can be seen at the lower left. Figure 4-6 shows the oxygen tank shelf, with oxygen tank no. 2 at left center. Figure 4-7 shows the hydrogen tank shelf with hydrogen tank no. 1 on top and hydrogen tank no. 2 below. The bottom of the oxygen shelf shows some of the oxygen system instrumentation and wiring, largely covered by insulation. Figure 4-8 is a photograph of the bay 4 panel, which was missing from the service module after the accident.

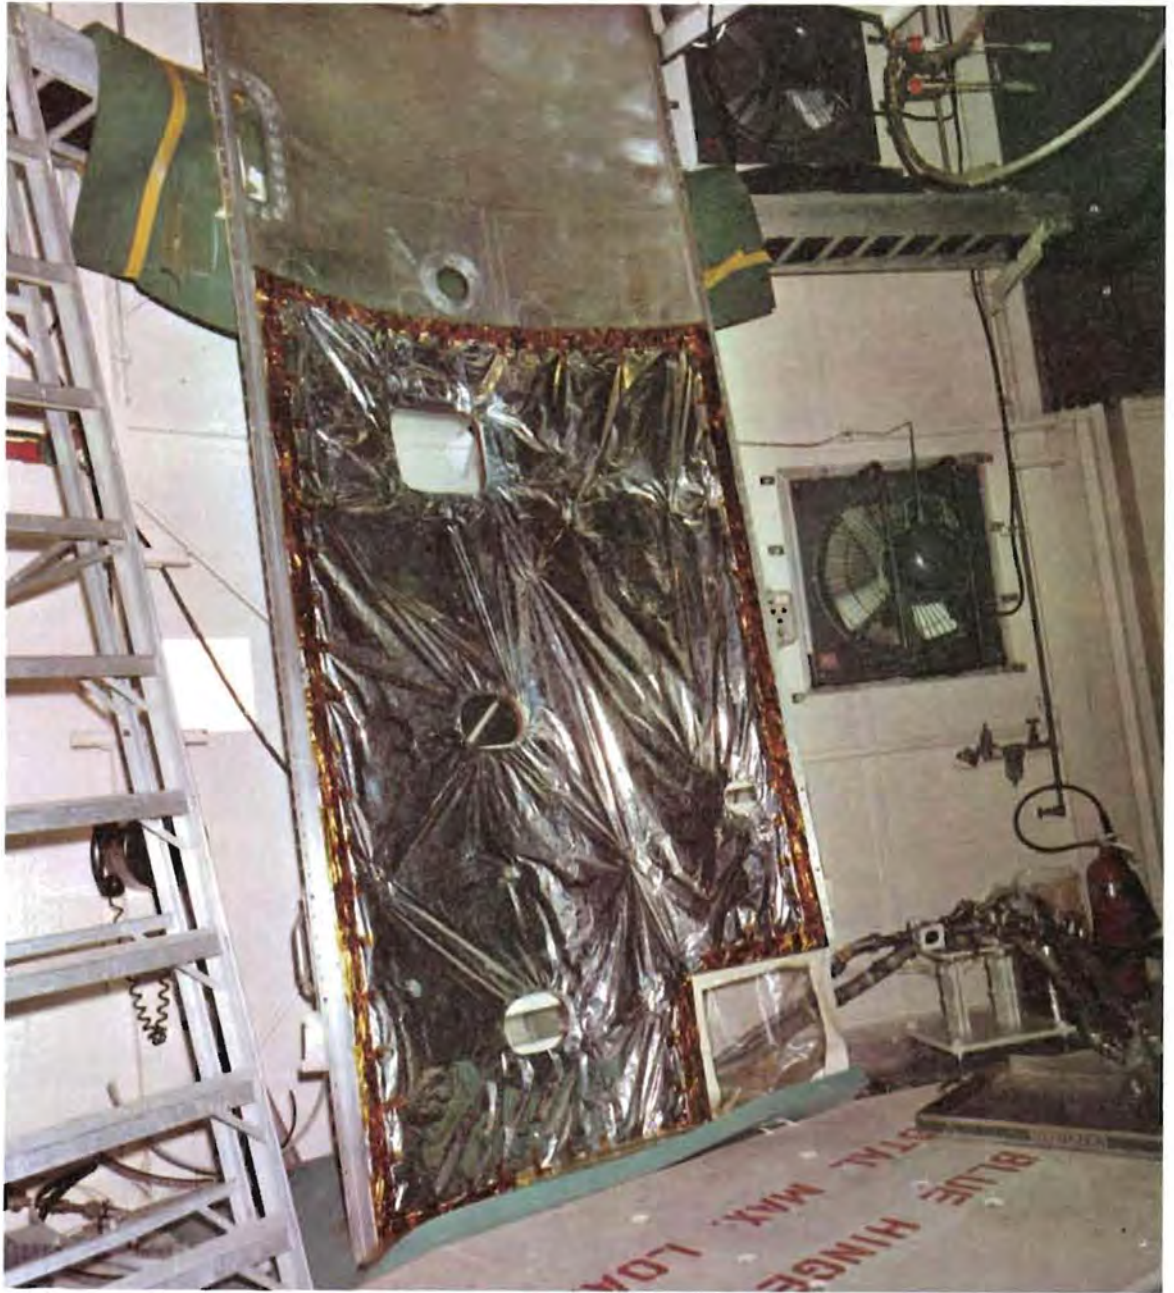
4-8.-
Figure ~~XXX~~ Inside view of panel covering bay 4.

The failure of oxygen tank no. 2 and consequent removal of the bay 4 panel produced a shock which closed valves in the oxygen supply lines to fuel cells 1 and 3. These fuel cells ceased to provide power in about 3 minutes, when the supply of oxygen between the closed valves and the cells was depleted. Fuel cell 2 continued to power ac bus 1 through dc main bus A, but the failure of fuel cell 3 left dc main bus B and ac bus 2 unpowered (see fig. 4-12). The oxygen tank no. 2 temperature and quantity gages were connected to ac bus 2 at the time of the accident. Thus, these parameters could not be read once fuel cell 3 failed at 55:57:44 until power was applied to ac bus 2 from main bus A.

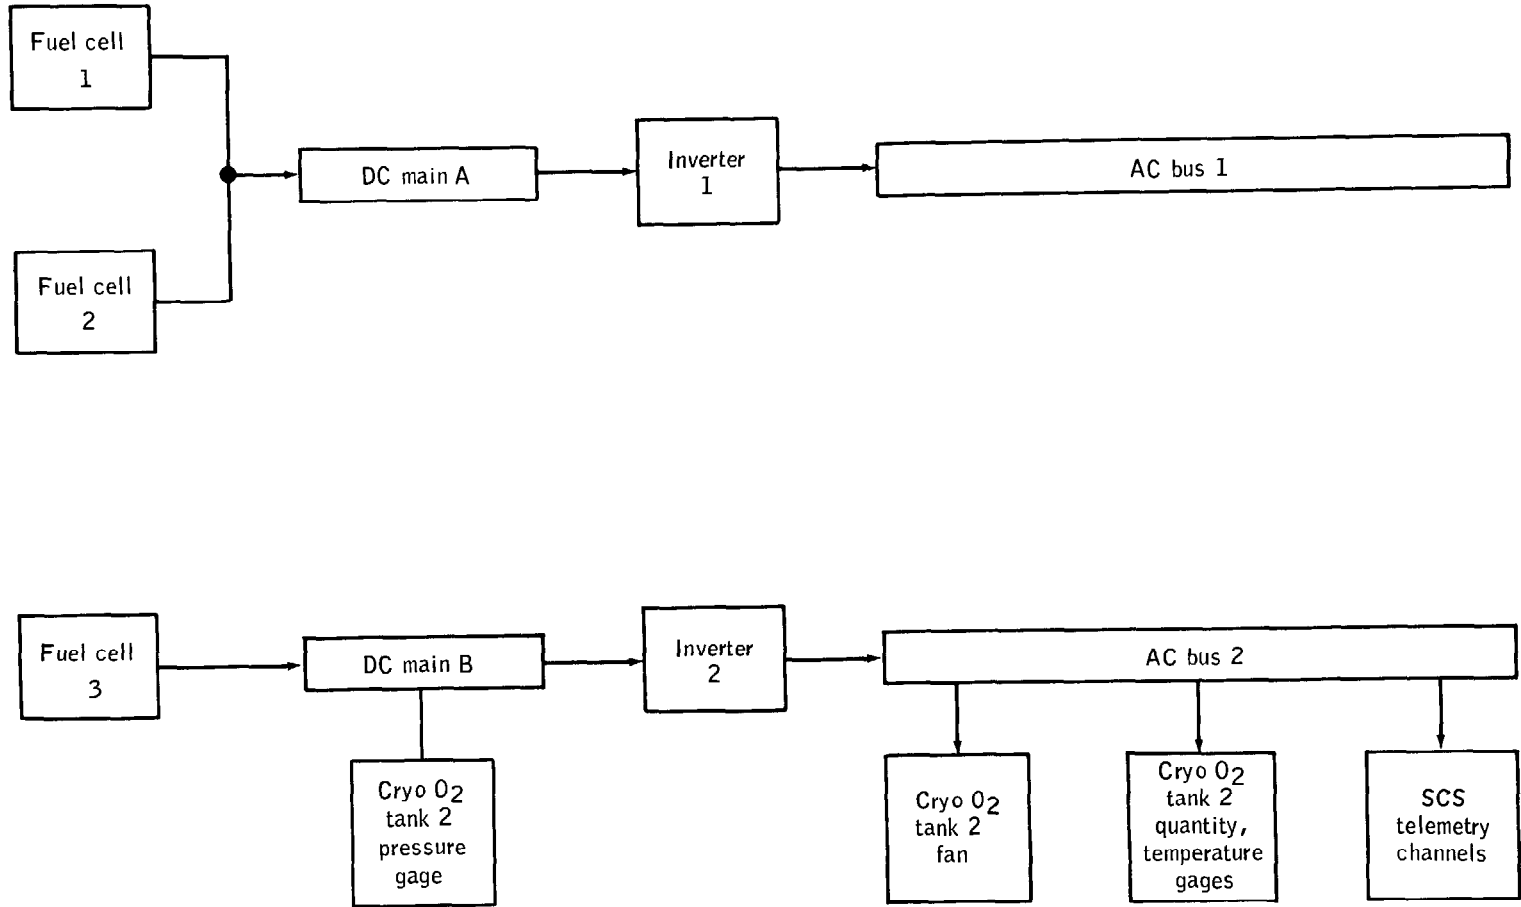
Figure 4-12.- Electrical configuration at 55:54:53 g.e.t.

The crew was not alerted to closure of the oxygen feed valves to fuel cells 1 and 3 because the valve position indicators in the CM were arranged to give warning only if both the oxygen and hydrogen valves closed. The hydrogen valves remained open. The crew had not been alerted to the oxygen tank no. 2 pressure rise or to its subsequent drop because a hydrogen tank low pressure warning had blocked the cryogenic subsystem portion of the caution and warning system several minutes before the accident.

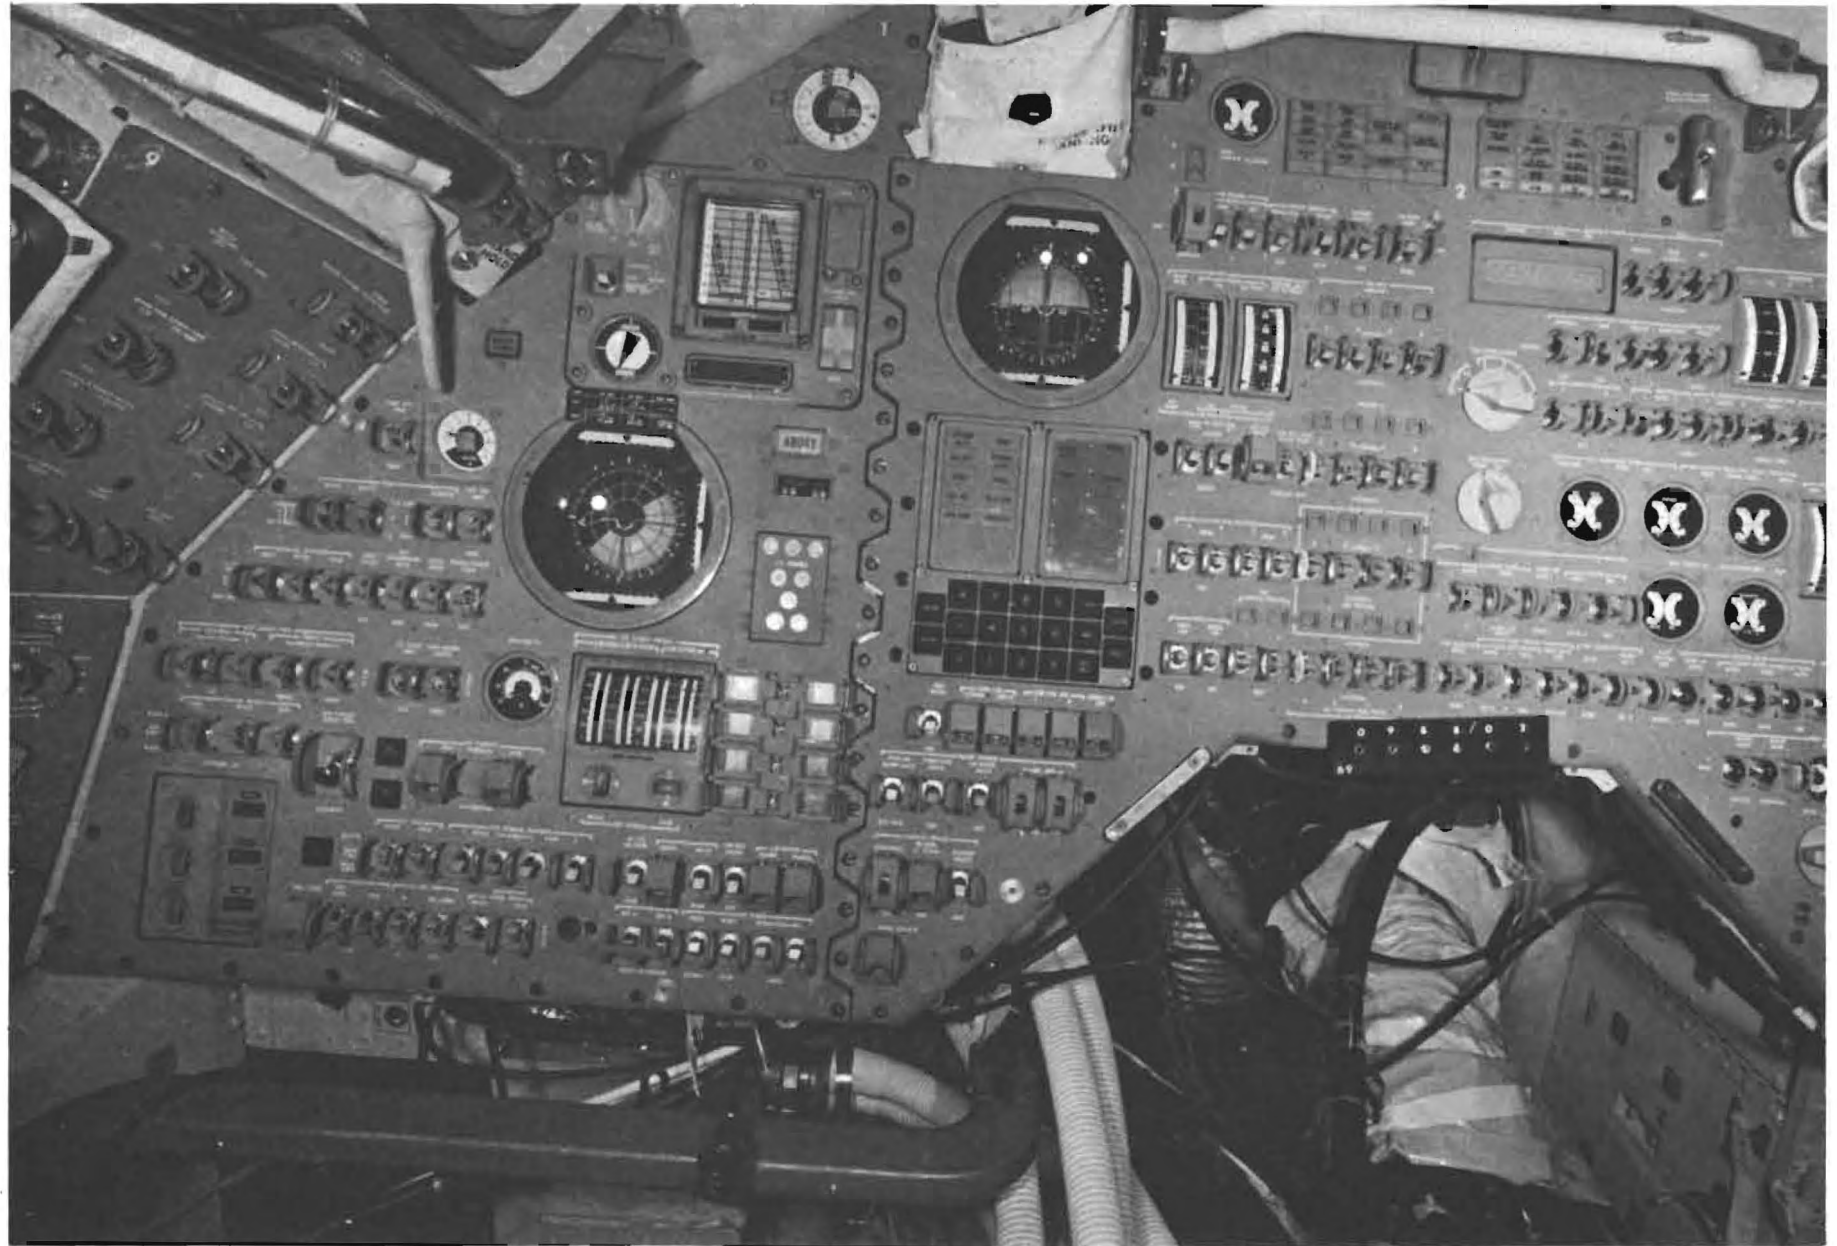
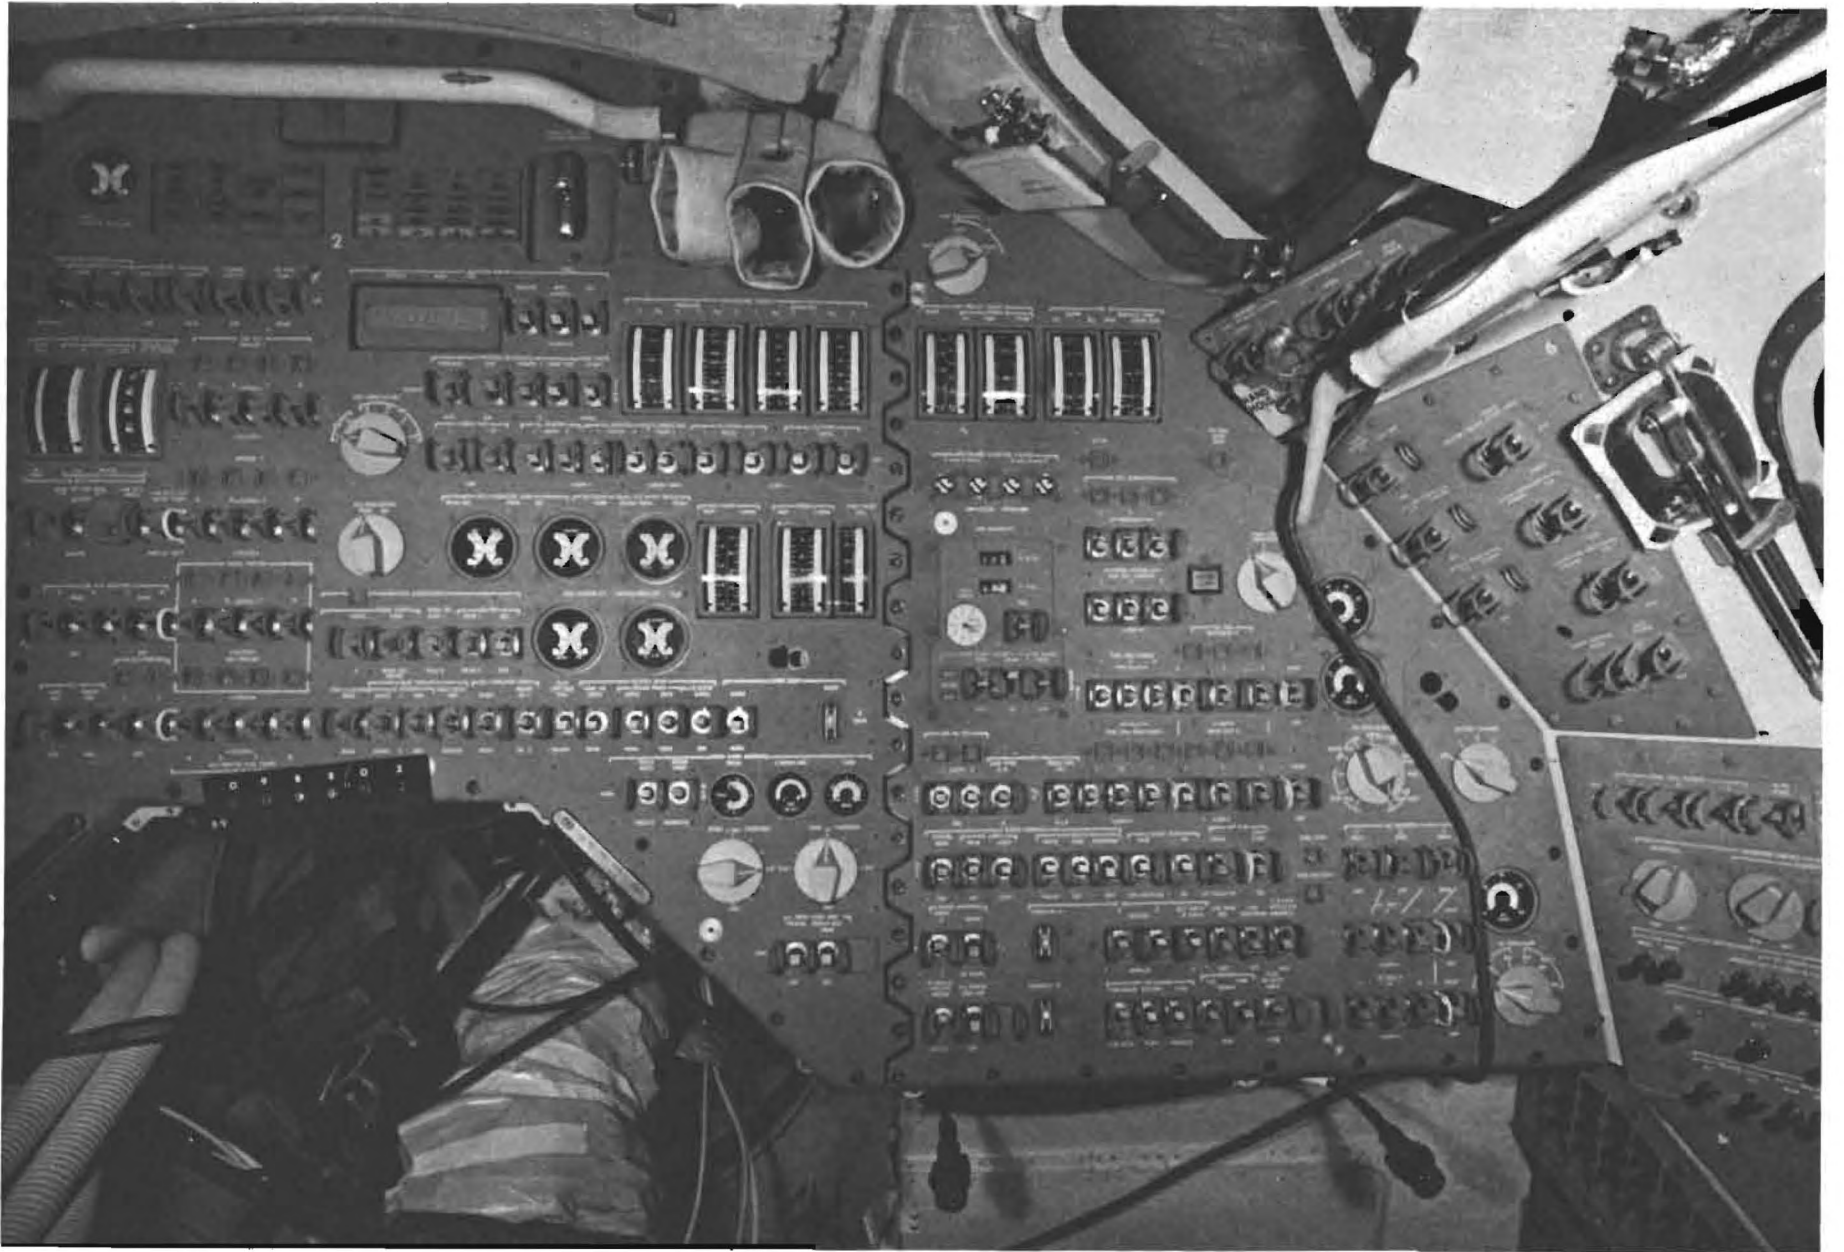
Figure 4-13.- Main display panel.

The Lunar Module Pilot was in the tunnel between the CSM and the LM, returning to the CSM. The Command Module Pilot was in the left-hand couch, monitoring spacecraft performance. Because of the master alarm indicating low voltage, the CMP moved across to the right-hand couch where CSM voltages can be observed. He reported that voltages were "looking good" at 55:56:10. At this time, main bus B had recovered and fuel cell 3 did not fail for another 1-1/2 minutes. He also reported fluctuations in the oxygen tank no. 2 quantity, followed by a return to the off-scale high position. (See fig. 4-13 for CM panel arrangement).
