**Roof Survey**

**13-31 Elm Street  
Springfield, MA**

Prepared for: Mr. Dan Dodge & Mr. Brian Connors  
Prepared by: Mr. Chuck Gray  
September 28, 2011

**Inspection Date:** September 27, 2011

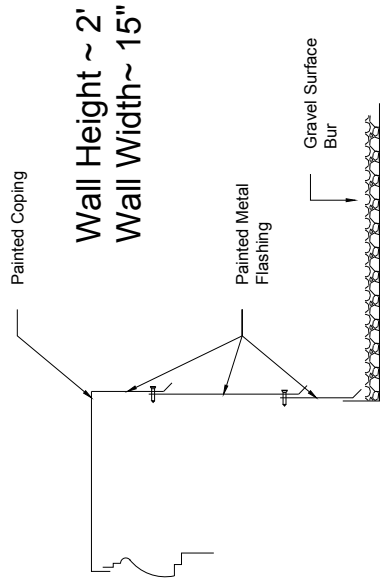
## Existing Detail D

**Detail D:**  
The existing metals are in disrepair. The mortar in the brick wall has deteriorated completely in areas. This wall section may be able to be addressed in a similar fashion to detail B. As opposed to utilizing a base flashing along with the coping detail, a single ply membrane can totally encapsulate the brick wall and seal the top of the wall below the new coping.

Wall Height ~ 2'  
Wall Width ~ 15"

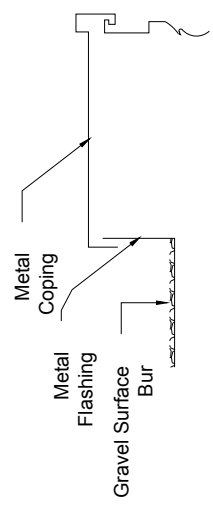
Detail G2:  
Showing the distressed  
perimeter detail along with the  
roof drain that is missing  
clamps and strainer.

<p>Metal Coping Metal Flashing Gravel Surface Bur</p> <p style="text-align: center;"><b>Existing Detail G2</b></p>
<p>Existing Metals Painted Metal</p> <p>Wall Height~ 6" to 24" Wall Width~ 15"</p>
