Runaway of Suburban Electric Passenger Train 5264 and collision with Diesel Locomotive Hauled Passenger Train 8141

Spencer Street Station, Victoria,
3 February 2003

RAIL INVESTIGATION REPORT

No. 2003/0001

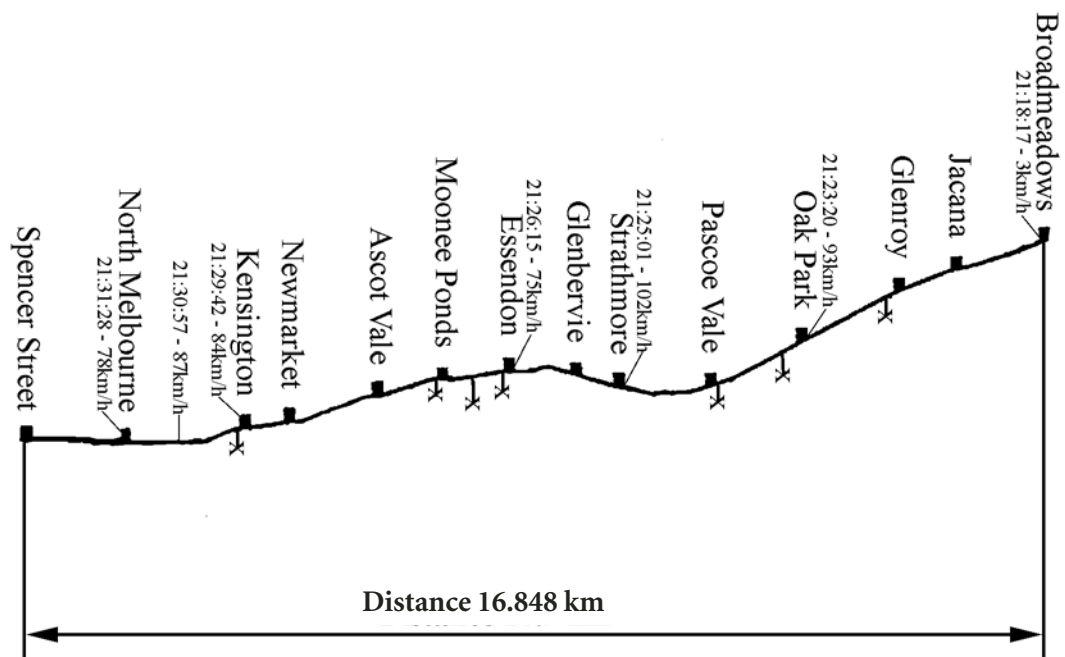
FIGURE 1:
Diagram of route

There is then a very short slight downgrade before becoming almost level on the approach to and at Essendon Station itself. A very slight downgrade is then evident until Moonee Ponds Station where the grade again levels out. Immediately beyond Moonee Ponds Station though, the grade increases again through to Moonee Ponds Creek at a rate that varies between 1:89 and 1:84. This is a distance of about 4.8 kilometres. Moonee Ponds Creek is about two kilometres from Spencer Street Station, the final portion of the route to Spencer Street being basically level except for two very short undulations of a rising 1:125 grade. A diagram of this route showing gradient details is contained at figure 1 of this report.

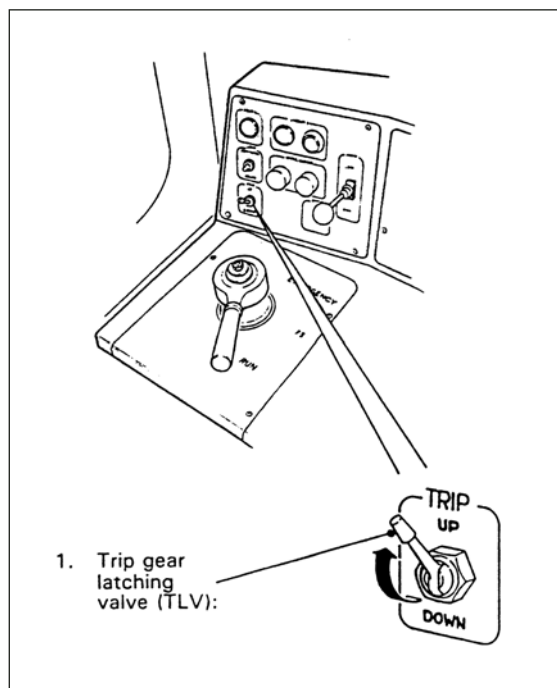
FIGURE 2:
Raising the trip

As train 5859 was arriving at Broadmeadows Station, the driver said he noticed that the passenger information display on the platform was showing the next train as being a Seymour service. This led him to think that he may have to perform a shunting movement to clear the platform after arrival. After coming to a stand he advised that he isolated the driver's controls as per procedures, latching up the train trip in the process.

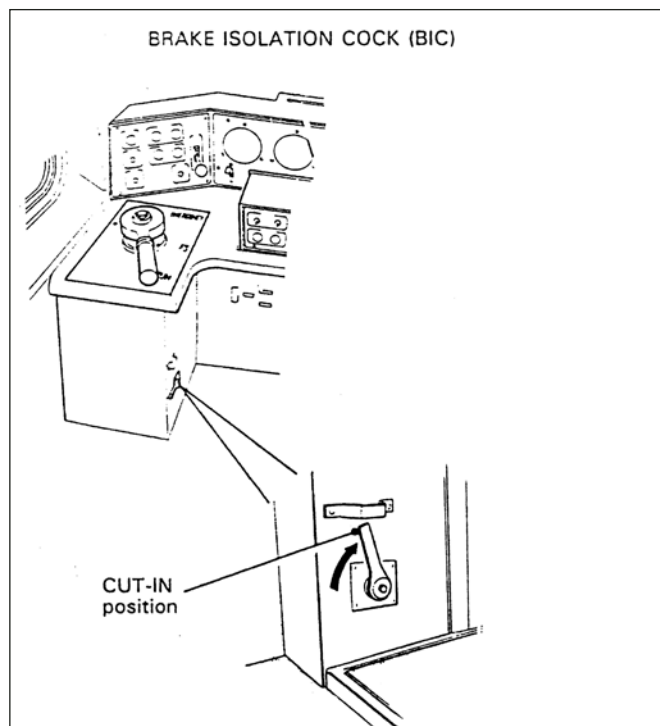
FIGURE 3:
Opening brake valve isolating cock

He then said that he waited for a short period of time anticipating that advice regarding the shunting movement would be forthcoming from station staff. When this advice did not materialise, he alighted onto the platform (figure 6 event 2) and looking back along the platform noticed that the passenger information display was now showing the correct return to Melbourne as per his scheduled run for train 5264. He re-entered the driving cabin of car 393, opened the brake valve isolating cock¹⁷ and entered the train description number into the data terminal in the driver's cabin.

He then said he made a 250kPa¹⁸ brake pipe reduction (by moving the brake handle to the emergency position) and then returned it to the service zone. He then closed the brake valve isolating cock and again alighted from the driver's cabin onto the platform (figure 6, event 3). At this time he checked the destination was correct on the rear of the train before intending to proceed to the opposite end of the train via the staff lavatory on the station platform.

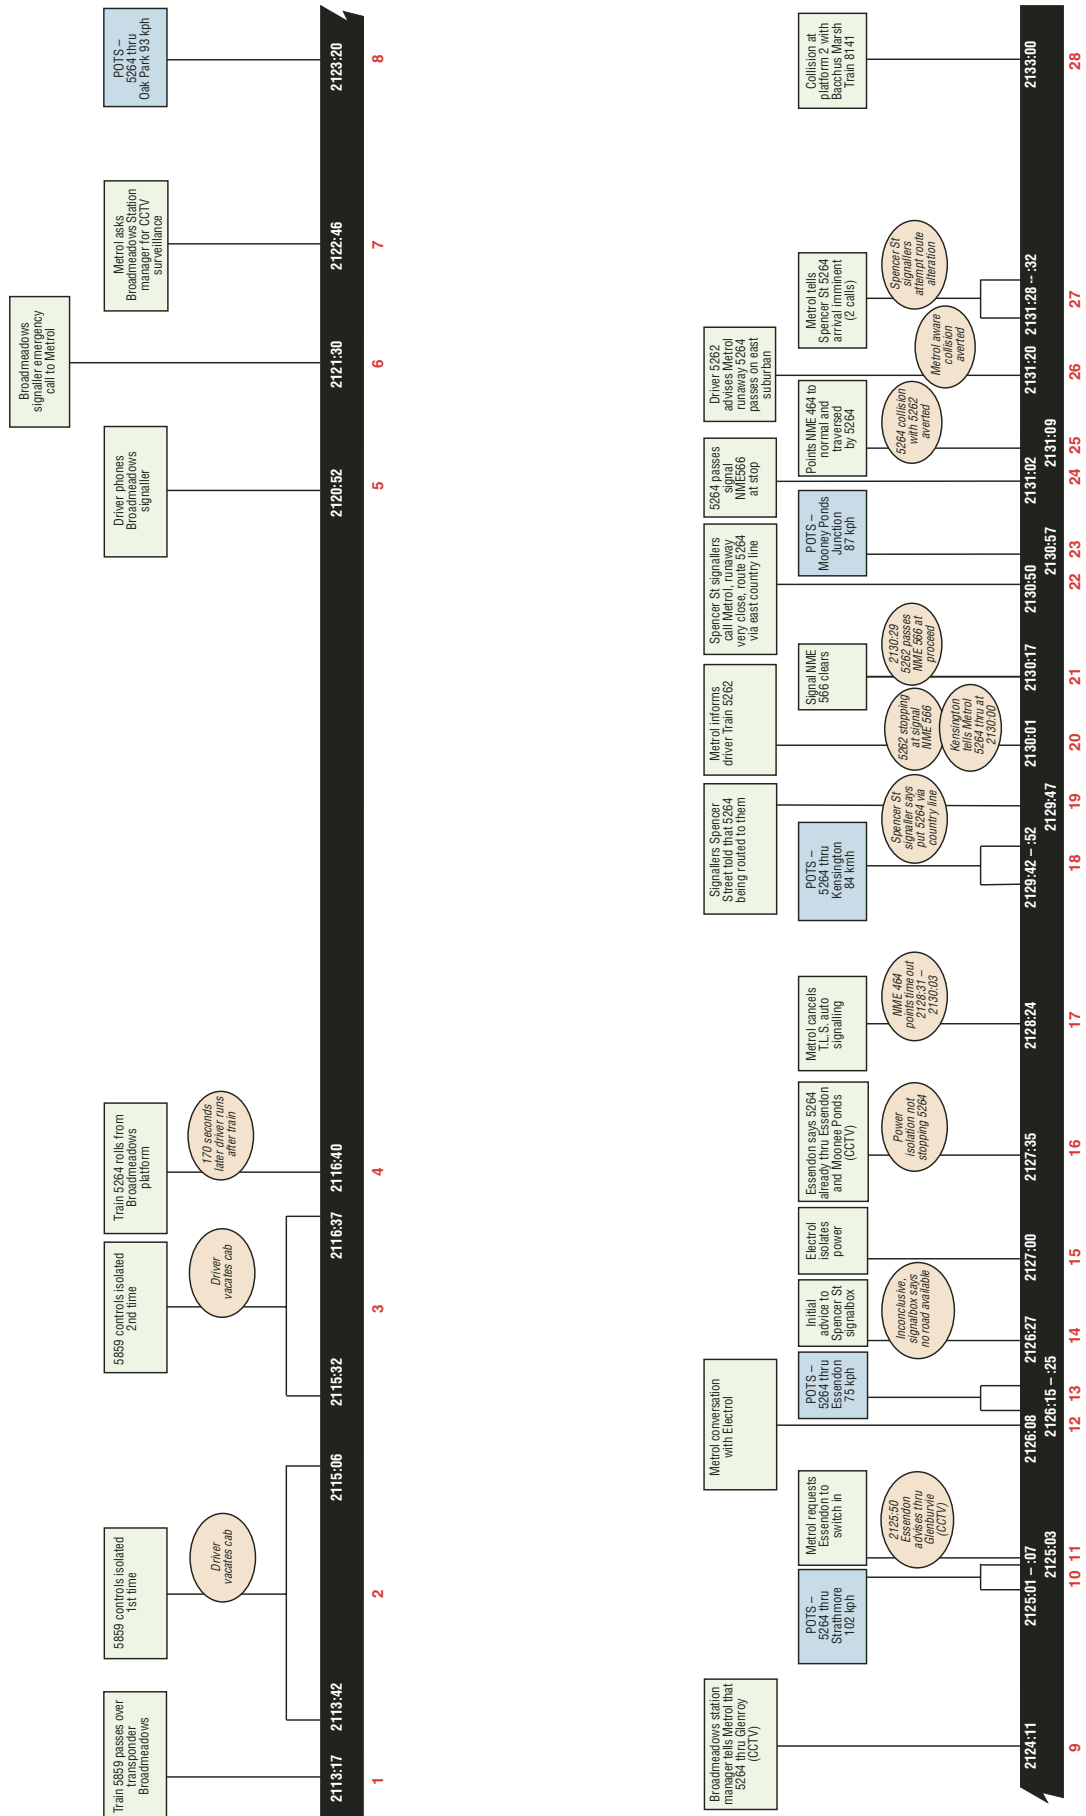
FIGURE 6:
Timeline sequence of events

Train 5264 commenced to roll very slowly from Broadmeadows platform as the driver turned and walked towards the station building (figure 6, event 4). By viewing CCTV footage it is concluded that this initial movement took place 190 seconds after coming to a stop as the arriving train 5869. The POTS unit travel report recorded this train traversing the track transponder located on the Up side of the Broadmeadows Platform at 2118:17 travelling at 3 km/h in the Up direction. From viewing the CCTV footage it is estimated that the train took between 70 and 90 seconds from initial movement to interaction with the track transponder.

At 2122:46 Metrol requested the Broadmeadows station manager to watch for progress of train 5264 on the CCTVs at remote stations under Broadmeadows surveillance (figure 6 event 7). At 2124:11 the Broadmeadows station manager told Metrol that he had seen train 5264 pass through Glenroy Station (figure 6, event 9). At 2125:03 Metrol officers contacted the station manager at Essendon and asked him to switch the local signal panel in and to keep the runaway movement heading in the Up direction. At 2125:50 the Essendon station manager advised Metrol that he had observed the runaway train go through Glenbervie Station on the CCTV surveillance monitor (figure 6, event 11). Glenbervie is the station on the Down (Broadmeadows) side of Essendon Station and is 7.6 kilometres from Broadmeadows Station.

At 2128:24 a Metrol officer cancelled the route originally set for train 5262 with the intention of re-routing train 5262 via the main suburban line. This cancellation caused signal NME 566 to return to a red aspect and for the points beyond to time out from 2128:31 to 2130:03 (figure 6 event 17). At 2130:01 another Metrol officer contacted the driver of 5262 and told him of the emergency situation and instructed him not to stop at North Melbourne. At the time of this contact, train 5262 was coming to a stand at signal NME 566 (figure 6 event 20). In the meantime (at 2129:47) Metrol officers had again contacted the Spencer Street signallers with confirmation that train 5264 would be routed towards the area under their control. To this end, agreement was hurriedly reached to route the runaway train off the east suburban line onto the country line after it had passed North Melbourne Station (figure 6 event 19).

The signaller at Metrol then reversed the points immediately beyond signal NME 566 the moment train 5262 cleared the relevant track circuitry. At this time the signaller's VDU screen showed all routes occupied in red and the train radio was crackling, indicating that a collision may have occurred. Metrol staff urgently tried to contact the driver, without immediate success. After a short period they received an answer from the driver of 5262 (at about 2131:20) telling them that the runaway train had passed his train on the east suburban line and was proceeding through platform one North Melbourne at speed (figure 6 event 26).

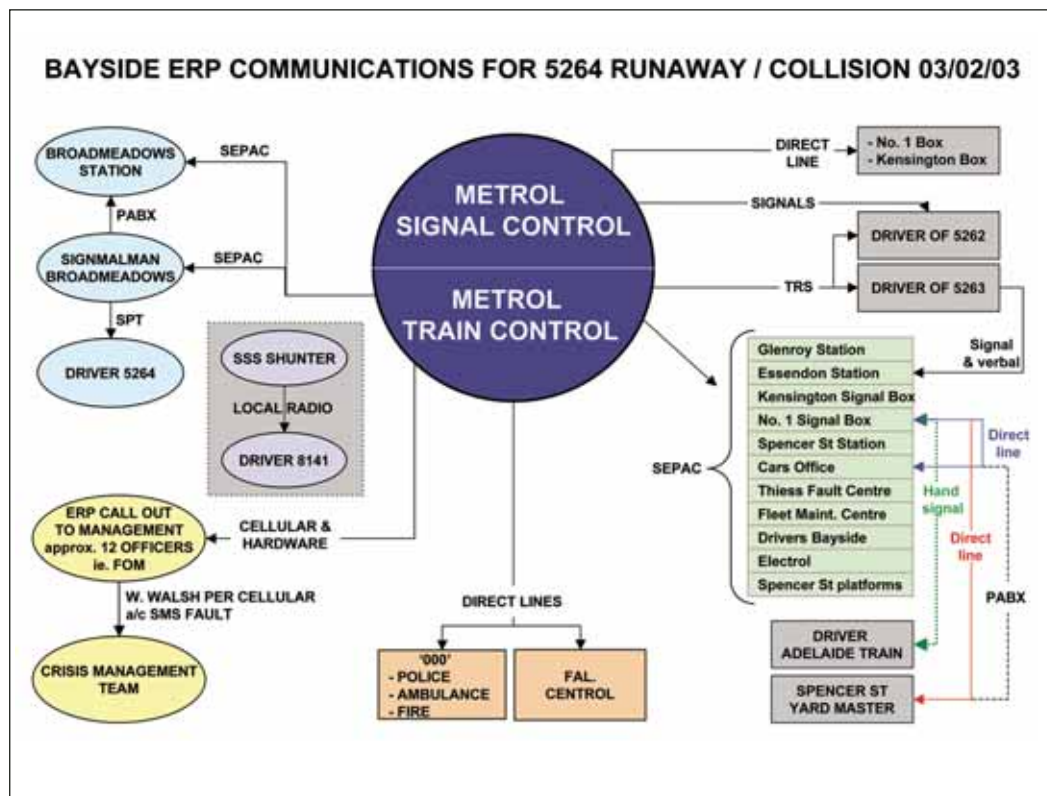
FIGURE 11:
Schematic diagram of communications

There is no open channel radio system in the Melbourne suburban rail network. Therefore, there was no way in which 'broadcast' messages over the rail network could be made.
