**HEAVY MOVABLE STRUCTURES, INC.
SIXTEENTH BIENNIAL SYMPOSIUM**

**Safeco Field Movable Stadium Roof
Bogie System Repair**
Frank Marzella, PE
Hardesty & Hanover, LLC

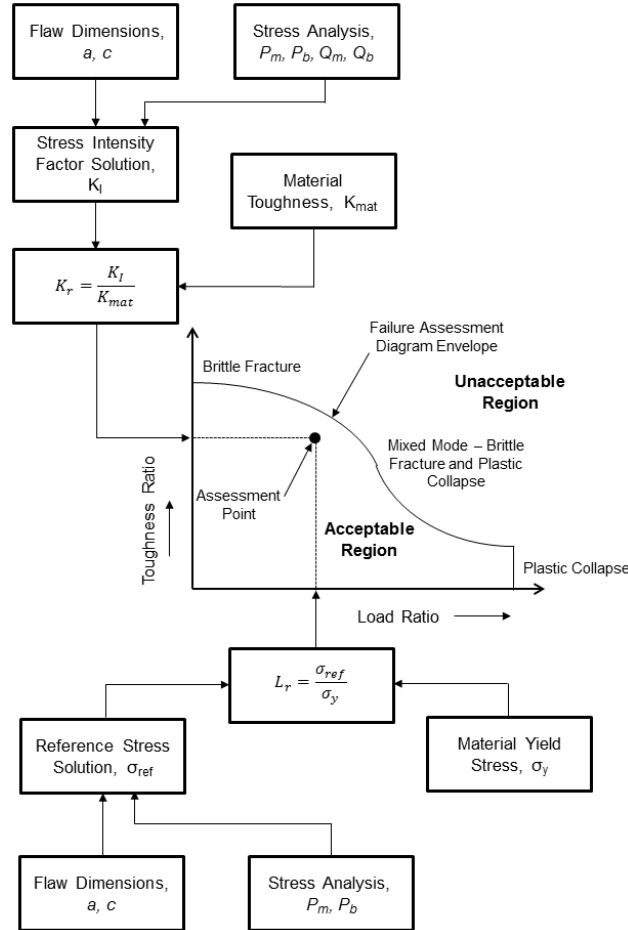
Figure 1: Flow Chart and Overview Illustrating FAD (From API 579)

The assessment of flaws for fracture potential is guided by the construction of what is known as a Failure Assessment Diagram (FAD) (see Figure 1). In its simplest form, the FAD is a method that graphically illustrates the potential for fracture failure, ranging from brittle fracture to plastic collapse. The vertical (x) axis of the FAD represents susceptibility to brittle fracture while the horizontal (y) axis is a measure of susceptibility to failure through plastic collapse. The FAD curve is derived from specific properties of the materials in question, primarily toughness, strength, and ductility (stress-strain). A Level One curve does not consider the interaction of those properties, while higher order FAD curves (Levels Two and Three) do respond to the interaction of the material properties and material behavior under load to derive a more accurate envelope of acceptability using linear elastic or elastic-plastic theories of material mechanics. A Level Two analysis was used for this assessment. The derivation of the FAD curve can be thought of as analogous to the "resistance" side of LRFD design approach for strength of a member, but without the application of factors of safety at higher levels of analysis (level two and three). Therefore, factors of safety are typically applied by the user based on a quantitative or qualitative risk assessment.

Calculations for the given flaw being assessed result in the determination of a single value or point representing the flawed condition. This point is then plotted against the envelope of acceptable values. A value falling within the curve indicates that the flaw is acceptably safe from fracture failure while one falling outside the curve would be unacceptable at that level of assessment and with the input values assumed.

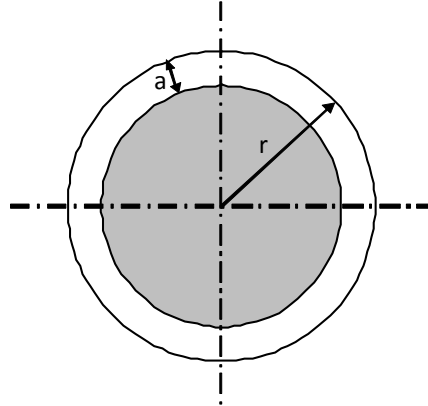
Figure 2 - Model used to calculate the critical crack size

To model the cracking observed in the axle, a solid circular shaft of radius 'r' and a circumferential crack of size 'a' was selected from the family of geometries included in BS7910. The model is capable of including the effects of primary axial and bending stresses, though only bending stresses were included. Further, no residual stresses were included, though the model is capable of accommodating as secondary stresses. Figure 2 illustrates the model conceptually. The axle that was evaluated contains the locking collar groove detail.

The model assumes the crack is circumferential. Evaluation of cracks that have extended partially around the circumference is not possible in this model. Further, the crack size (a) is uniform around the entire axle. Lastly, the threaded dowel holes that were found to exist are not included in the model.

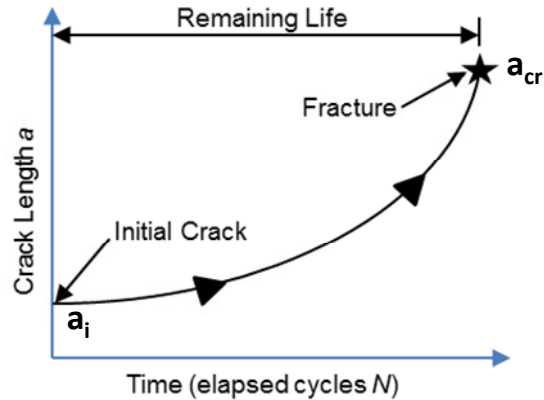
Figure 3 – Illustration of crack growth rate as a function of crack size.

As stated, accurately establishing the *initial* crack size (a_i) is essential in the analysis. The reasons are illustrated in Figure 3, which shows schematically the change in crack length 'a' vs. the applied number of cycles. As is readily apparent, as the number of cycles increase, the crack size also increases, but at an increasing rate. In other words, the growth rate is not linear. At the initial stages of crack growth, there is relatively little crack extension with increasing cycles (N) and much more time (i.e., cycles) is spent growing the crack from the initial size (a_i). However, toward the right hand of the plot (especially near fracture), it can be seen that for the same number of applied cycles, there is much greater crack growth.

Figure 3 also reveals that the selected value of a_i has a major influence on the total estimated life. The implication of this observation is most important in axles where cracks are already believed to extend out of the locking collar groove. In such cases, much of the life has already been exhausted, in contrast to those axles where there appears to be no evidence of cracking. This also emphasizes the need for UT procedures that have been calibrated such that they consistently result in data of high confidence.

However, as stated earlier, it is important to recognize that crack growth is non-linear, as was shown in Figure 3. As seen, as the crack gets larger, it grows at an increasing rate. The practical implication is that although the crack may have only grown to a depth that is half of the critical crack size, perhaps 90% of the life may have been exhausted. Note this approach also requires there be high confidence in the UT crack sizing capability. Therefore, caution must be exercised when setting the inspection interval based on the crack size.

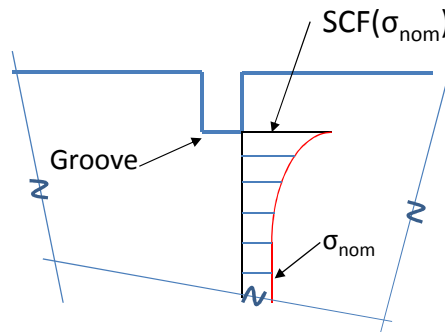
Figure 4- Illustration of the Effect of SCF at the Base of Groove

The data obtained thus far appears to confirm the cracks all originate at the machined grooves in the axle shaft. One of the reasons for this is due to the fact that at the base of the groove there is a high stress concentration factor (SCF) which amplifies the nominal stress (σ_{nom}). The SCF due to the groove was estimated to be on the order of 4.5 to 4.7 or even higher. However, it is well known that the effect of the stress concentration decreases with the distance from the groove, as illustrated schematically in Figure 4. Eventually, the stress state returns that consistent with the nominal stress.

Examination of Figure 4 makes it clear that cracks growing out of the groove are initially subjected to much higher stress ranges due the influence of the SCF. However, as these cracks propagate, the effect of the SCF diminishes and crack growth slows.

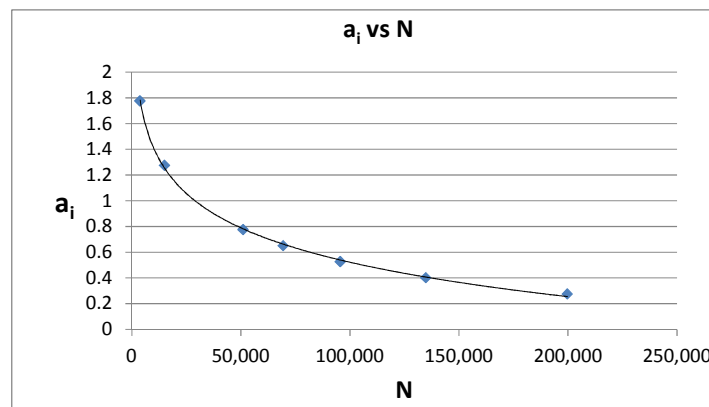
Figure 5 – Plot illustrating the influence of increasing the initial crack size (a_i) on total fatigue life (N)

However, it is important to recognize that the above assumes that the initial crack size is equal to the depth of the groove. As previously stated, there are several axles where it is believed that cracks extend beyond the base of the groove. As shown in Figure 3, larger assumed values for the initial crack size result in significant decreases in the total calculated life (N). In order to illustrate the effects of existing cracks which extend below the grooves, various initial cracks sizes were evaluated, the results of which are tabulated in Table 2 and plotted in Figure 5.

It is clear that increases in the initial crack size have large effects on the total estimated life, especially as the initial crack size increases. The implication is that at locations where cracks extend beyond the base of the groove, even if only say 0.25 inches, there is a significant decrease in the calculated life.

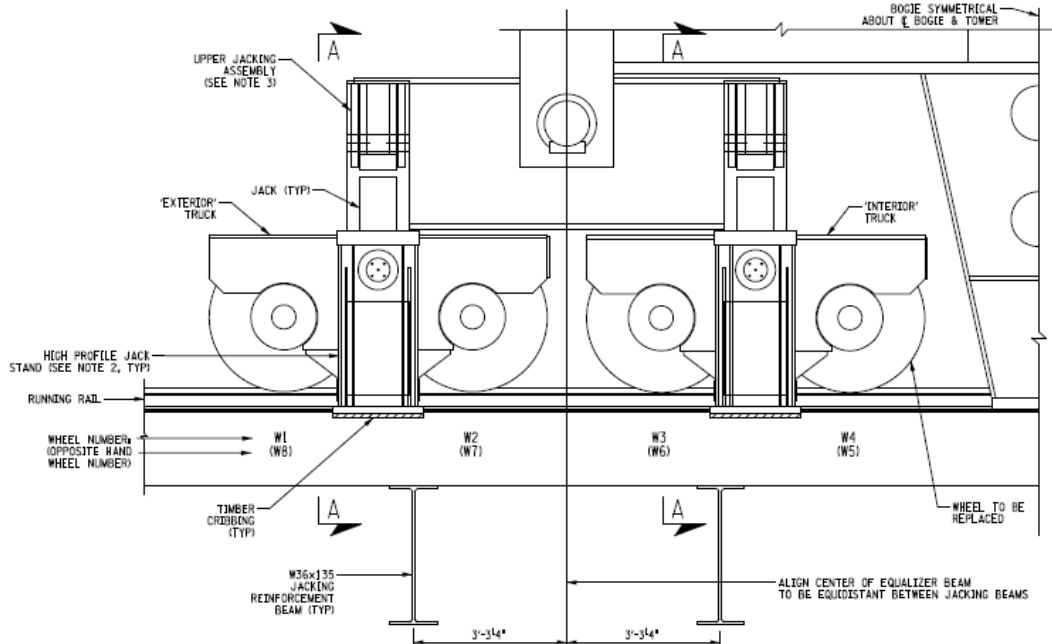
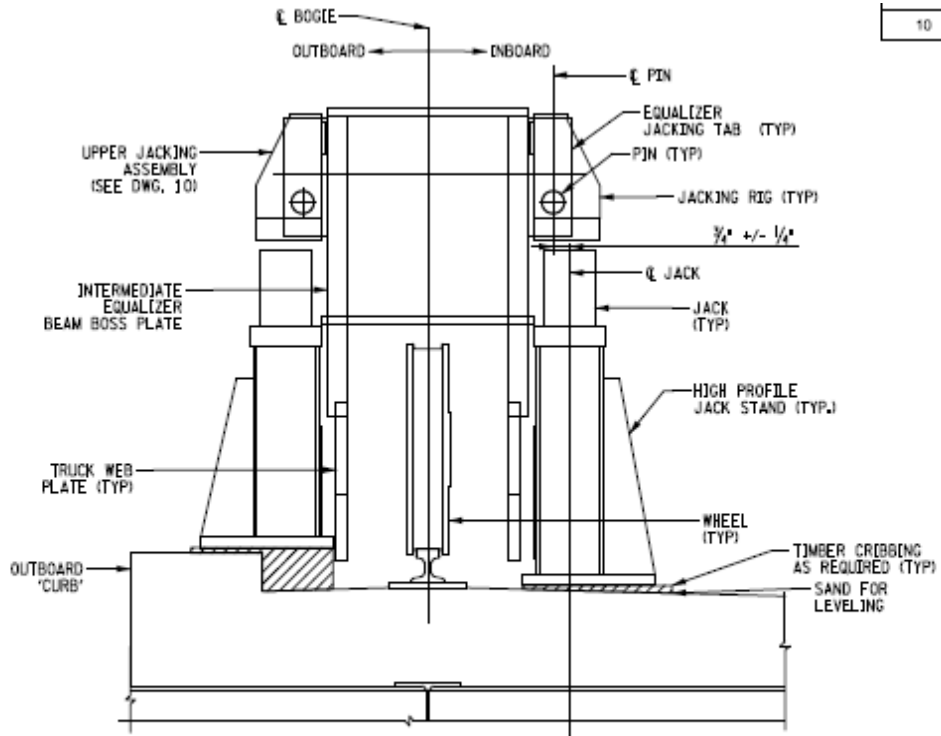
BOGIE ELEVATION - JACKING CONFIGURATION #4 (WHEELS 4/5)

Multiple jacking configurations were required depending on where in the system the wheel assembly to be replaced was located. A typical jacking configuration is shown below.
