Safety Recall

Code: 69L2

Subject	Steering Wheel Clock Spring
Release Date	December 10, 2015
Affected Vehicles	U.S.A. & CANADA: Certain 2010-2014 Model Year Volkswagen vehicles <i>Check Campaigns/Actions screen in Elsa on the day of repair to verify that a VIN qualifies for repair under this action. Elsa is the <u>only</u> valid campaign inquiry & verification source.</i> <ul style="list-style-type: none">✓ Campaign status must show "open."✓ If Elsa shows other open action(s), inform your customer so that the work can also be completed at the same time the vehicle is in the workshop for this campaign.
Problem Description	Hair or other fibers may contaminate the airbag clock spring (a spiral wound, flat cable that keeps the airbag powered while the steering wheel is being turned). This contamination may tear the cable and result in a loss of electrical connection to the driver's frontal airbag. A loss of electrical connection to the driver's frontal airbag will prevent the airbag from deploying in the event of a vehicle crash, increasing the risk of injury.

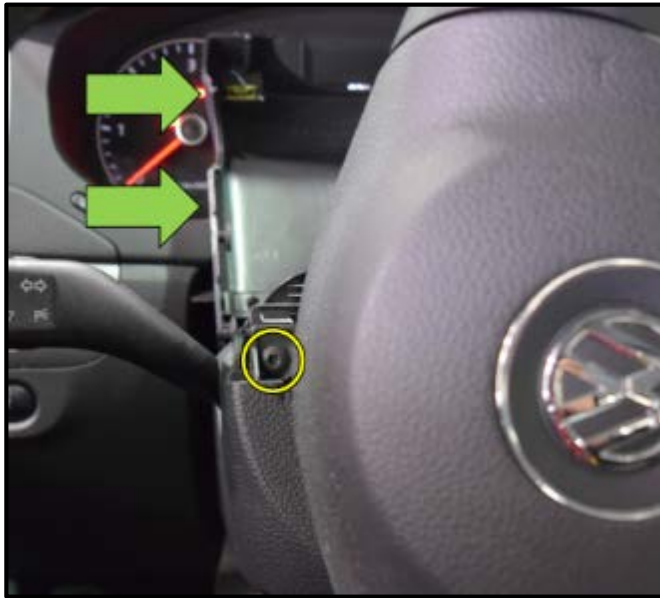
DTC memory entry	
Number:	Driver airbag igniter Resistance too high (B10001B)
Error type 2:	active/static
Symptom:	9437211
Status:	10001001
Standard ambient conditions:	Date: 5/18/15
	Time: 10:24:12 PM
	Mileage: 11075
	Priority: 2
	Frequency counter: 1
	Elimination counter / driving cycle: 255

DTC memory entry	
Number:	Driver side airbag igniter (VAG00588)
Error type 1:	Upper limit exceeded
Error type 2:	static
Standard ambient conditions:	Date: 7/24/15
	Time: 5:25:08 PM
	Mileage: 26299
	Priority: 2
	Frequency counter: 1
	Elimination counter / driving cycle: -1

- If the airbag warning light is illuminated, connect the VAS6150C (or equivalent) to the vehicle and perform a Guided Fault Finding (GFF) scan.
- Determine the cause of the airbag warning light.
- If the airbag system faults include “Driver airbag igniter Resistance too high (B10001B)” or “Driver side airbag igniter (VAG00588) Upper limit exceeded” <as shown>, the clock spring **MUST** be replaced. Leave the VAS tester connected to the vehicle and **Proceed to Section D – Clock Spring Replacement**
- If the airbag system faults are unrelated to the driver airbag igniter circuit, additional diagnosis is required outside of this action. Clock spring replacement is not necessary. **Proceed to Section C – Clock Spring Cover Installation.**
