SEISMIC EVALUATION OF HOSPITAL PIPING SYSTEMS

SUMMARY

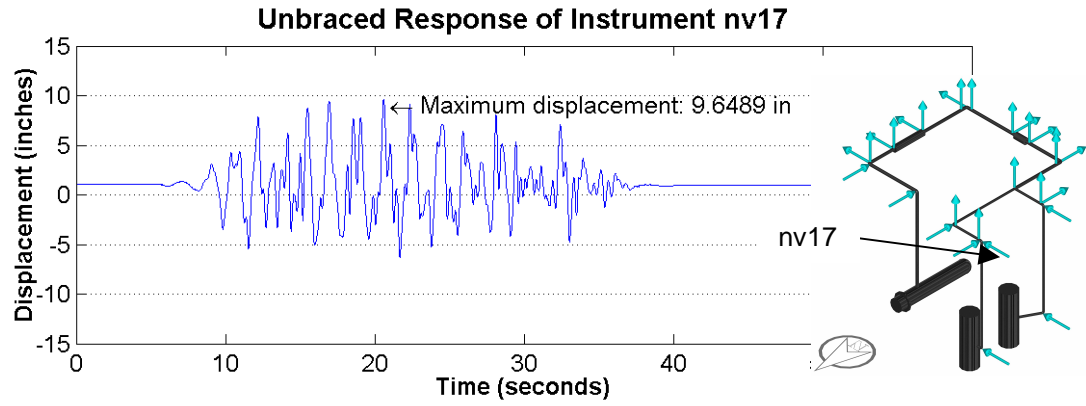
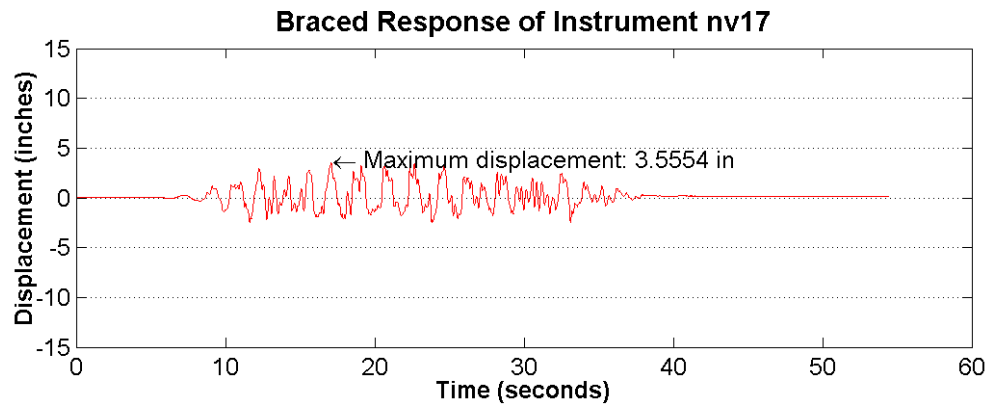
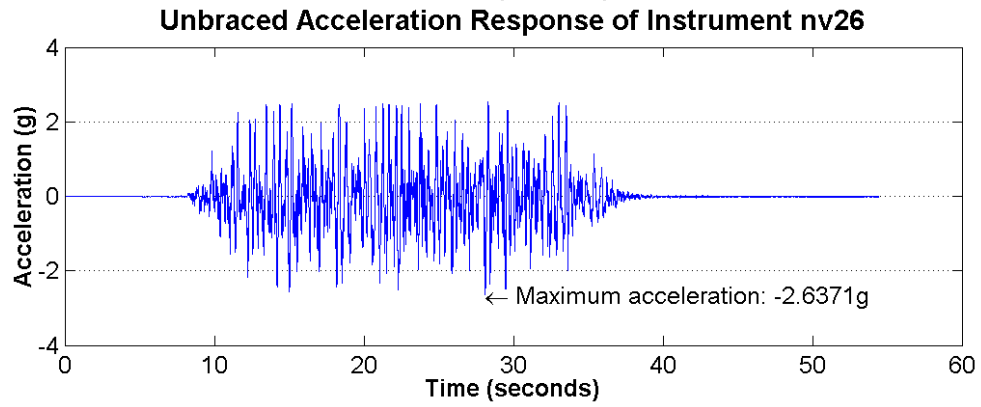
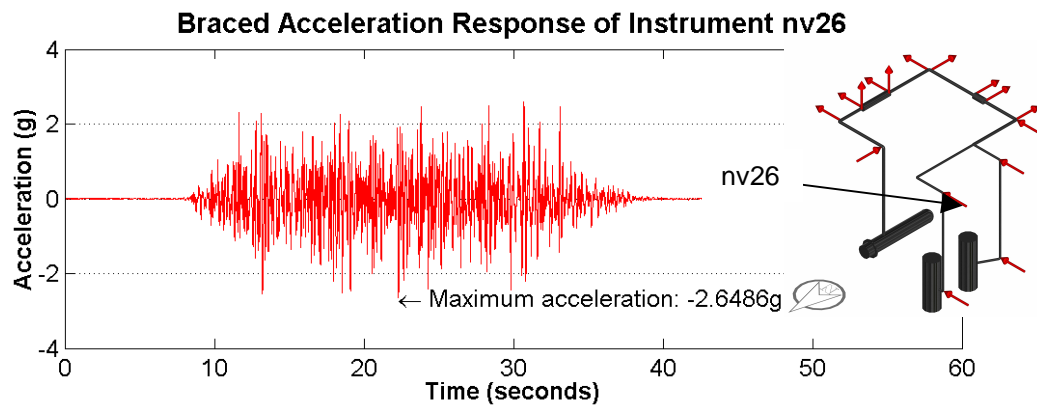
Figure 13. Response of Instruments nv26 and nv17

Figure 13 shows a comparison of the braced and unbraced displacement response of instrument nv17 at the highest SIMQKE input motion. As noted on the graph, the maximum unbraced displacement response for instrument nv17 was 9.65 in, and for the braced case the maximum displacement response for instrument nv17 was 3.56 in. Figure 13 also shows a comparison of the braced and unbraced acceleration response of instrument nv26, which was located at the same position as nv17. The maximum unbraced acceleration response for instrument nv26 was 2.64g and for the braced case, the maximum acceleration response was 2.65g. Similar behavior was observed in other instruments. The above can be explained by looking at the displacement and response spectra's for the SIMQKE motion shown in Figure 8. The accelerations are constant for frequencies between 2 and 33 Hz. However, the displacements drop off sharply for increasing frequency.
