SERVICE BULLETIN

Inspection of turbocharger assy. for ROTAX® Engine Type 915 i A and 915 i B (Series)

ATA System: 78-10-00 Exhaust system

MANDATORY

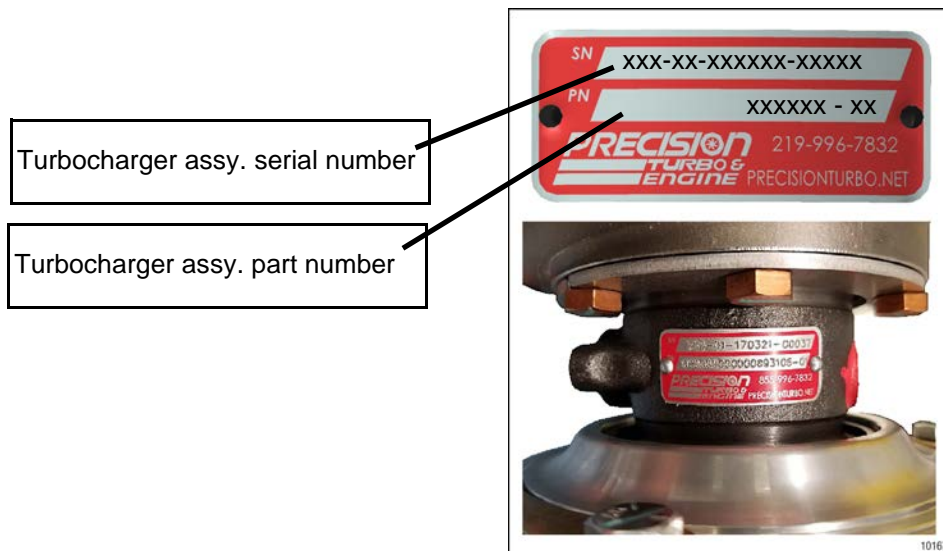
Fig. 1

Turbocharger assy. serial number

Turbocharger assy. part number

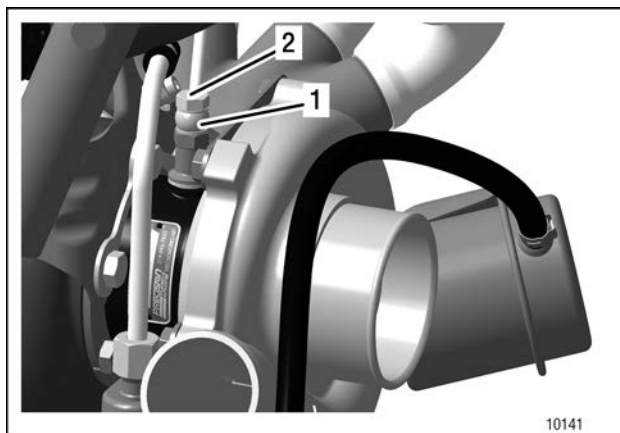
Fig. 2

1 Turbo pressure oil line
2 Banjo bolt M8x17

| Step | Procedure |
|---|--|
| 2 | Depending upon the aircraft, remove cowling. Follow the instructions of the aircraft manufacturer. |
| 3 | Disconnect the turbo pressure oil line (1) by removing banjo bolt M8 (2) and sealing ring from turbocharger. |

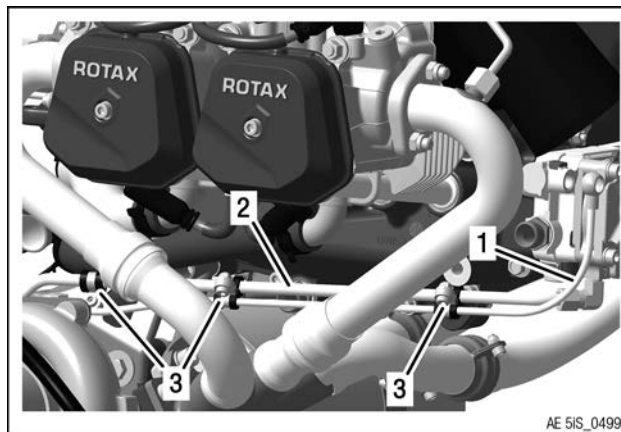
Fig. 3

- 1 Turbo pressure oil line
- 2 Turbo return line
- 3 Oil line clamps

| Step | Procedure |
|---|--|
| 4 | Disconnect oil line clamps (3) and remove turbo pressure oil line (1). |

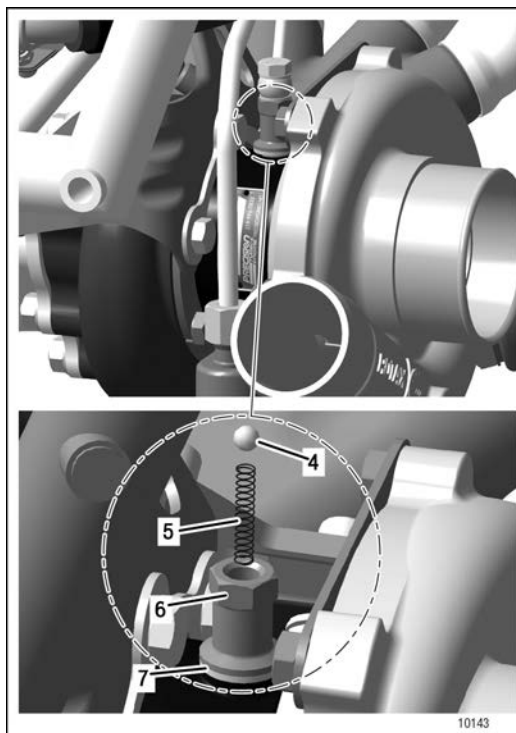
Fig. 4

- 4 Ball
- 5 Compression spring
- 6 Valve housing
- 7 Sealing ring 12x18

| Step | Procedure |
|---|--|
| 5 | Remove the ball (4) and compression spring (5). |
| 6 | Remove turbo oil inlet valve housing (6) and discard sealing ring (7). |

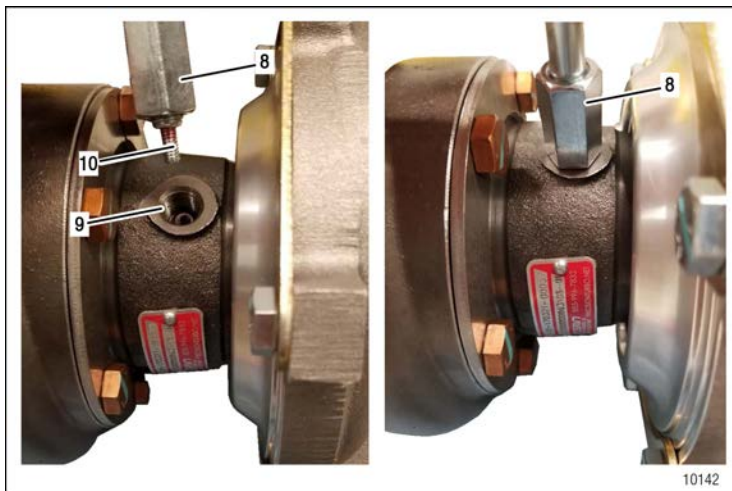
Fig. 5

8 Pin removal tool:
 threaded hex spacer
 9 Turbo oil inlet
 10 Pin removal tool: screw

| Step | Procedure |
|---|---|
| 7 | Install pin removal tool (8, 10) into turbo oil inlet (9) and carefully thread the screw (10) into inner valve. |
| 8 | Tighten by hand until threaded hex spacer (8) is seated. |

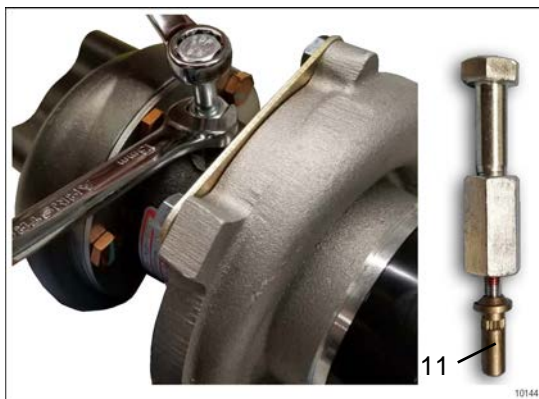
Fig. 6

Be certain not to move the rotor group (turbo rotor shaft) while the pin is removed. If it is, the bearing may not line up with the pin hole.

11 Pin

| Step | Procedure |
|---|---|
| 9 | Tighten the threaded hex. spacer (8) clockwise with one wrench (13 mm), while holding the screw (10) with an other wrench (13 mm). This will pull out the pin (11). |
| 10 | Pull out the pin (11) completely and lay it aside. |

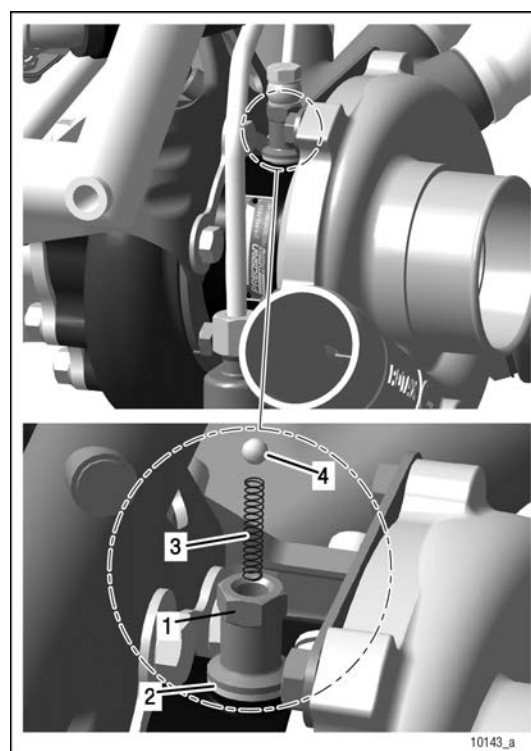
Fig. 10

Severe engine damage can result!
The ball must be on top of the spring and not below the spring.

- 1 Valve housing
- 2 Sealing ring 12x18
- 3 Compression spring 22.0
- 4 Ball

| Step | Procedure |
|---|---|
| 4 | Seat the pin by tightening the pin seating tool (1). The pin seating tool will nearly bottom out when pin is seated as shown. Tightening torque 17 Nm (150 in. lb). |

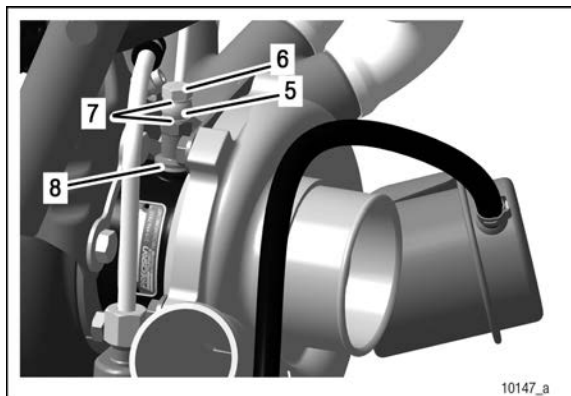
Fig. 11

- 5 Turbo pressure oil line
- 6 Banjo bolt M8x1x17
- 7 Sealing ring A 8x13
- 8 Sealing ring A 12x18

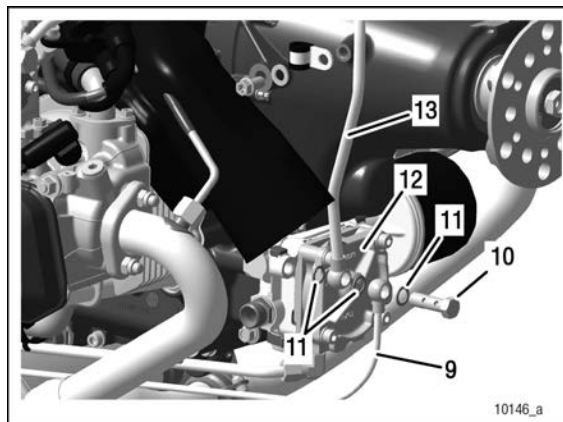
Fig. 12

- 9 Turbo pressure oil line
- 10 Banjo bolt M10x1x30
- 11 Sealing ring 10x14
- 12 Oil pump
- 13 Governor pressure oil line

| Step | Procedure |
|---|--|
| 4 | Install turbo pressure oil line (9) with banjo bolt (10) and three new sealing gaskets (11) at oil pump (12). Install finger tight only. |

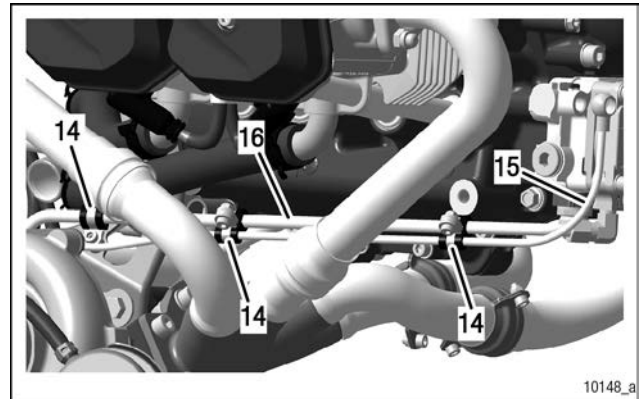
Fig. 13

- 14 Clamps 8/M5, 5/M5
- 15 Turbo pressure line
- 16 Turbo oil suction line

| Step | Procedure |
|---|--|
| 7 | Clean up any residual oil and degrease to allow proper leak inspection. |
