SERVICE UPDATE SEMINAR

2017-2018

Proper Preparation and Diagnosis of Subsequent Valve Cover Failures with RTV Sealant

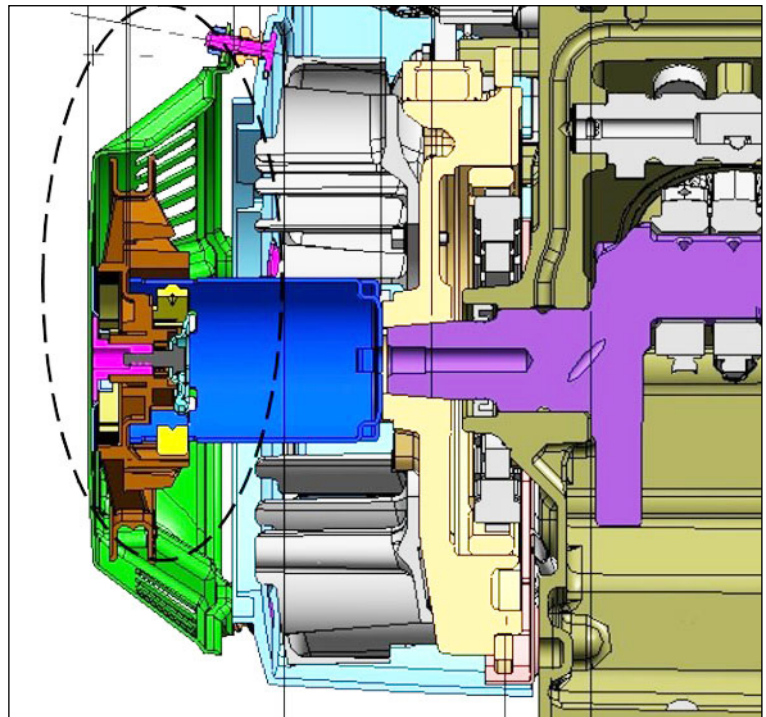
24 165 03 Recoil Design

There has been an updated recoil starter released for Command PRO Twins. The new design has stronger, more durable engagement pawls, features a single piece, windowed engagement cup and a recoil pulley made of stronger material.

The previous recoil assembly (24 165 01-S) is superseded in Kohler PLUS to a new kit (24 165 03-S) as the new recoil starter is not compatible with the old engagement cup and requires all the components to be be replaced including a shortened flywheel bolt.

Installation Instruction 25 790 16 that is packed with these starters has been revised to cover the new design.

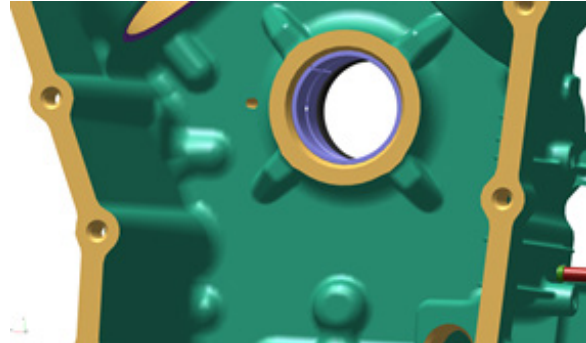
An upper main bearing sleeve has been inserted to the flywheel side of the crankcase for increased durability.

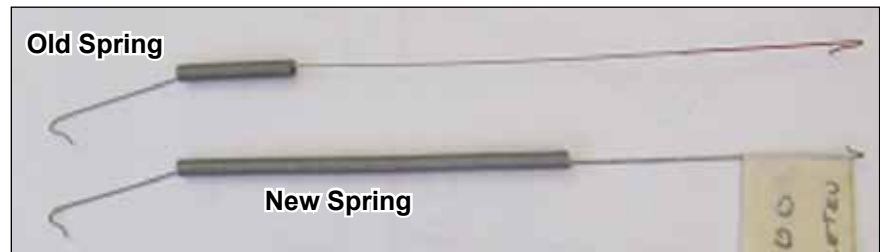
Mechanical Governor

New spring designs have been implemented for both types of governor controls.

Note the longer coil spring body used for mechanical governor systems and the changes in spring arm for the electronic governor linkage spring.

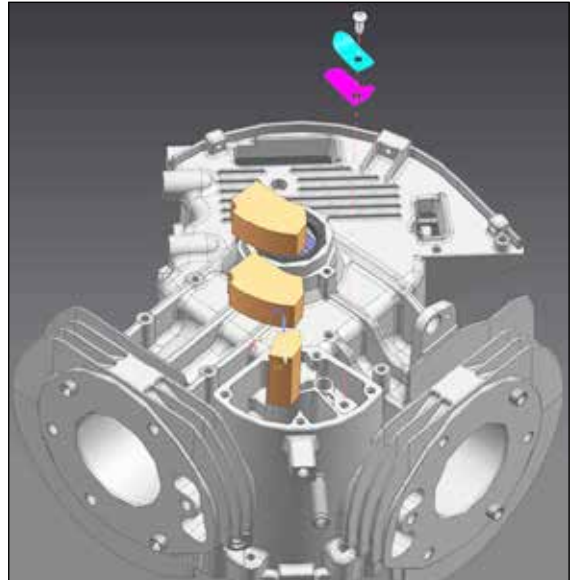
New Design

Several changes to the breather system have been made to reduce oil consumption. These changes include a change in the breather filter media as well as the addition of a 90° restrictor fitting.

New production units will come with a new breather filter media and different breather reeds. These changes are designed to reduce the amount of oil making it into the intake stream from the breather system.

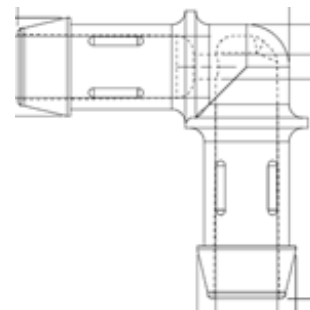
The newly designed fitting that gets placed in the breather tube features a restrictor orifice that is molded into the part. This reduces the amount of vacuum being pulled through the breather system and reduces the amount of the oil being consumed. This part is backwards compatible for all 824 cc engines and is available as a service kit, part number 19 755 17-S. This is to be used in situations where excess oil consumption is observed through both cylinders and the breather system is believed to be suspect.

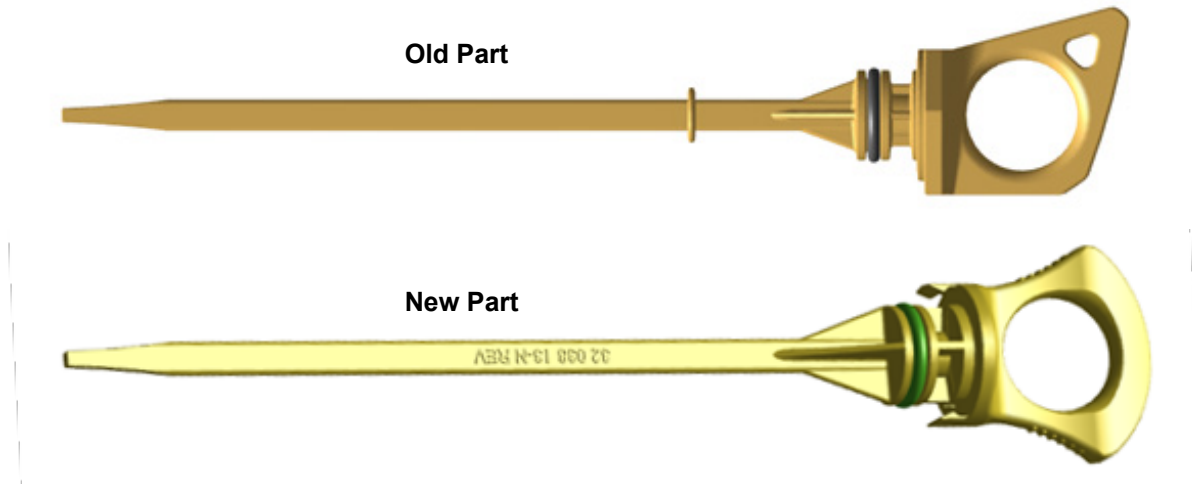
824 cc units in production since December 2016 now utilize a positive retention dipstick similar to what is used on the 7000 Series engines. The new dipsticks must use a matching dipstick tube when used in Service to ensure the retaining tabs engage with the outside diameter of the fill tube.

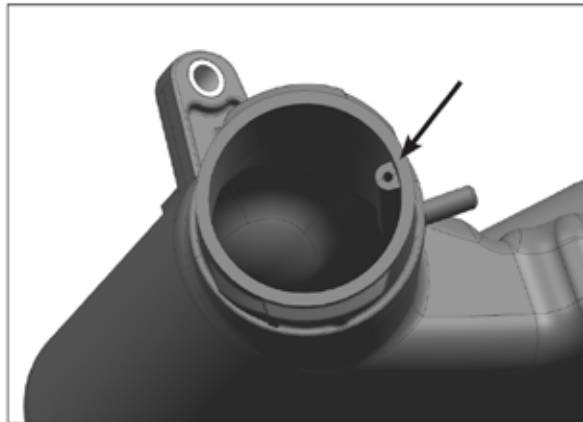
Figure 2. New Tank 14 065 63-S.

This new tank should be used as the replacement for any such reports and can be identified visually by the round shape of the internal tank neck feature shown below.

If you have inventory of the 14 065 56-S fuel tank, please contact your Central Distributor for a new replacement.

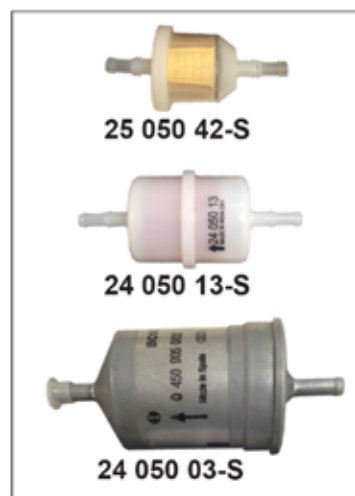
One suspect cause of unnecessary FPM replacement is restricted fuel flow to the FPM. Verify the correct fuel filter has been used and serviced at the proper intervals. If in doubt, replace the fuel filter before assuming the FPM is defective. **FPM failure that occurs due to improper filter use or service is not a warrantable defect.**

Replacement FPMs now include replacement fuel filter 24 050 13-S. When the FPM is replaced, replace the fuel filter and retain the filter removed. **FPMs requested for return to the factory for testing now require the fuel filter to be returned. Please drain all fuel from filter and FPM before returning.**

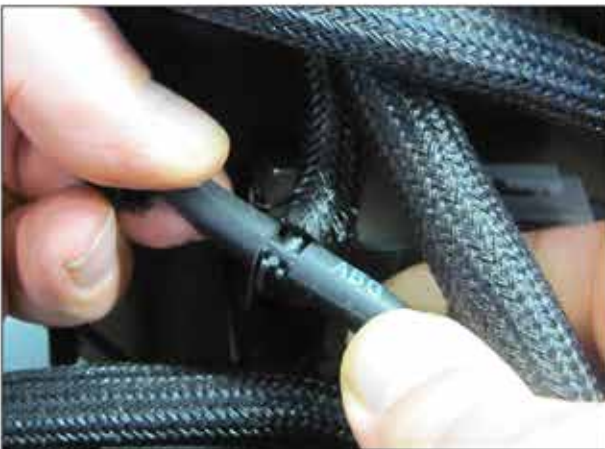
Figure 3.

2. **Broken FPM vent nipple:** Prying on the FPM to remove the vent hose can result in breaking off the vent nipple. If the hose cannot be removed from the FPM by hand (see Figure 2), remove from the vent tee fitting (see Figure 3). It may be possible to twist the hose free once removed from the vent tee fitting. If risk of damaging the FPM is probable, cut and replace the hose.
3. **Damaged engine wiring harness terminals at the FPM connector:** Forcing a test probe into the electrical connector results in terminal damage and potential intermittent connections. Use a probe with a diameter of 0.032 in. (0.8128 mm) or smaller.
4. **Broken high pressure fuel hose fittings at the #2 injector:** Remove and/or back out FPM fasteners before attempting to remove the high pressure hose from the FPM.
