DEPARTMENT OF DISASTER MANAGEMENT

SITUATION REPORT 002

Event: Hurricane Irma
Date of Event: September 6, 2017
Issue Date: September 16, 2017
Issue Time: 10:00 pm
Report Number: 002

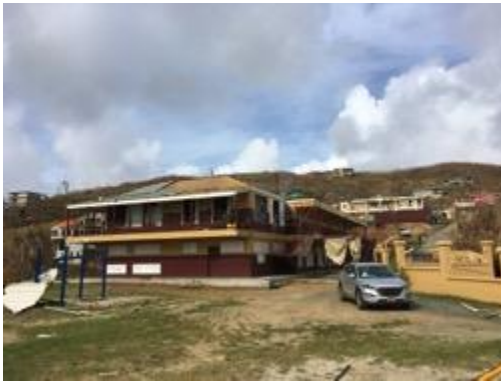
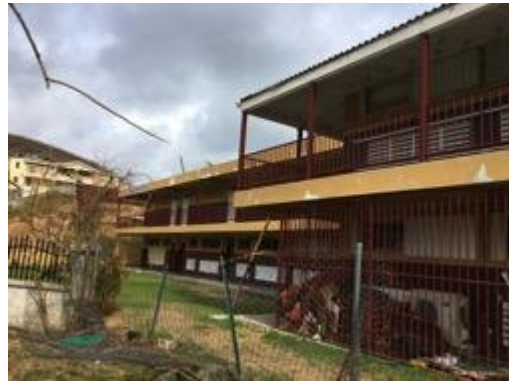
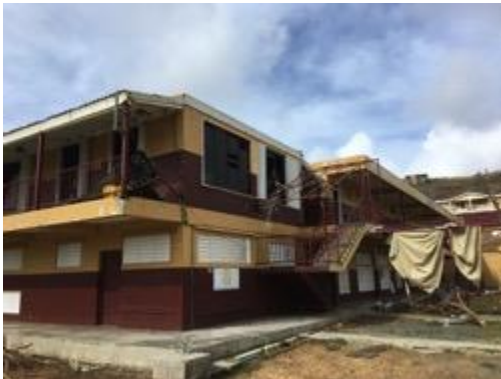
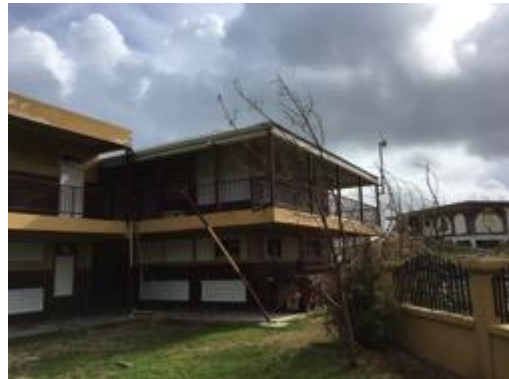
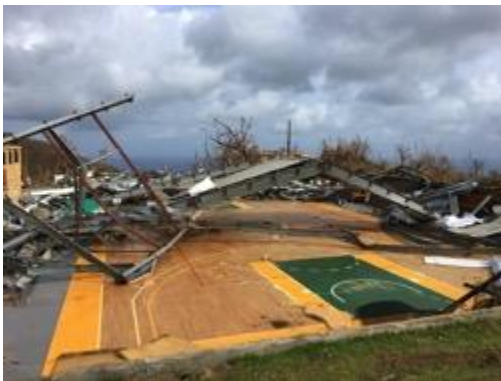
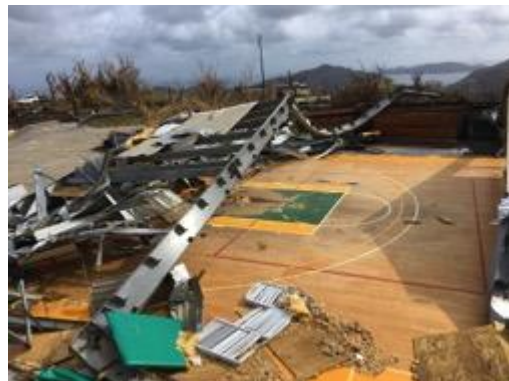
- Confirmed water storage tank (approx. dia. 13'x12')
- No power on site
- No mobile signal on site.
- Medium debris levels
- School Capacity unconfirmed
- No confirmed water supply
