Insurance assesor 'summary of damage' *Orca*

Technical analysis of Musto lifejacket worn by skipper of *Orca*

FLEETWOOD TESTING LABORATORY
EVALUATION OF
MUSTO 150N INFLATABLE LIFEJACKET
ON BEHALF OF
MARINE ACCIDENT INVESTIGATION BRANCH
MOUNTBATTEN HOUSE
GROSVENOR SQUARE
SOUTHAMPTON
SO15 2JU
UK

ORCA: accident leading to a fatality on 8 June 2014

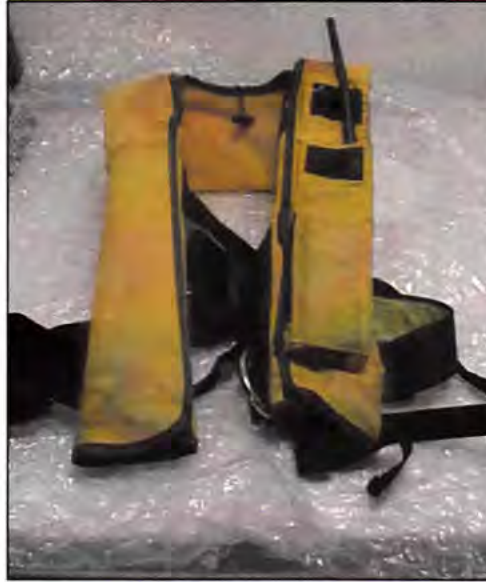
Fig.1. Lifejacket as received (front).

The yellow cover fabric was worn. There were no visual signs of any damage or defects to the cover fabric. The black webbing is faded in parts on the back double shoulder straps. The front pocket containing the VHF radio was in an open position. The VHF radio aerial was damaged as the internal metal coil of the aerial was exposed (see Fig. 3). The VHF radio was wedged in to the pocket and we were unable to remove the radio from the pocket. The VHF radio cord handle was found loose inside the pocket (see Fig. 4).

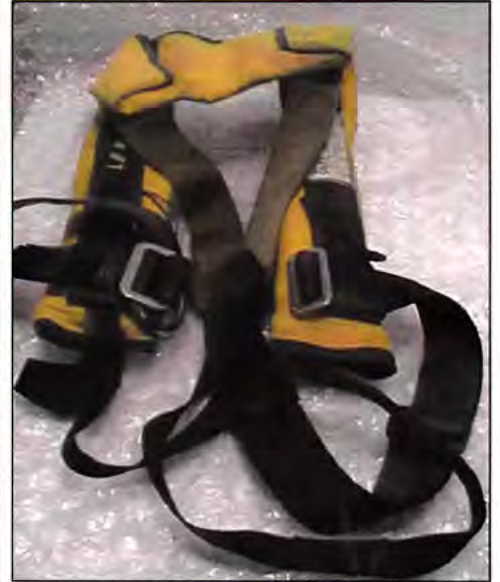
Fig.2. Lifejacket as received (back).

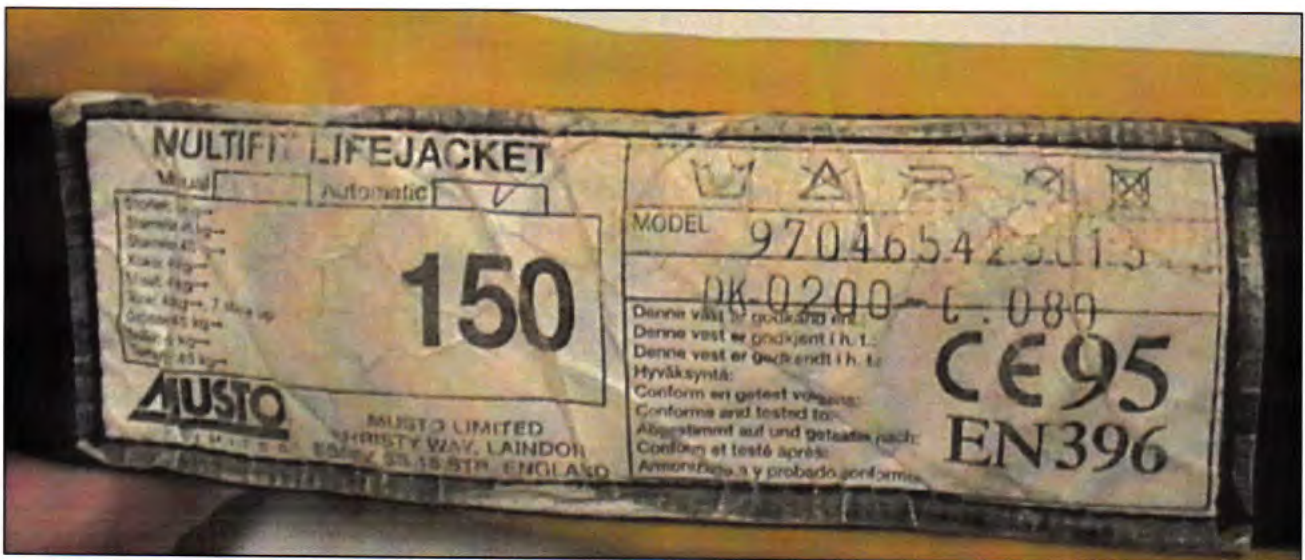
Fig.5. Lifejacket label and information.

- The label is marked with 'MULTIFIT LIFEJACKET' intended for size range 45kg (7stone) plus.
- There is a tick in a box to indicate that the lifejacket is automatic.
- It contains the manufacturer logo and address as follows: Musto Limited, Christy Way, Laindon, Essex, SS15 STR, England
- Simple washing instructions via pictograms.
- A model/serial number as follows: 97046542XX1372 DK-0200-C.080
- Note. The numbers have faded on the label and the letters XX have replaced the numbers which are illegible.*
- Conforms and tested to EN396 with the CE mark 'CE95'

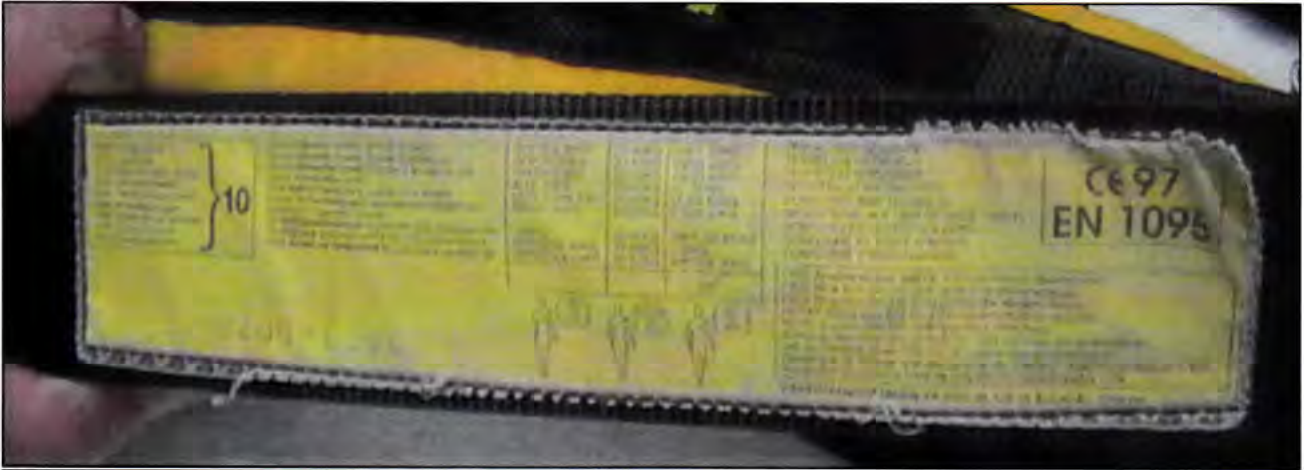
Fig.6. Deck safety harness label and information.

- Max life span/ years 10.
- Conforms and tested to EN 1095 with the CE mark 'CE97'.
- The serial number has faded and is illegible.
- The statement 'This harness is suitable for a wearer of over 50kg.'
- A warning; 'NOTE! Use only Baltic approved safety lines.'
- Address on harness label: CRAFTMANSHIP MARIN, AB BOX 60, 54502 Ä1 GARÄS, SWEDEN

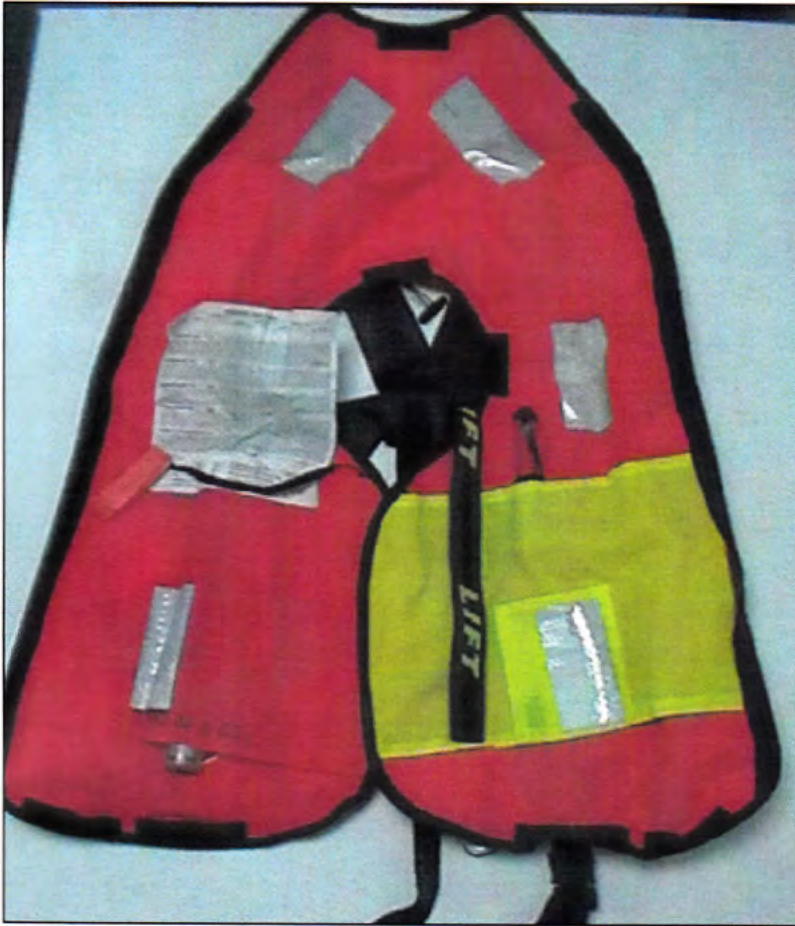
Fig.7. Lifejacket unpacked.

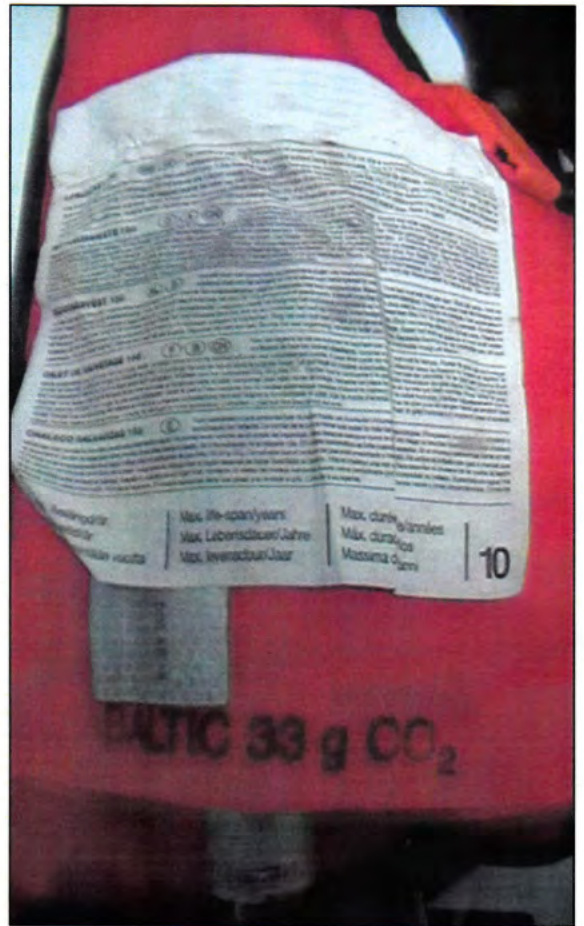
Fig.8. Internal label (front).

Note: The information on the lifejacket for servicing recommendations states; 'This lifejacket should be serviced once a year. Refer to agent.'

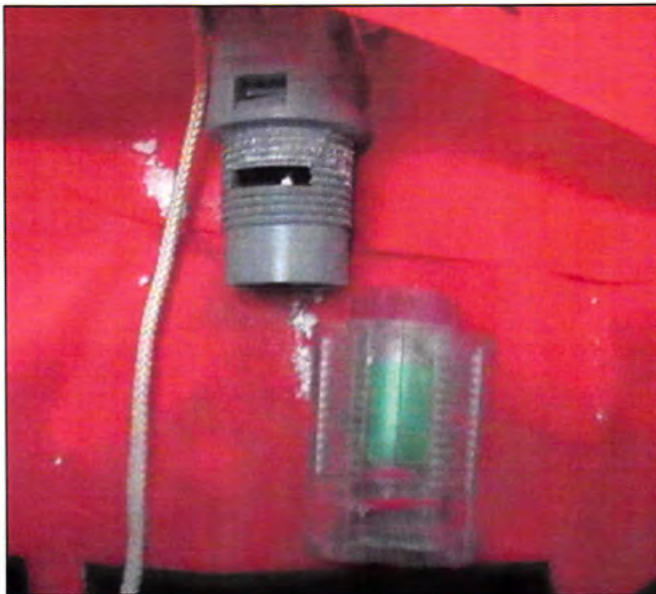
Fig.14. Halkey Roberts inflation mechanism with automatic cap removed.

The automatic cap was unscrewed from the main body of the inflation mechanism to inspect the automatic inflator components. There was a white residue present, as seen in Fig.14. This is further indication that the system had previously automatically activated. The Halkey Roberts red bobbin was marked with HRC 02/97. This indicates a manufacture date of February 1997.

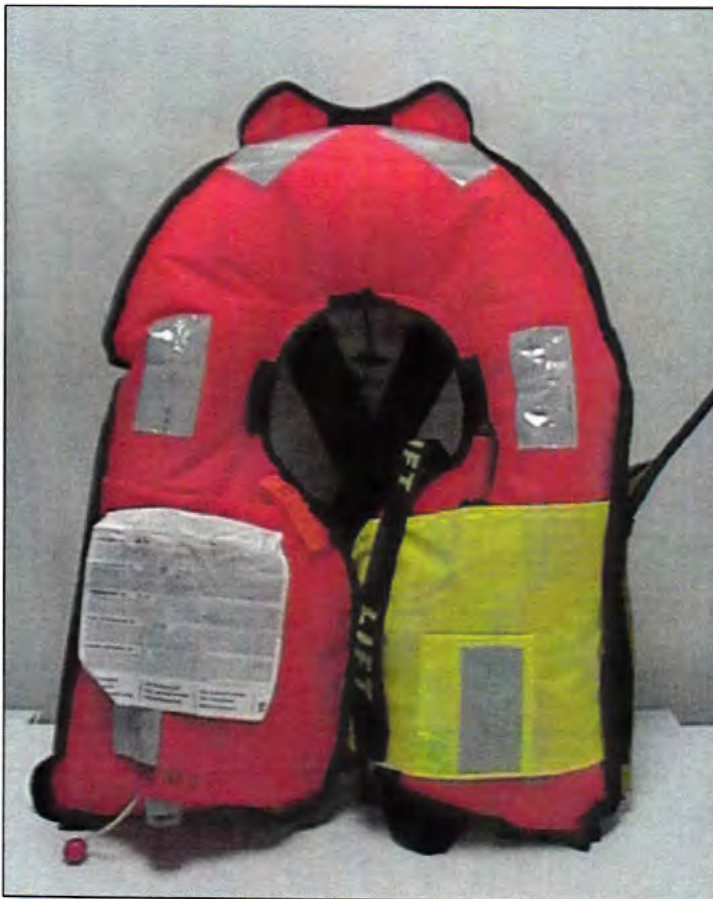
The lifejacket sample was fitted with a new 33g CO₂ cylinder. The new fully charged cylinder was screwed into the inflation mechanism*. The cylinder needed slight manipulation to screw in to the inflation mechanism as there was damage to the top of the thread of the inflation mechanism (see Fig.15). Once screwed in correctly the inflation mechanism pin (which was already in a fired upright position) pierced the new cylinder and the lifejacket inflated successfully (see Fig. 17 and 18).

There was no damage to the inflatable chamber and the lifejacket maintained its operating pressure.

Fig.17.Lifejacket inflated – front view.

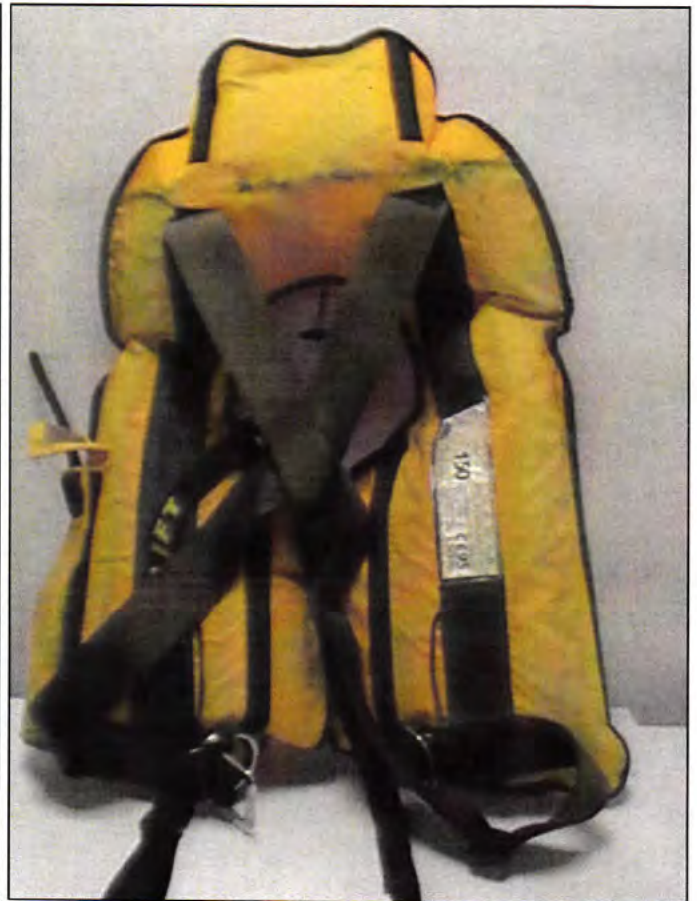
In addition a leakage test was carried out to check the integrity of the inflatable chamber. When submerged under a head of fresh water there was no leakage of the inflatable chamber.

Fig.18.Lifejacket inflated – back view.

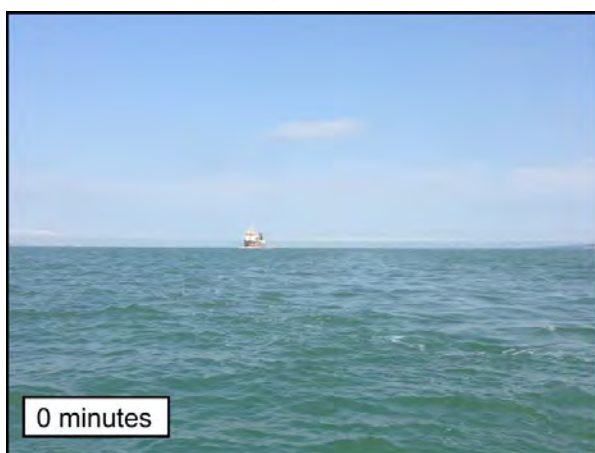
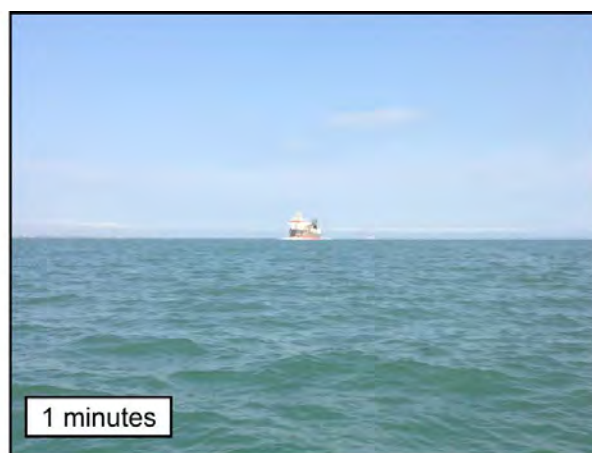
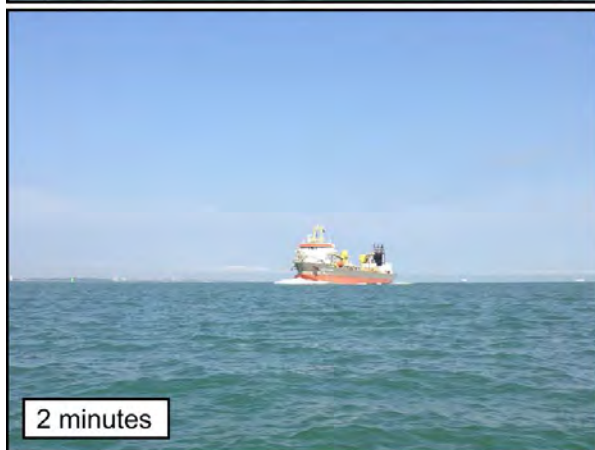
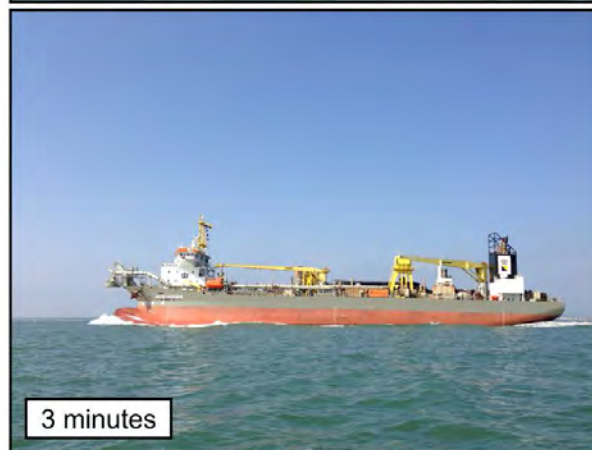
- Leisure sailors need to be particularly aware of closing speeds between their own vessels and other vessels. In this case, *Shoreway* was travelling at 12.9kts but many types of vessels, including ferries, cruise ships and container ships, regularly sail at speeds over 25kts and, as a result, distances that initially appear sufficient can be reduced surprisingly quickly.

The following four pictures, taken from a stationary vessel, give an indication of how rapidly a vessel, in this case a dredger, can approach.
