Space Shuttle Body Flap Actuator Bearing Testing for NASA Return to Flight

Abstract

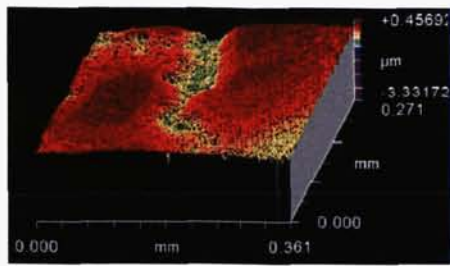
Higher magnification of the ball revealed some particles present on the ball (Figure 6). The presence of aluminum and silicon, in addition to other elements detected by EDS on these particles, were likely attributed to the bentonite clay additive present in the Braycote 601 grease and not contamination as was originally proposed. Analysis of the inner and outer raceways showed surfaces similar to the black ball. EDS performed on those surfaces detected the carbon iron oxide coating found on the black balls. Examination of the inner raceway away from the burnished band showed the original finishing marks which gradually translated into a smoother region as the burnished area was approached (Figure 7). Figure 8 shows the surface for the coating present on the black ball obtained by surface profilometry.

Figure 8. Surface profilometry trace showing the coating present on the black ball including a segment of the grain boundary-like structure in the center

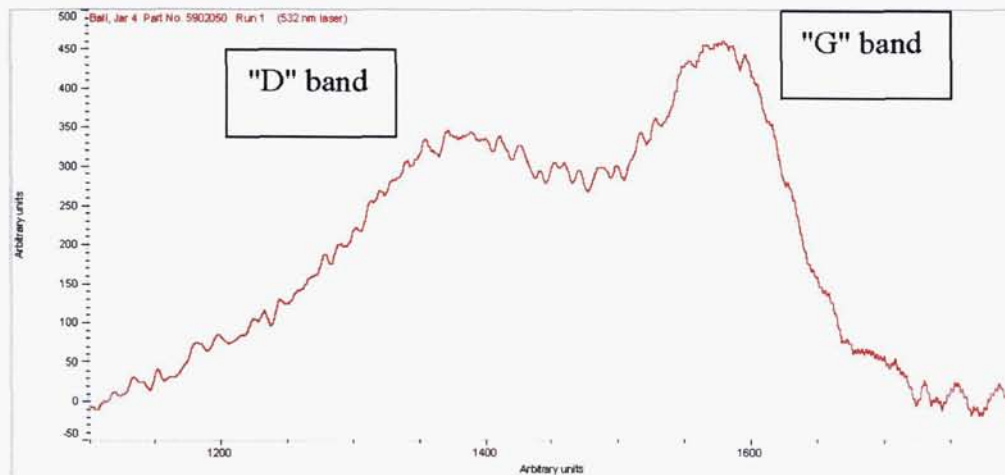
Raman spectroscopy of the black balls showed carbonaceous peaks from the carbon coating on the surface of the complex iron oxide, black, tribological coating [6]. Specifically, the diamond, D, and graphitic, G, peaks were observed confirming the presence of amorphous carbon (Figure 9).

Figure 9. Raman spectrum for black ball showing the graphitic (G) and diamond (D) peaks associated with amorphous carbon.

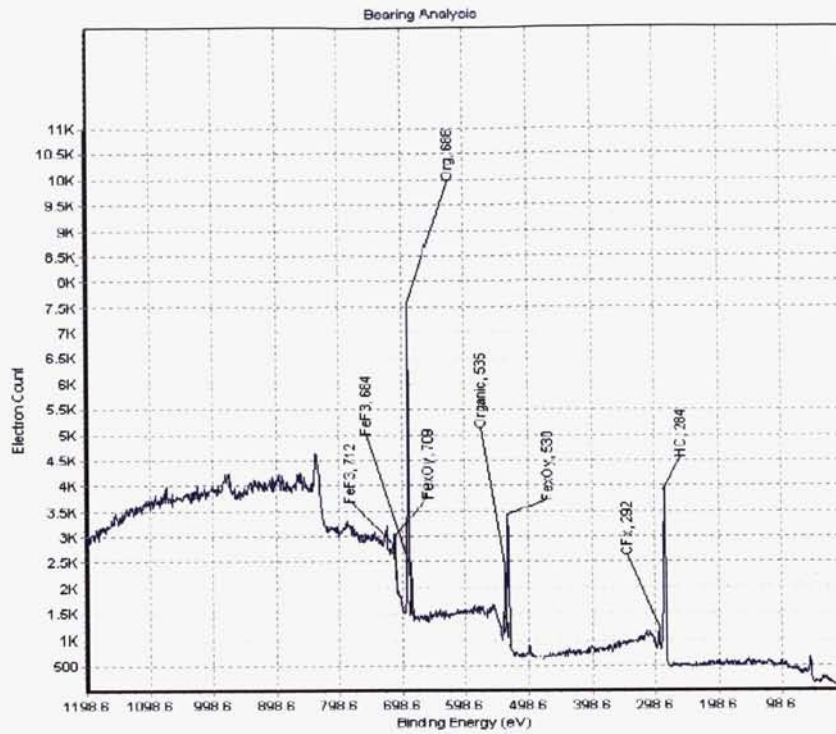
XPS was performed on the black ball at three different locations and on the inner race. Following the initial scans, depth profiling was performed by application of fifteen sputtering cycles, each lasting ten seconds, and a total sputter time of 450 seconds per location. The results show a carbon-rich coating on top of an iron oxide-rich surface. The carbon-rich top surface forms during the tribological decomposition of Braycote 601 grease and contains fluorine and sodium from the grease [7, 8]. The Raman spectrum of the carbon-rich coating is reported in the Raman spectroscopy section. Below the carbon-rich coating is the black tribological iron oxide-rich coating that also contains fluorine from the grease. At the end of the sputtering cycles, sodium was no longer present and chromium was observed in both locations in addition to carbon oxygen, fluorine, and iron (Figure 10).

A black ball and a segment of the race from the blackened bearing, S/N V6L009, were metallographic cross sectioned and the tempered martensitic 52100 steel and black tribological coating examined (Figure 10 and 11) [5]. The microstructure of the black ball was consistent with properly processed 52100 temper martensite with finely dispersed carbides with a hardness of R_c 64-65 from the surface into the ball. Tapered sections showed no evidence of annealing below the black tribological coating therefore the

temperature of the ball did not go above 204°C during the formation of the black tribological coating. The black coating appears to be a micron or two thick. Pits present on the cross-section were very shallow.

Figure 10. An XPS spectrum for black ball

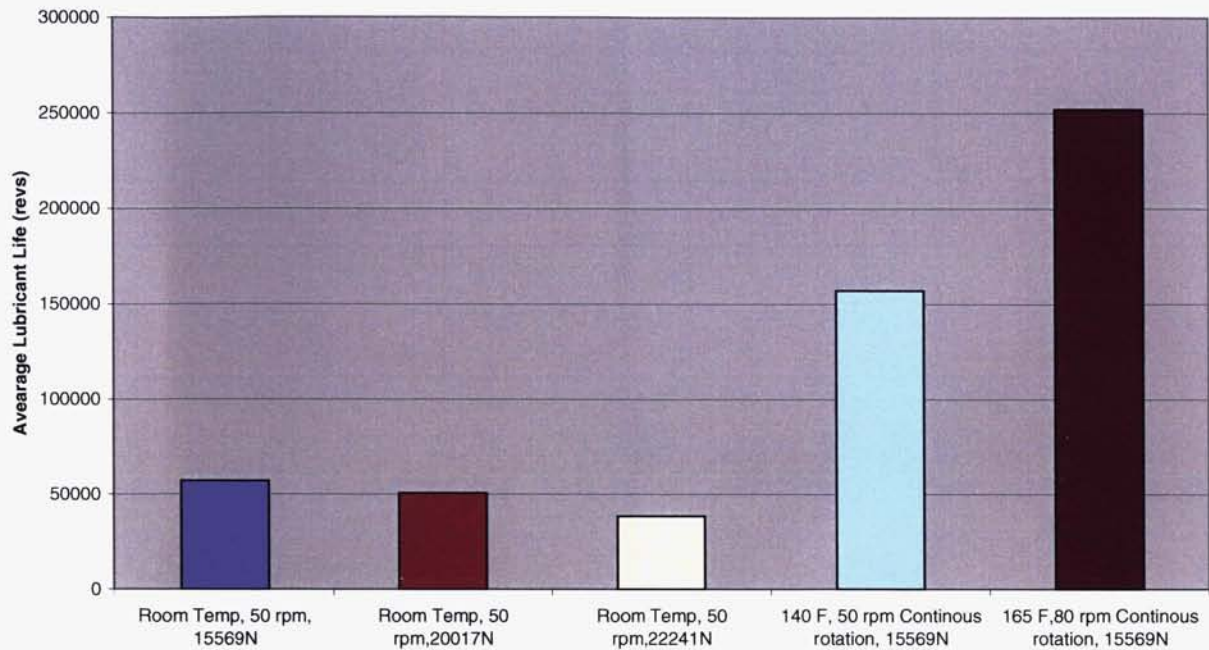
Due to these unexpected results of lower life at room temperature, life tests at elevated temperatures were performed to confirm this trend. Tests were run at 60°C with 15569-N axial load at 50 rpm continuous shaft rotation. One test was run at 70°C under the same conditions. The same bearing test rig as previously described was used. The results are shown in Table 6 and Figure 20.

Bearing Number	Load (N)	Speed (rpm)	Temp (°C)	Time (hours)	Cycles (Krev)	Failure Mode
BF015	15569	50	60	65.35	196	Lubricant failure, Severe wear
BF017	15569	50	60	39.65	119	Lubricant failure, Severe wear
BF031	15569	80	70	56.52	271	Lubricant failure, Severe wear

Figure 20. The effect of temperature on lubricant life

The results of this testing indicated that temperature had a significant effect on bearing life. Increased temperature yielded a significant increase in bearing life. The cause of this effect has not been determined. One theory is the higher temperature afforded better lubrication either by a decrease in apparent grease viscosity or by an increase in oil separation rate. This resulted in more oil available in wear contact area thus extending bearing life.

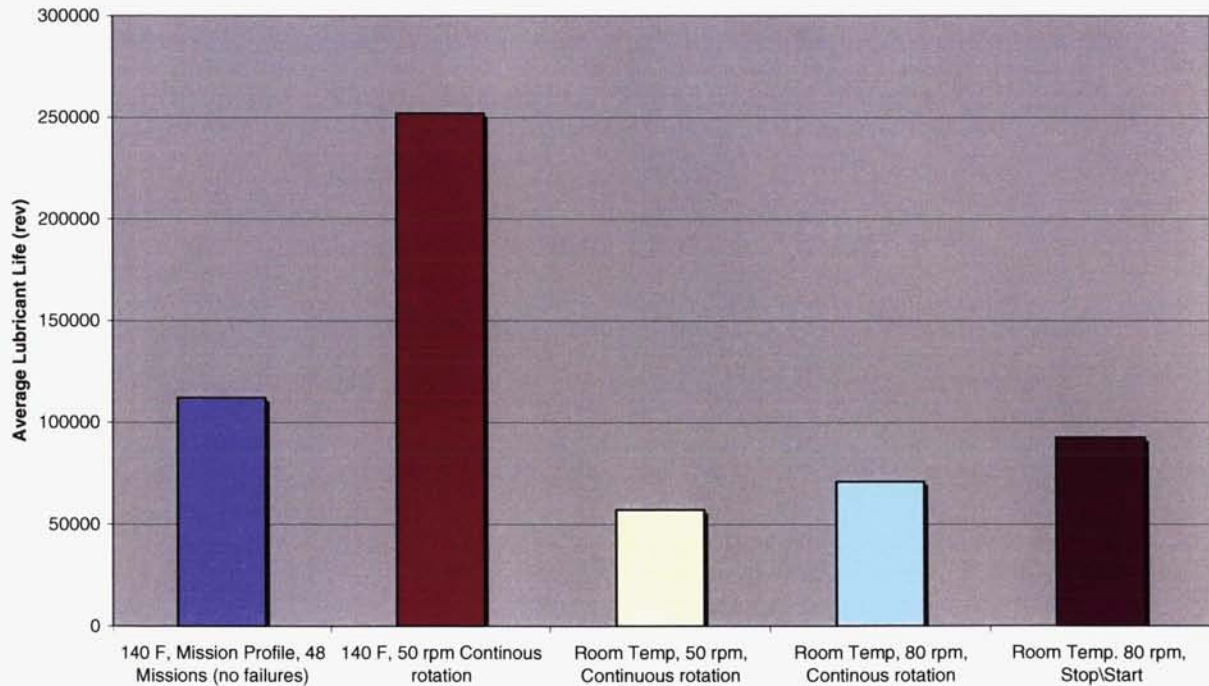
For this testing the bearing rig was run for 30 minutes at 80 rpm shaft rotation and then held idle for 30 minutes. This cycle was continuously repeated until bearing failure occurred. For a baseline comparison three additional tests were conducted with continuous rotation at 80 rpm. The results of this testing are shown in Table 7 and Figure 21.

Bearing Number	Load (N)	Temp (°C)	Speed (rpm)	Time(hr)	Cycles (Krev)	Failure Mode
BF019	15569	23	80	20.1	96.5	Lubricant failure
BF021	15569	23	80	13.55	65	Lubricant failure
BF023	15569	23	80	14.76	51	Lubricant failure
BF026(start/stop)	15569	23	80	23.8	114	Lubricant failure
BF028(start/stop)	15569	23	80	21.31	102	Lubricant failure
BF030(start/stop)	15569	23	80	12.8	61.4	Lubricant failure

Figure 21. Results of start/stop lubricant life testing

The start/stop testing at 80 rpm most closely simulated the actual BFA operation. The majority (92%) cycles on the BFA are applied during ground operation under stop/start conditions. All of these cycles occurred at 80 rpm with 15569-N axial load at room temperature. The remaining cycles occurred during flight. The BFA was never operated under maximum load (22241-N load). This load occurred during ascent when the actuator is in a lock position. The actuator was operated for several seconds in space to test the actuator, but the remainder of cycles occurred during re-entry where temperature probably
