Organizational Results Research Report

Structural Steel Coatings for Corrosion Mitigation

FINAL Report

October 2010

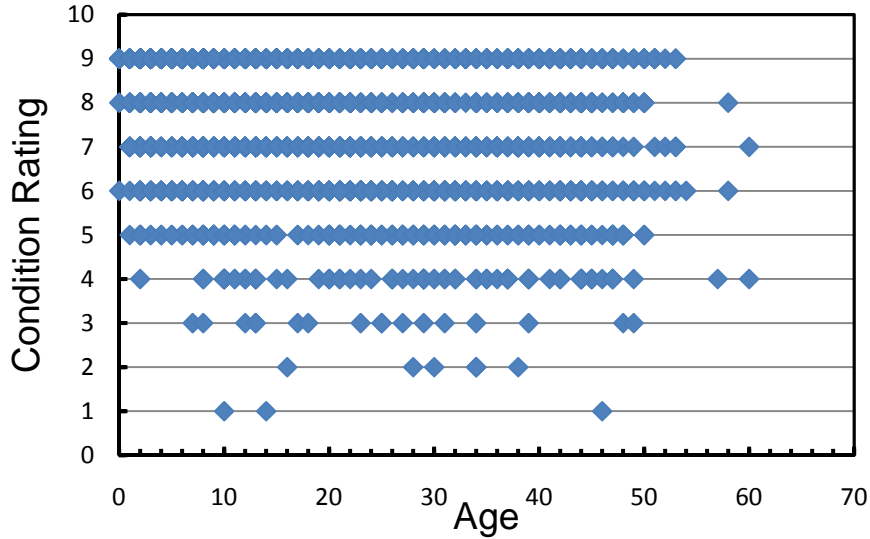
Figure 3.2 TMS Condition Data for Coatings in Missouri.

To get an overall view of the existing paint inventory in Missouri, a graph of Age versus Condition Rating was plotted from the data in the TMS database, which helps to illuminate some issues with the existing condition ratings and for predicting future coating performance (see Figure 3.2). Namely, there are no easily observable trends that relate the age of the coating and the condition rating. The Age was

Such dispersion of data is common for bridge inventory condition data, due to the stochastic nature of deterioration patterns common to bridges, the subjective nature of the rating systems, and the ongoing nature of maintenance activities that can influence the rating. Additionally, in the case of the TMS data, the condition data for the coating system may not be representative of the current condition due to historical limitations on data entry. Based on the field survey, this may be made more complicated by maintenance coating activities that address aesthetic needs for a bridge coating, i.e. painting the worst

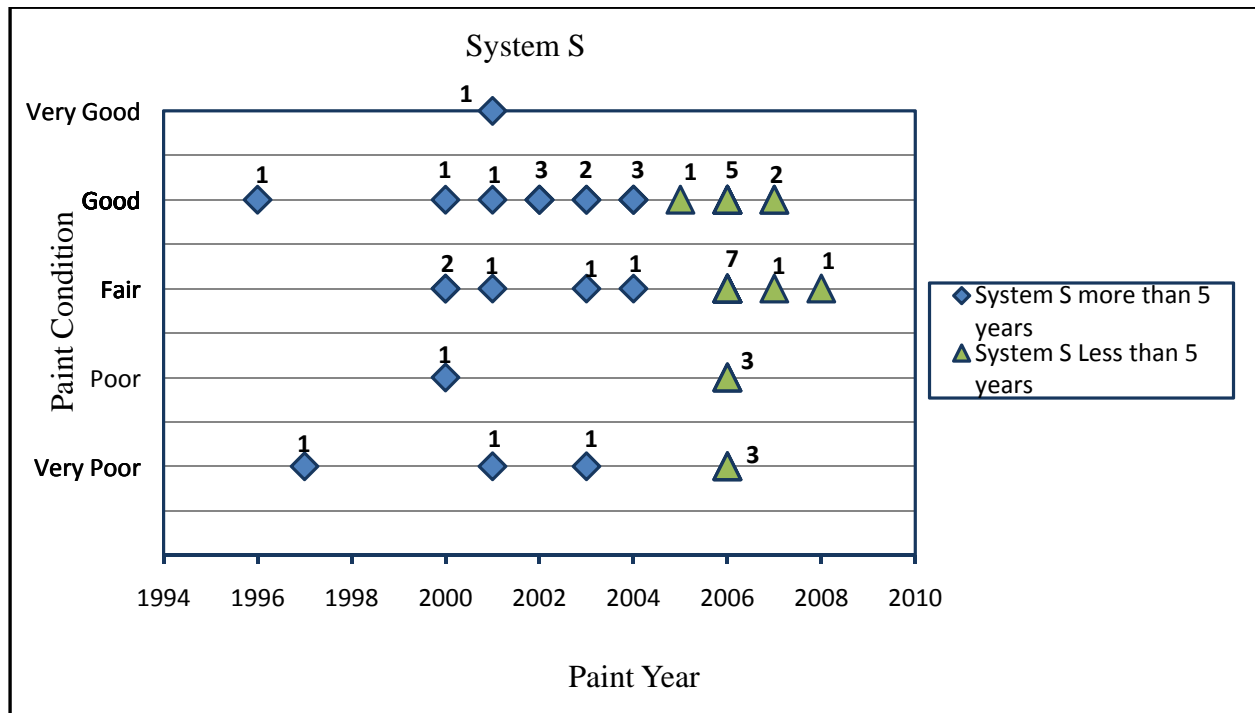
Figure 4.1 Summary of Conditions for System S Overcoatings.

When considered within the context that bridges with system S coating are less than 5 years old, the data suggests the overcoating process can be successful in extending the service life of the coatings. Based on observations in the field and discussion with experts, it would appear that the variations in the performance are likely related to a combination of the variations in the effectiveness of surface preparation and the severe damage that is present at the time of the over-coating. Figure 4.1 shows the coating conditions observed as a function of the time in service for the coatings. As shown in the figure, the age of the recoating does not appear to correlate with the condition of the coating, such that the condition of the recoating does not appear to be time-dependant, which further suggests that the condition is driven by factors such as surface preparation and localized environment.

Given that the expected service life of the over-coating can realistically be estimated in the range of 10 to 15 years, the data from the field evaluations indicates that this service life in many cases is being achieved, with isolated cases of early failures.

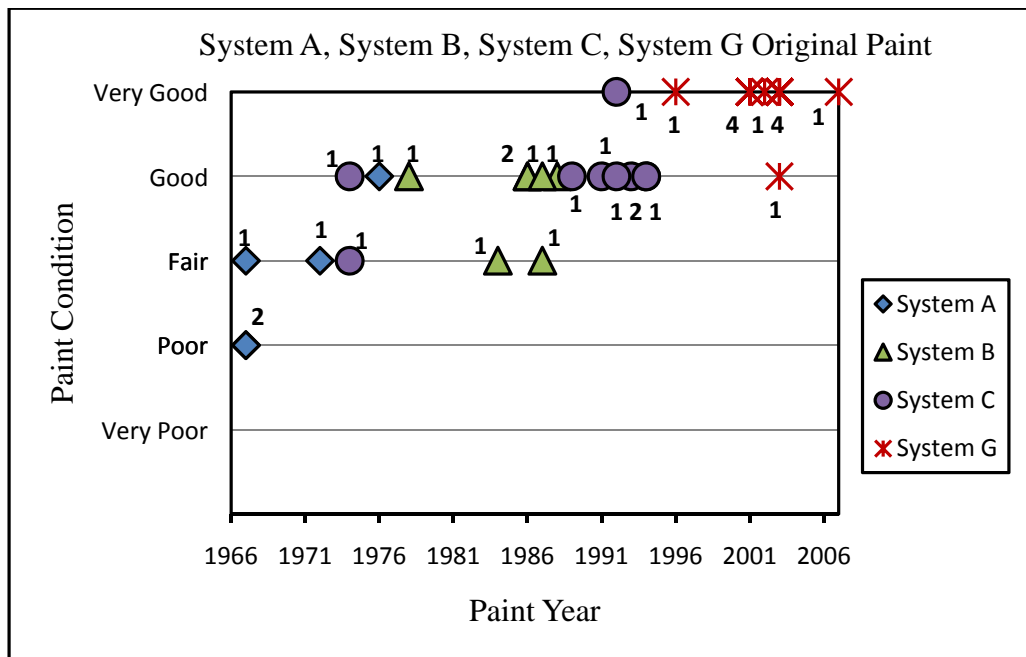
Figure 4.8 Condition Evaluation of Original Coating Systems.

The overall performance of the different original coating systems is shown in Figure 4.8. As shown in the figure, System G coatings are contemporary coatings that have had, so far in their service lives, very good performance in the field. Among the other systems that exist on the system, several are in poor or very poor condition. In each case, this degradation can be explained not by the service life of the coating, but by the drainage condition at the bridge as currently discussed. It should be noted that there are a number of original coating systems in the 30 to 40 years of service life range that are in fair to good condition. These bridges typically have very good drainage characteristics. Of course, what is missing from the data is the number of these older systems that have previously failed. The population of system A, B and C coating systems is somewhat skewed in terms of illustrating the overall performance of the coating systems since the time of their original application. Coating systems that have previously failed and have been replaced or overcoated are no longer available for evaluation, and therefore the coating systems failures are not included in the available population. However, among those systems that are available, it is clear that the most important factors in the performance of the systems are the drainage condition at the beam-end and the deck condition.

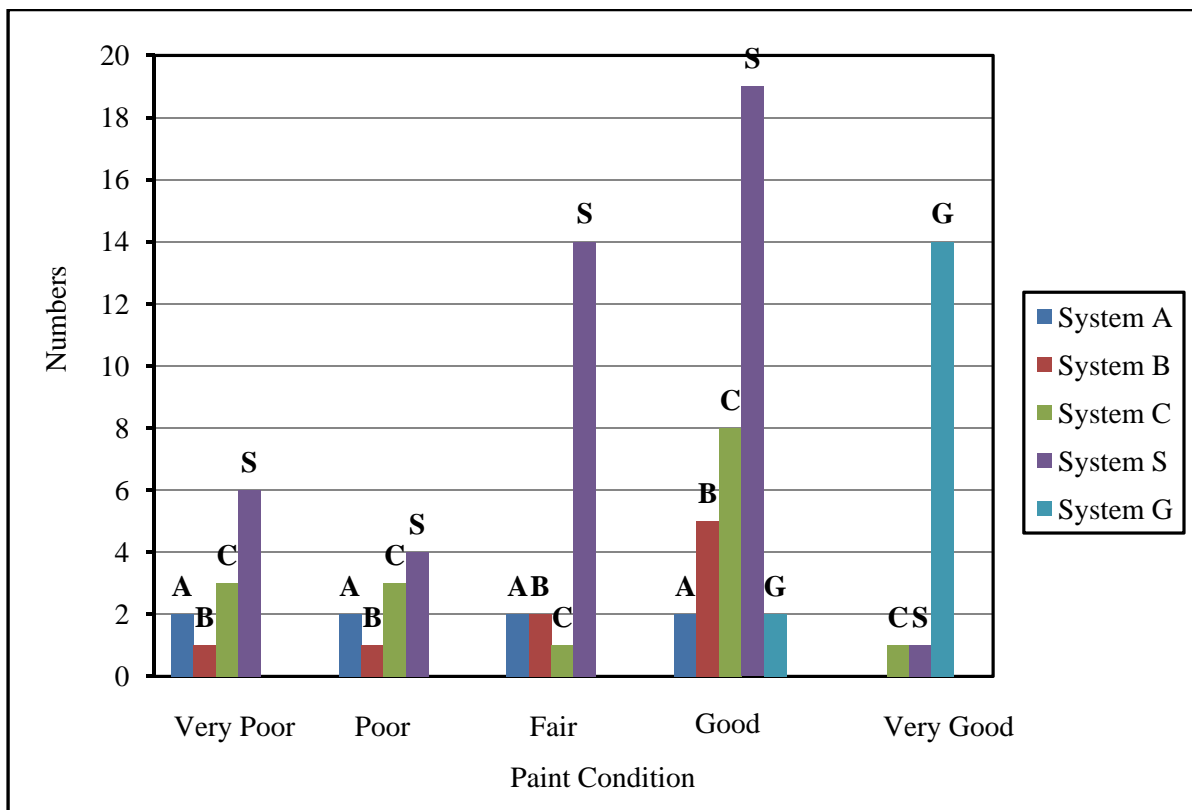
Figure 4.9 Overall Summary of Coatings Conditions Observed in the Study.

Figure 4.9 summarizes the overall evaluation from all of the bridge observed during the course of the research, according to the current condition evaluation of the coating system. This overall data shows what could be expected, the older coating systems are typically in worse condition, the newer systems in better condition, generally. Of note in the figure is that the system S overcoating have a number of cases where their condition is poor or very poor. The system A, B, and C, which are typically much older, have many cases where their condition is above expectations given their age, these systems are in fair or good condition even after many years of service. In virtually every case, the performance of the coating systems results directly from the drainage conditions at the bridge. For system S coatings that have performed poorly, the existing coating system that was overcoated was in poor condition and the drainage continues to effect the overcoating. For system A, B and C systems that are performing well, the surface of the steel has been kept dry by proper deck drainage and/or deck rehabilitations. One assumes that a number of A, B and C coating systems have failed previously and have been recoated or overcoated, as previously discussed.
