Service Action

Code: 97U3

Subject: 2006-2007 Rabbit/R32/ GTI, 2005-2007 Jetta/Jetta Wagon, 2007-2008 Eos and 2006-2007 Passat/Passat Wagon
Inspect Front Seat Side Impact Airbag Connectors & Install Wiring Harness Kit(s), if Necessary

REVISED January 10, 2013**Revision Summary**

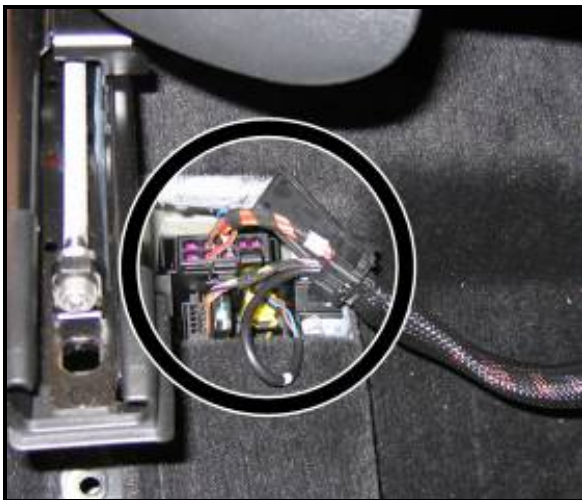
⇐ Carefully separate connectors –circle- from harness to side airbag igniter (-N199- driver seat) and (-N200- passenger seat)
