Sudden Acceleration in Vehicles with Common Rail Diesel Engines

Ronald A. Belt
Plymouth, MN 55447
1 July 2016

Abstract: An explanation is given for sudden unintended acceleration (SUA) in vehicles with common rail diesel engines. SUA is explained by an increase in the gain of the common rail pressure controller that leads to more fuel being injected into the engine than the throttle map specifies. The gain increase is caused by an erroneous battery voltage compensation coefficient produced by a negative voltage spike occurring while the battery voltage is being sampled. The erroneous battery voltage compensation coefficient increases the fuel injected into the engine, causing an increase in the engine speed, which causes the next iteration of the throttle map to issue a new common rail pressure set-point that is even higher than the previous one. The result is a runaway engine speed without the driver's foot being on the accelerator pedal. No diagnostic trouble code (DTC) is produced because all the engine sensors and actuators are working normally except for the battery voltage compensation coefficient, and this compensation coefficient is not checked for an erroneous value. Thi

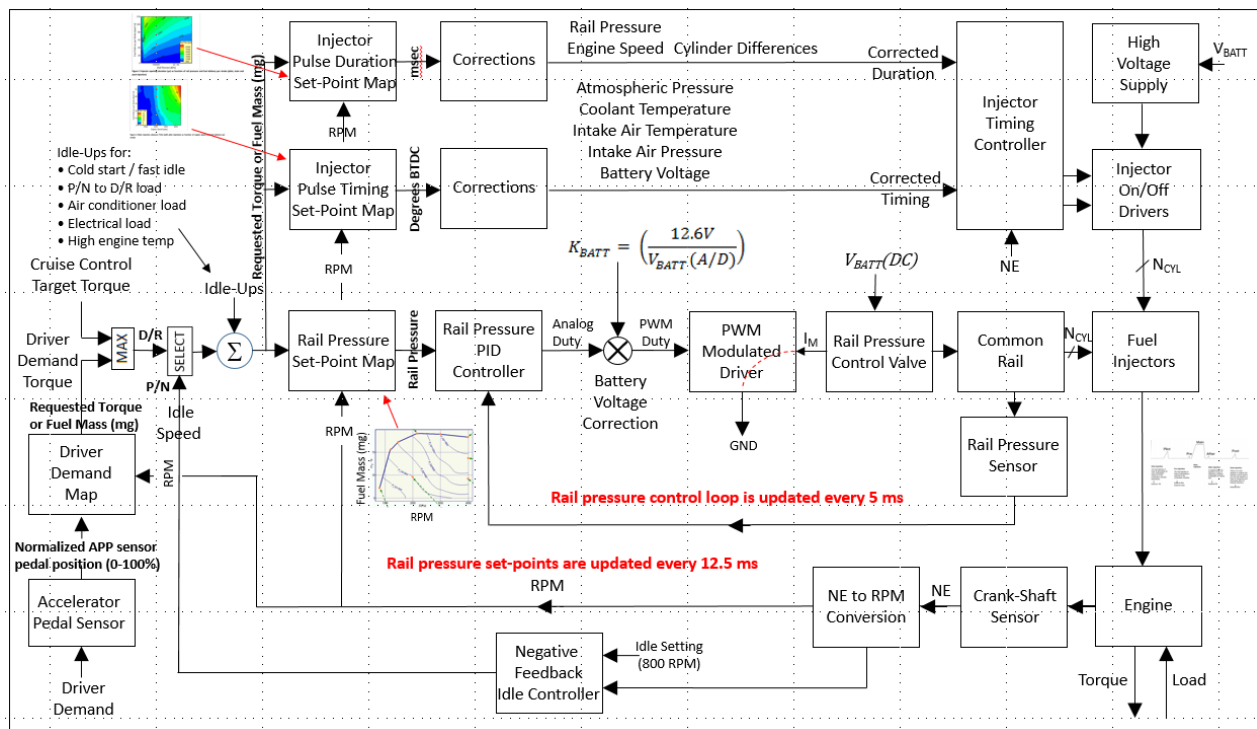
Figure 1 shows the design of a common rail fuel injection control system. It consists of two engine controllers that control the amount of fuel injected into the engine cylinders¹: 1) a closed-loop negative feedback idle controller that is used in the PARK/NEUTRAL mode to maintain a constant engine RPM, and 2) an open-loop feed-forward engine speed controller without feedback that is used in the DRIVE/REVERSE mode to control the engine torque. The closed-loop negative feedback idle controller maintains a constant engine speed while in PARK/NEUTRAL by decreasing the engine speed when it goes above the normal set-speed (usually 800 RPM) and by increasing the engine speed when it goes

Figure 1. Common rail fuel injection control system design. The control system consists of an open loop feed-forward controller in the D/R mode and a closed loop negative feedback controller in the P/N mode. The figure is based on information from a variety of sources, including Denso common rail brochures, Mitsubishi repair manuals, control system research papers, auto maker's patents, and auto industry educational material. It is more informative than the ECU software because it provides an overview of how the engine is controlled all the way from the accelerator pedal to the engine output.

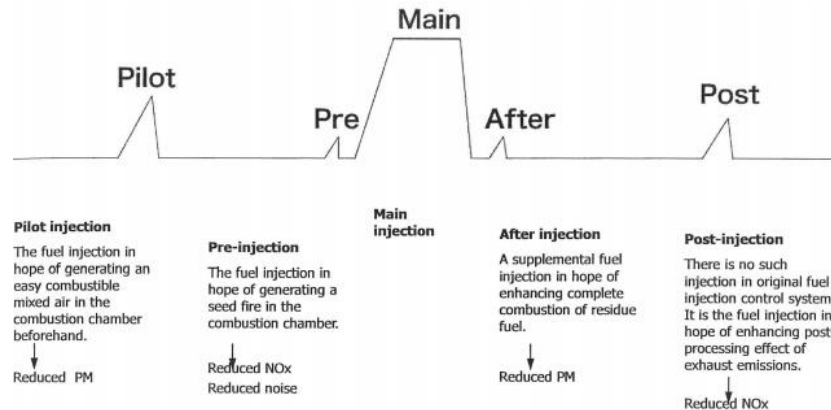
Figure 2. Modern common rail controllers provide up to five injection pulses per injection event. The duration of the smaller pulses can be as short as 250 microseconds, while the duration of the main pulse can vary from 500 microseconds to five milliseconds. Only the main pulse controls the engine torque and speed.

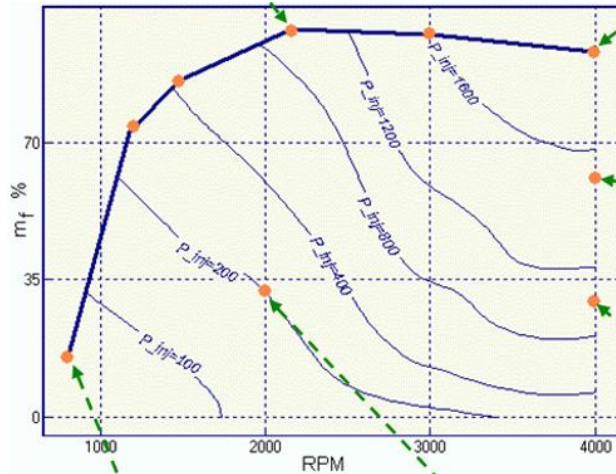
One can see that maps or look-up tables are used to control the pressure, timing, and duration of the fuel injection pulses. These maps are all a function of the desired engine torque and the current engine speed. The map for the common rail pressure is shown in Figure 3, and the maps for the timing and duration are similar. Values of pressure, timing, and duration for engine speeds and torques lying in between the values on the map axes are determined by two-dimensional interpolation. The values in the maps are determined by a process called map calibration, which is done by an engineer during engine design and again for each model vehicle using the same engine design. This tuning is done with such care that the map values are sensitive to the battery voltage used for the actuators unless the actuators are compensated for the battery voltage as shown in Figure 1. This is because the rail pressure control valve opening depends upon the current through the control solenoid, which varies with the battery voltage. A higher current means a higher rail pressure and thus a higher engine torque and speed. Therefore, one must compensate for variations in the battery voltage by multiplying the PWM duty cycle of the control valve by the inverse of the battery voltage normalized to some constant battery voltage, such as 12.6 volts. Similarly, the injector timing and duration can change with battery voltage because the start of injection and the pulse duration vary with battery voltage. These can be compensated by starting the injection at an earlier or later time or by changing the pulse duration as determined by a look-up tables of timing or duration compensation values versus battery voltage.

Figure 3. Map of common rail pressure versus requested fuel mass (or torque) and engine speed. The heavy curve of maximum torque (or fuel mass) for any given RPM is identical to the engine torque curve advertised by the auto manufacturer. This map is sometimes referred to as an inverse engine map because it is used to obtain the rail pressure from the requested engine torque, while the engine map is used to obtain the engine torque from the applied rail pressure. But they are the same map, just used differently.

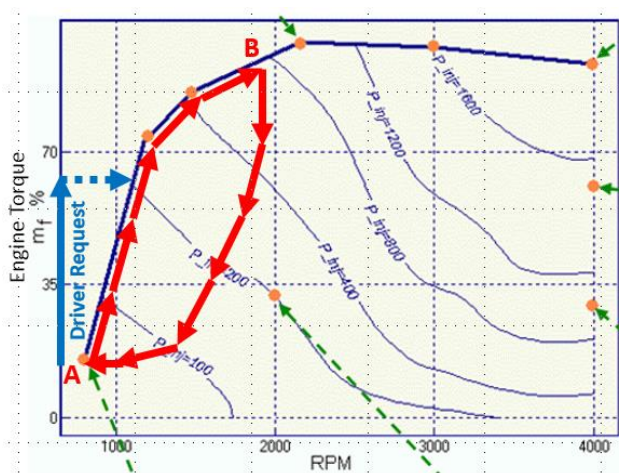
The process causing a runaway of the engine speed is explained more clearly in Figures 3 and 4. Figure 3 shows the normal operation of the set-point map in the open-loop feed-forward engine controller. Normally, when the driver requests a higher engine torque via pressing on the accelerator pedal, the rail pressure set-points are selected from the dark blue envelope curve based on driver's request for torque and the current engine speed, producing the upward-going trajectory A-B. When the driver releases the accelerator pedal, the rail pressure set-points are selected from the downward-going curve B-A to allow the engine speed to slowly decline instead of going back to idle abruptly. Figure 4 shows what happens during a sudden acceleration incident. During a sudden acceleration incident the rail pressure set-points follow the horizontal curve A-B to cause the engine speed to increase to the maximum speed in the map in less than one second without the driver pressing on the accelerator pedal. When a load is placed on the engine by the vehicle encountering an obstacle or by the brakes, the engine speed decreases and the engine torque increases along the constant pressure curve B-C causing the vehicle to jump over obstacles and causing the driver to feel that the brakes are acting like an accelerator.

Fig 3. During normal operation of the rail pressure map the pressure set-points are obtained from the upward-going dark envelope curve A-B during acceleration according to the driver's request for torque via pressing the accelerator pedal, and from the downward-going curve B-A during deceleration when the accelerator pedal is released.

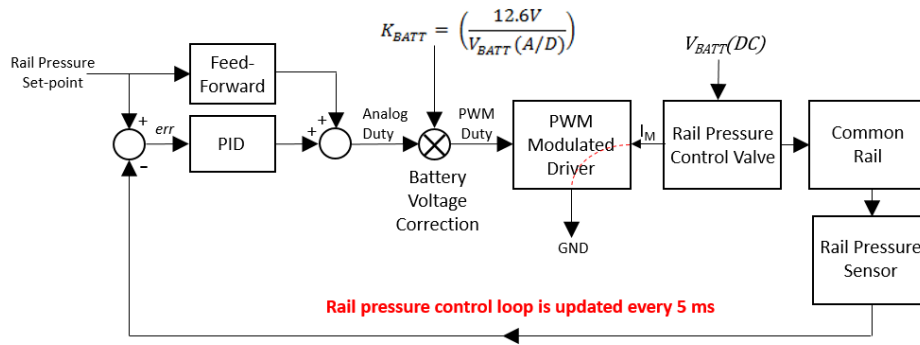
It is easy to see that the PID output changes with changes in the battery voltage compensation coefficient if one is aware that the rail pressure PID controller is not just a simple PID controller, but has a feed-forward component as shown in Figure 7. The feed-forward component is used to speed up the convergence of the PID controller as well as account for any non-linearity in the transfer function of the rail pressure control valve. The idea is to use one's *a priori* knowledge of the valve operation to provide a quick estimate of the PID controller output, to which the normal PID controller makes the output converge. This works well if the controller gain doesn't change, which is normally assured by a proper battery voltage compensation coefficient. But if the battery voltage compensation coefficient is erroneous, then the *a priori* PID output estimate as well as the simple PID output gets multiplied by the erroneous battery voltage compensation coefficient. The result is a change in the gain of the control valve by the value of the battery voltage compensation coefficient, which can be anywhere from 1 to 6 or more. At some value of the battery voltage compensation coefficient this will cause sudden acceleration.

Figure 7. The rail pressure PID controller uses a feed-forward controller to speed up the convergence of the PID controller.
