The 2010 Maule, Chile Earthquake: Lessons and Future Challenges

■ INTRODUCTION

In March 2010, Risk Management Solutions (RMS) deployed two reconnaissance teams to the region to investigate the impacts from the earthquake and tsunami. These teams spent two weeks in the field, collaborating with engineers and seismologists from other organizations, including the University of Chile, the USGS, and Stanford University. Post-event field reconnaissance, in its ability to rapidly and precisely make observations about the impacts from a disaster, is critical in the management of emergency response activities in the short term and the understanding of natural hazards in the long term.

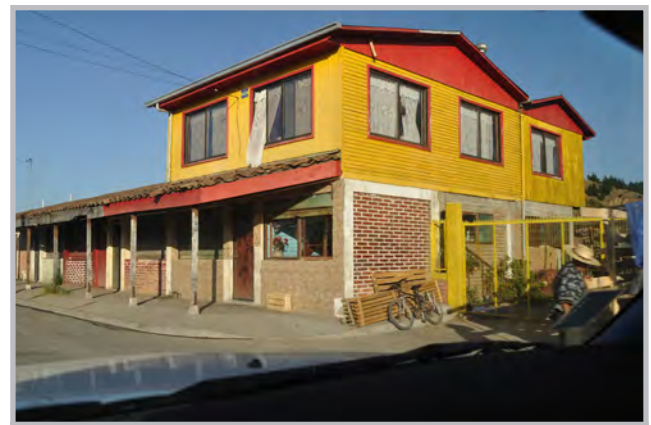
Confined masonry building in Coelemu, Chile (Source: RMS)

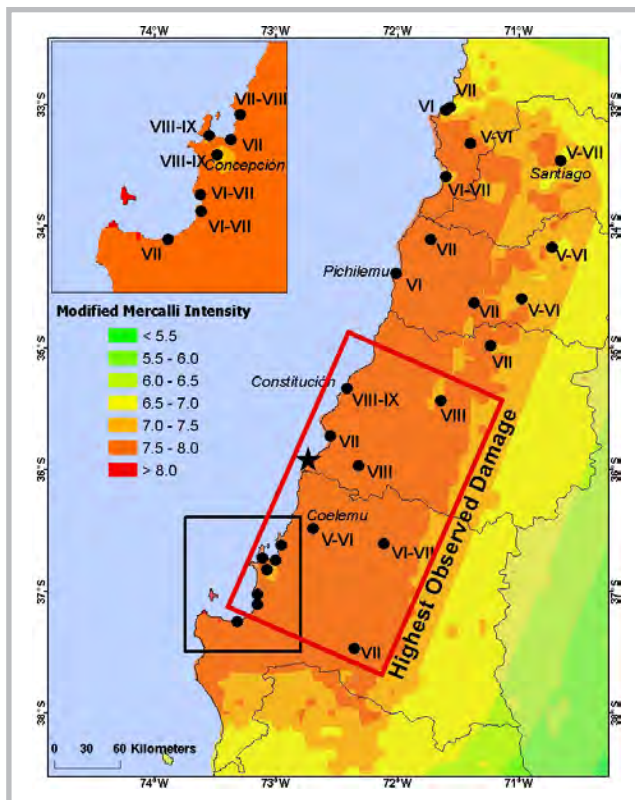
The MMI contours as estimated by the USGS immediately following the 2010 earthquake as compared to the RMS reconnaissance team observations (i.e., MMI levels noted next to locations denoted as block dots); the region of highest observed damage is highlighted (in red box)

underlain with poor soils that amplified the ground motion. The industrialized coastal region south of the epicenter (e.g., Talcahuano) was one of the hardest hit regions, sustaining both tsunami damage and ground shaking levels between VIII and IX. In Concepción, the MMI levels from the USGS ShakeMap program were estimated between VII and VIII. From ground reconnaissance, RMS estimates that MMI levels were higher in this region—measuring as high as IX in some parts of the city.

Through ground reconnaissance efforts, RMS concluded that the region of highest damage corresponded to a zone centered on the coast near the event's epicenter and extending inland to include the major cities along Chile Highway 5 (Ruta 5). The northern boundary of this zone spans from the inland town of Talca to Constitución along the coast. The southern boundary spans from Coronel and Lota along the coast to Los Ángeles in the central valley. This high damage region lies above a zone of high slip on the subduction interface (inferred from ground motion inversions).

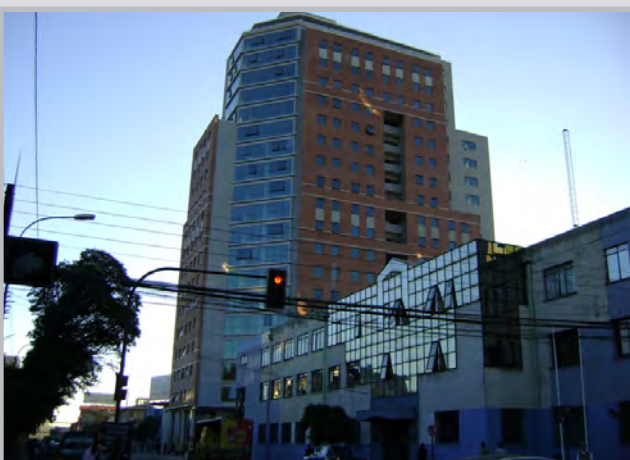
The 2010 Maule, Chile Earthquake caused the partial collapse of the O'Higgins Tower (Torre O'Higgins) in Concepción. This 21-story reinforced concrete structure experienced localized losses of vertical carrying capacity as a result of the earthquake's ground motion. With construction completed in 2008, this office building was designed to the latest Chilean seismic code and its failure was not anticipated, given the construction standards. The building experienced

dramatic failures in several of its upper levels that were likely a result of stiffness discontinuities and vertical irregularities in the structure.

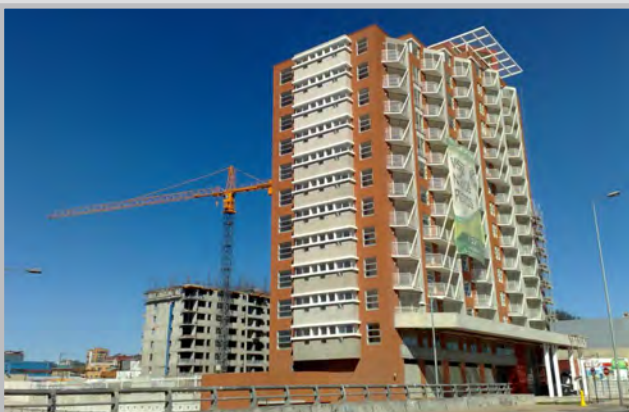
The collapse of the Alto Río building (Edificio Alto Río) in Concepción represents one of the most dramatic structural failures in the 2010 Maule, Chile Earthquake. The Alto Río was a 15-story apartment building constructed during 2008–2010 that housed 80 apartments and two underground parking levels. This reinforced concrete shear wall building completely collapsed onto its eastern face as a result of overturning. From visual inspection, the supporting shear walls at the ground level were too slender and inadequately reinforced to withstand the earthquake

forces. The seismic loads imposed an overturning moment on the shear walls at the ground floor, leading to the loss of vertical carrying capacity in the first story above ground. After the failure of the shear walls, the east side of the building collapsed into the subterranean parking garage while the west side lifted off the ground. As it crashed onto its side, the building broke into two pieces between the ninth and tenth floors.
