Feasibility Study for
The Town of Glenrock, Wyoming

The Lincoln Building

July 29, 2013

Structural Assessment of the Bronco Building Glenrock, Wyoming

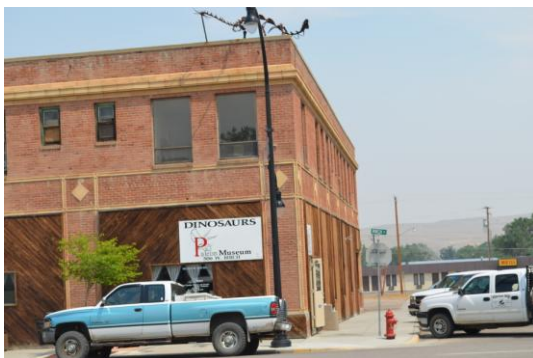
Visible Foundation Wall at
North Elevation

Structurally, the portions of the foundation observed were in fair to good condition. Cracking was observed around the perimeter foundation walls at several locations.

In general, repair of the foundations is low priority. It is suggested that the concrete cracks be repaired.
