The Olympia 465

A Brief History by Mark Wills.

A brief history of the EoN Olympia 465.

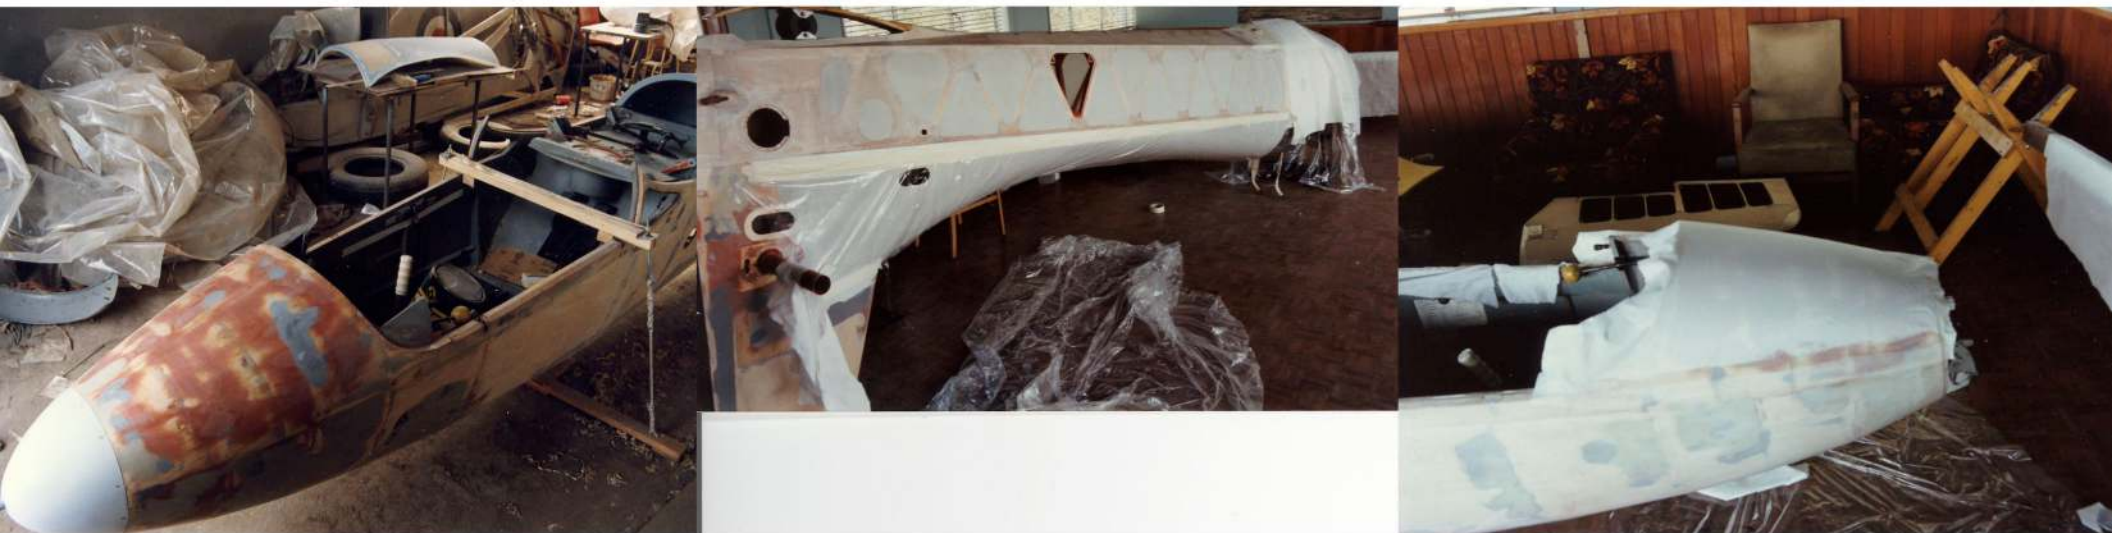
Left to right. Nose section filled and rubbed down. Centre the rear fuselage being re-covered.
Right the nose covered but the fabric is not stretched and doped yet.

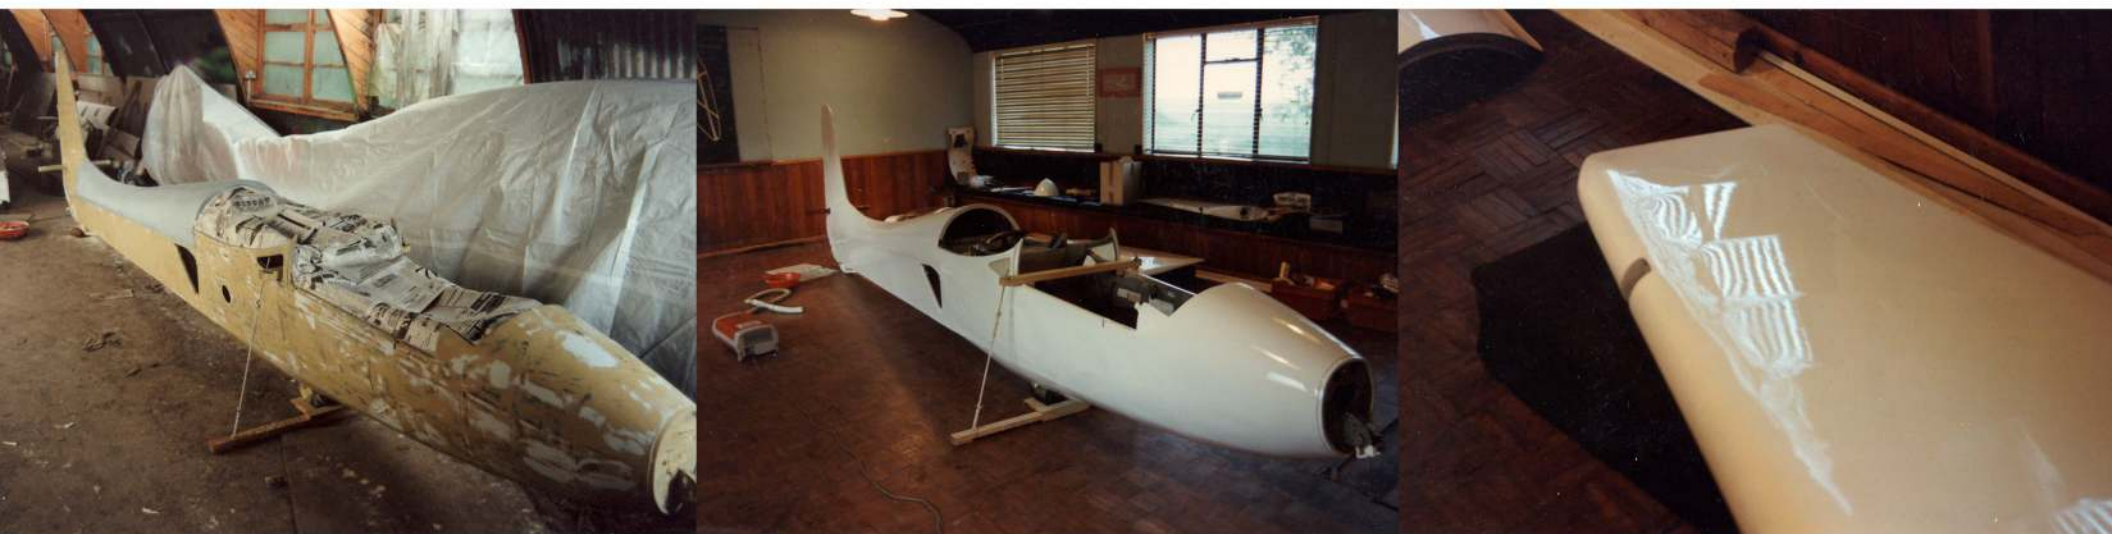
Left to right. Fuselage primed rubbed down and ready for a top coat. Sprayed and ready for re-assembly. Note the nose hook now fitted to avoid problems on aerotow. The rudder nice and shiny in its new paint.

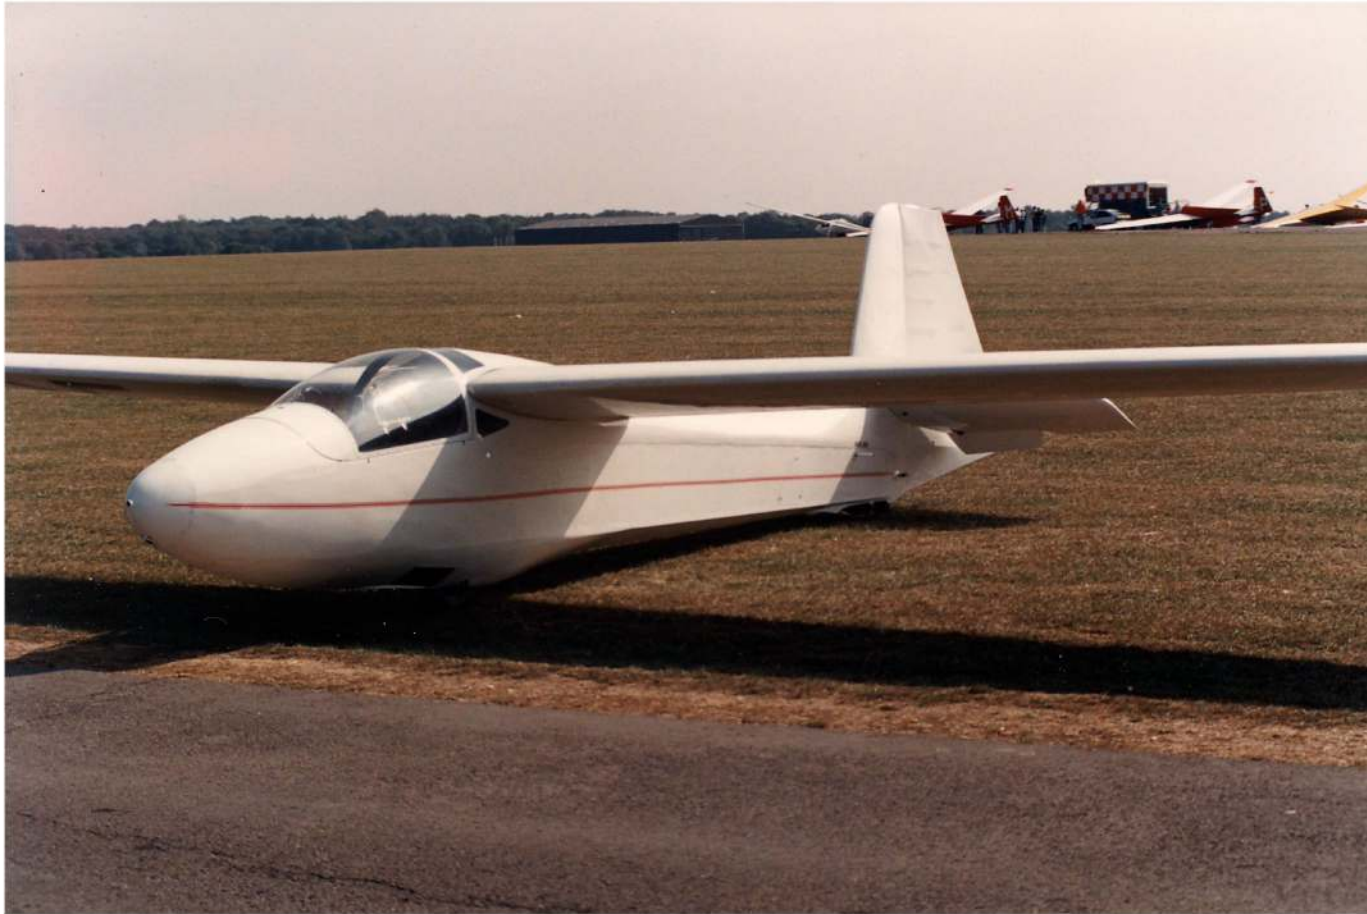
The 465 with fuselage recently re-furbished after a winter and most of the summer of 1990.
Several hundred hours work.

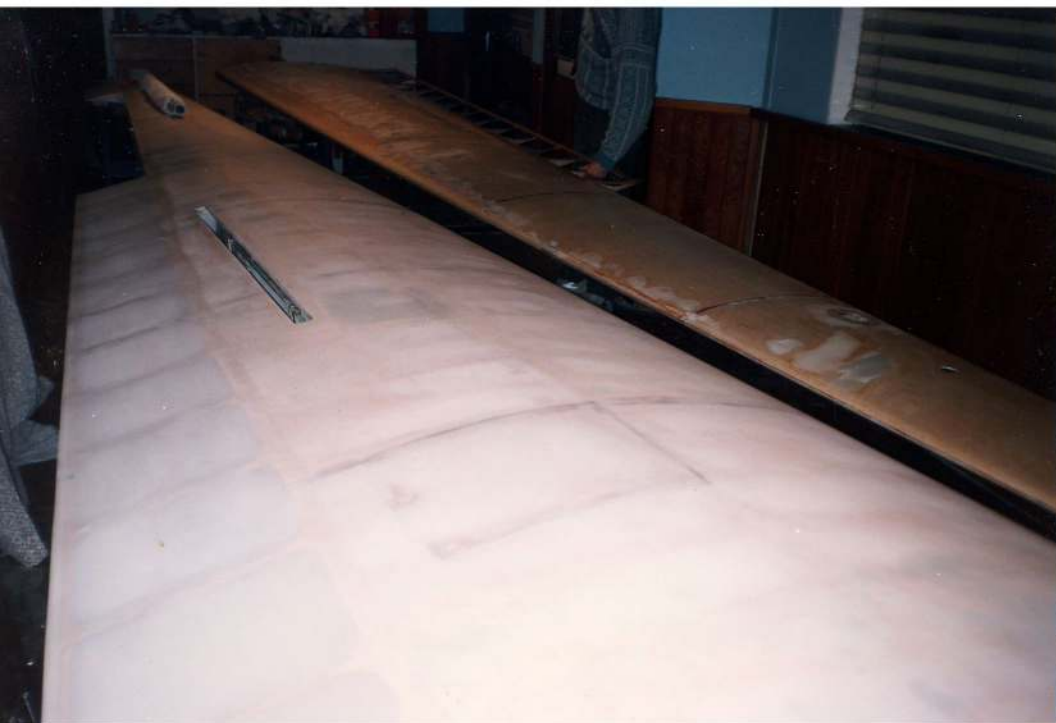
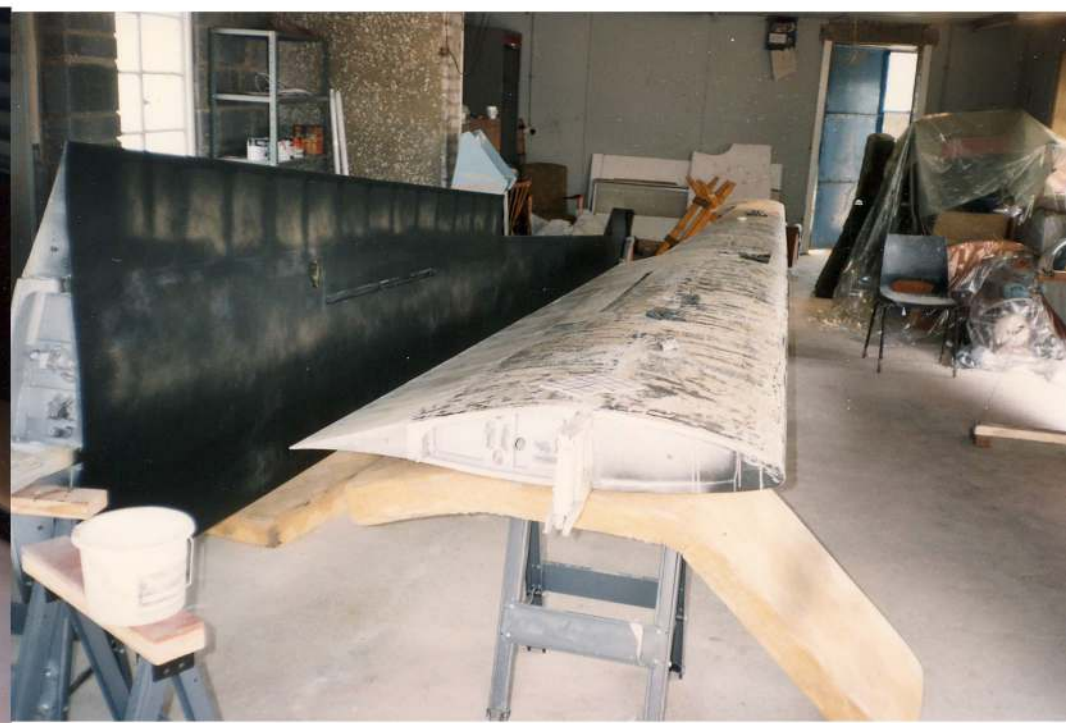
Left one wing covered and partly doped. Right the wings have been sprayed with silver UV protection then a primer surfacer. The primer is being rubbed down with fine wet and dry paper for a good finish. at least 90% of the work is in the preparation.

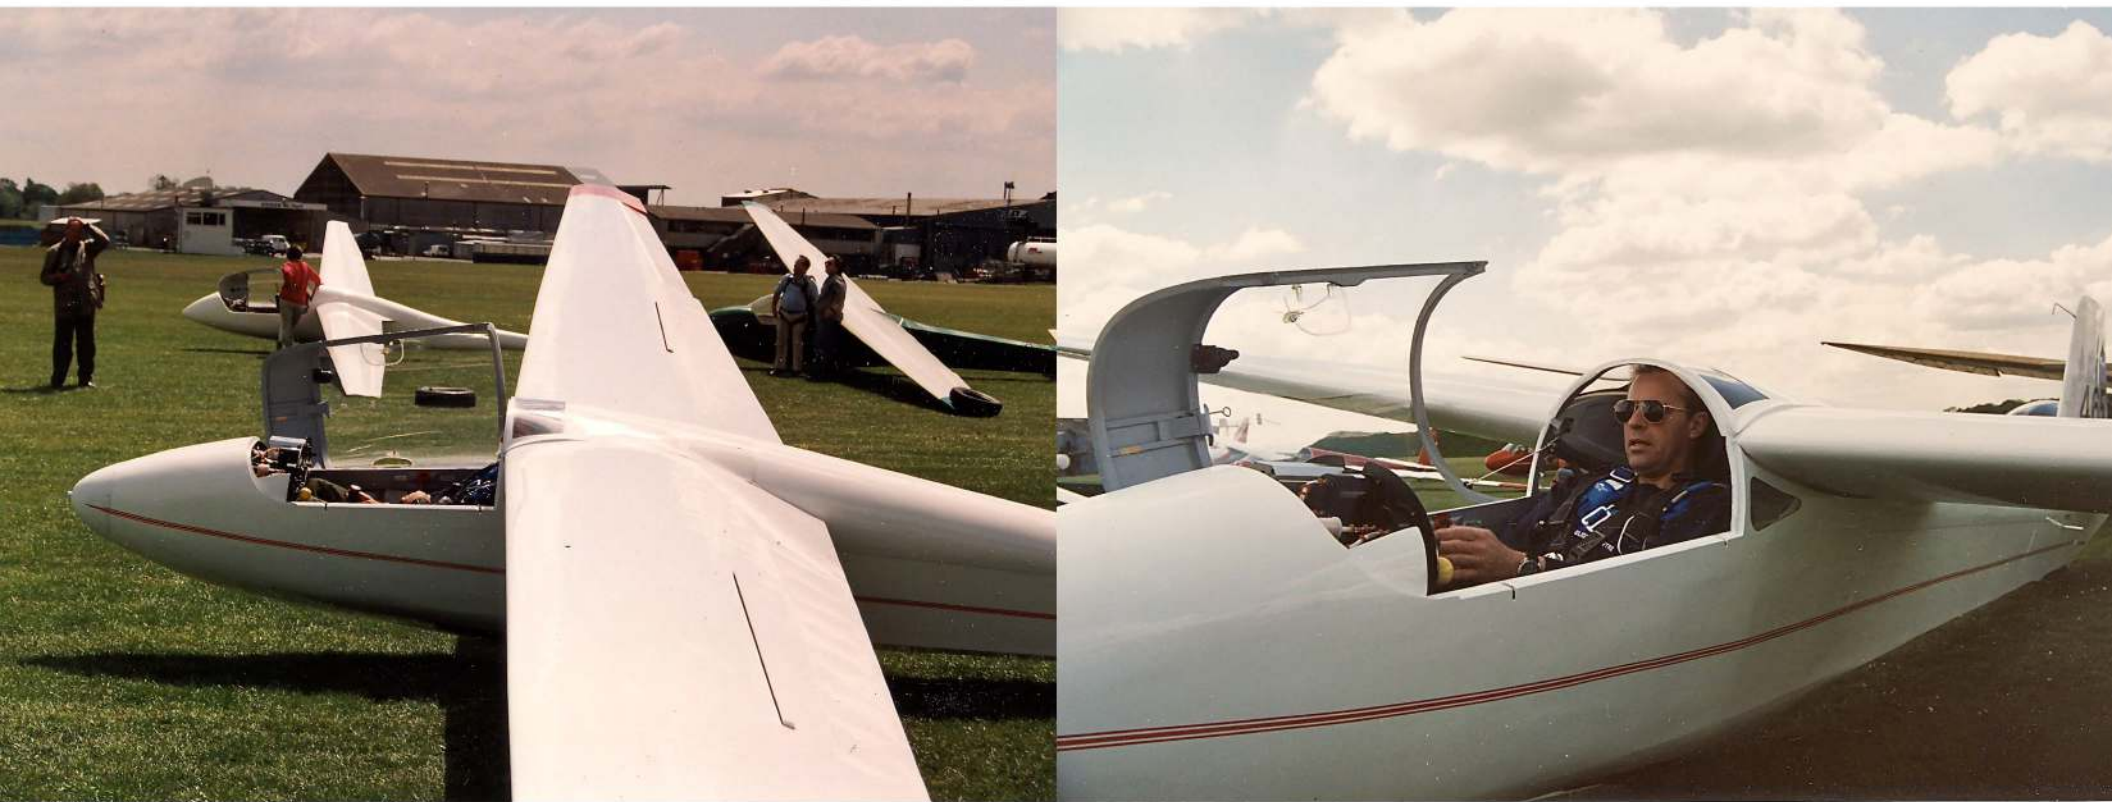
After another winters work on the wings and ailerons the project is complete. Keith Green in the cockpit awaiting launch. As you can see it's a tight fit.
