Kansas Department of Health and Environment

**Third Five-Year Review
Report**

**Landfill Subsite of the
Obee Road Superfund Site
Hutchinson, Reno County
Kansas**

September 2010

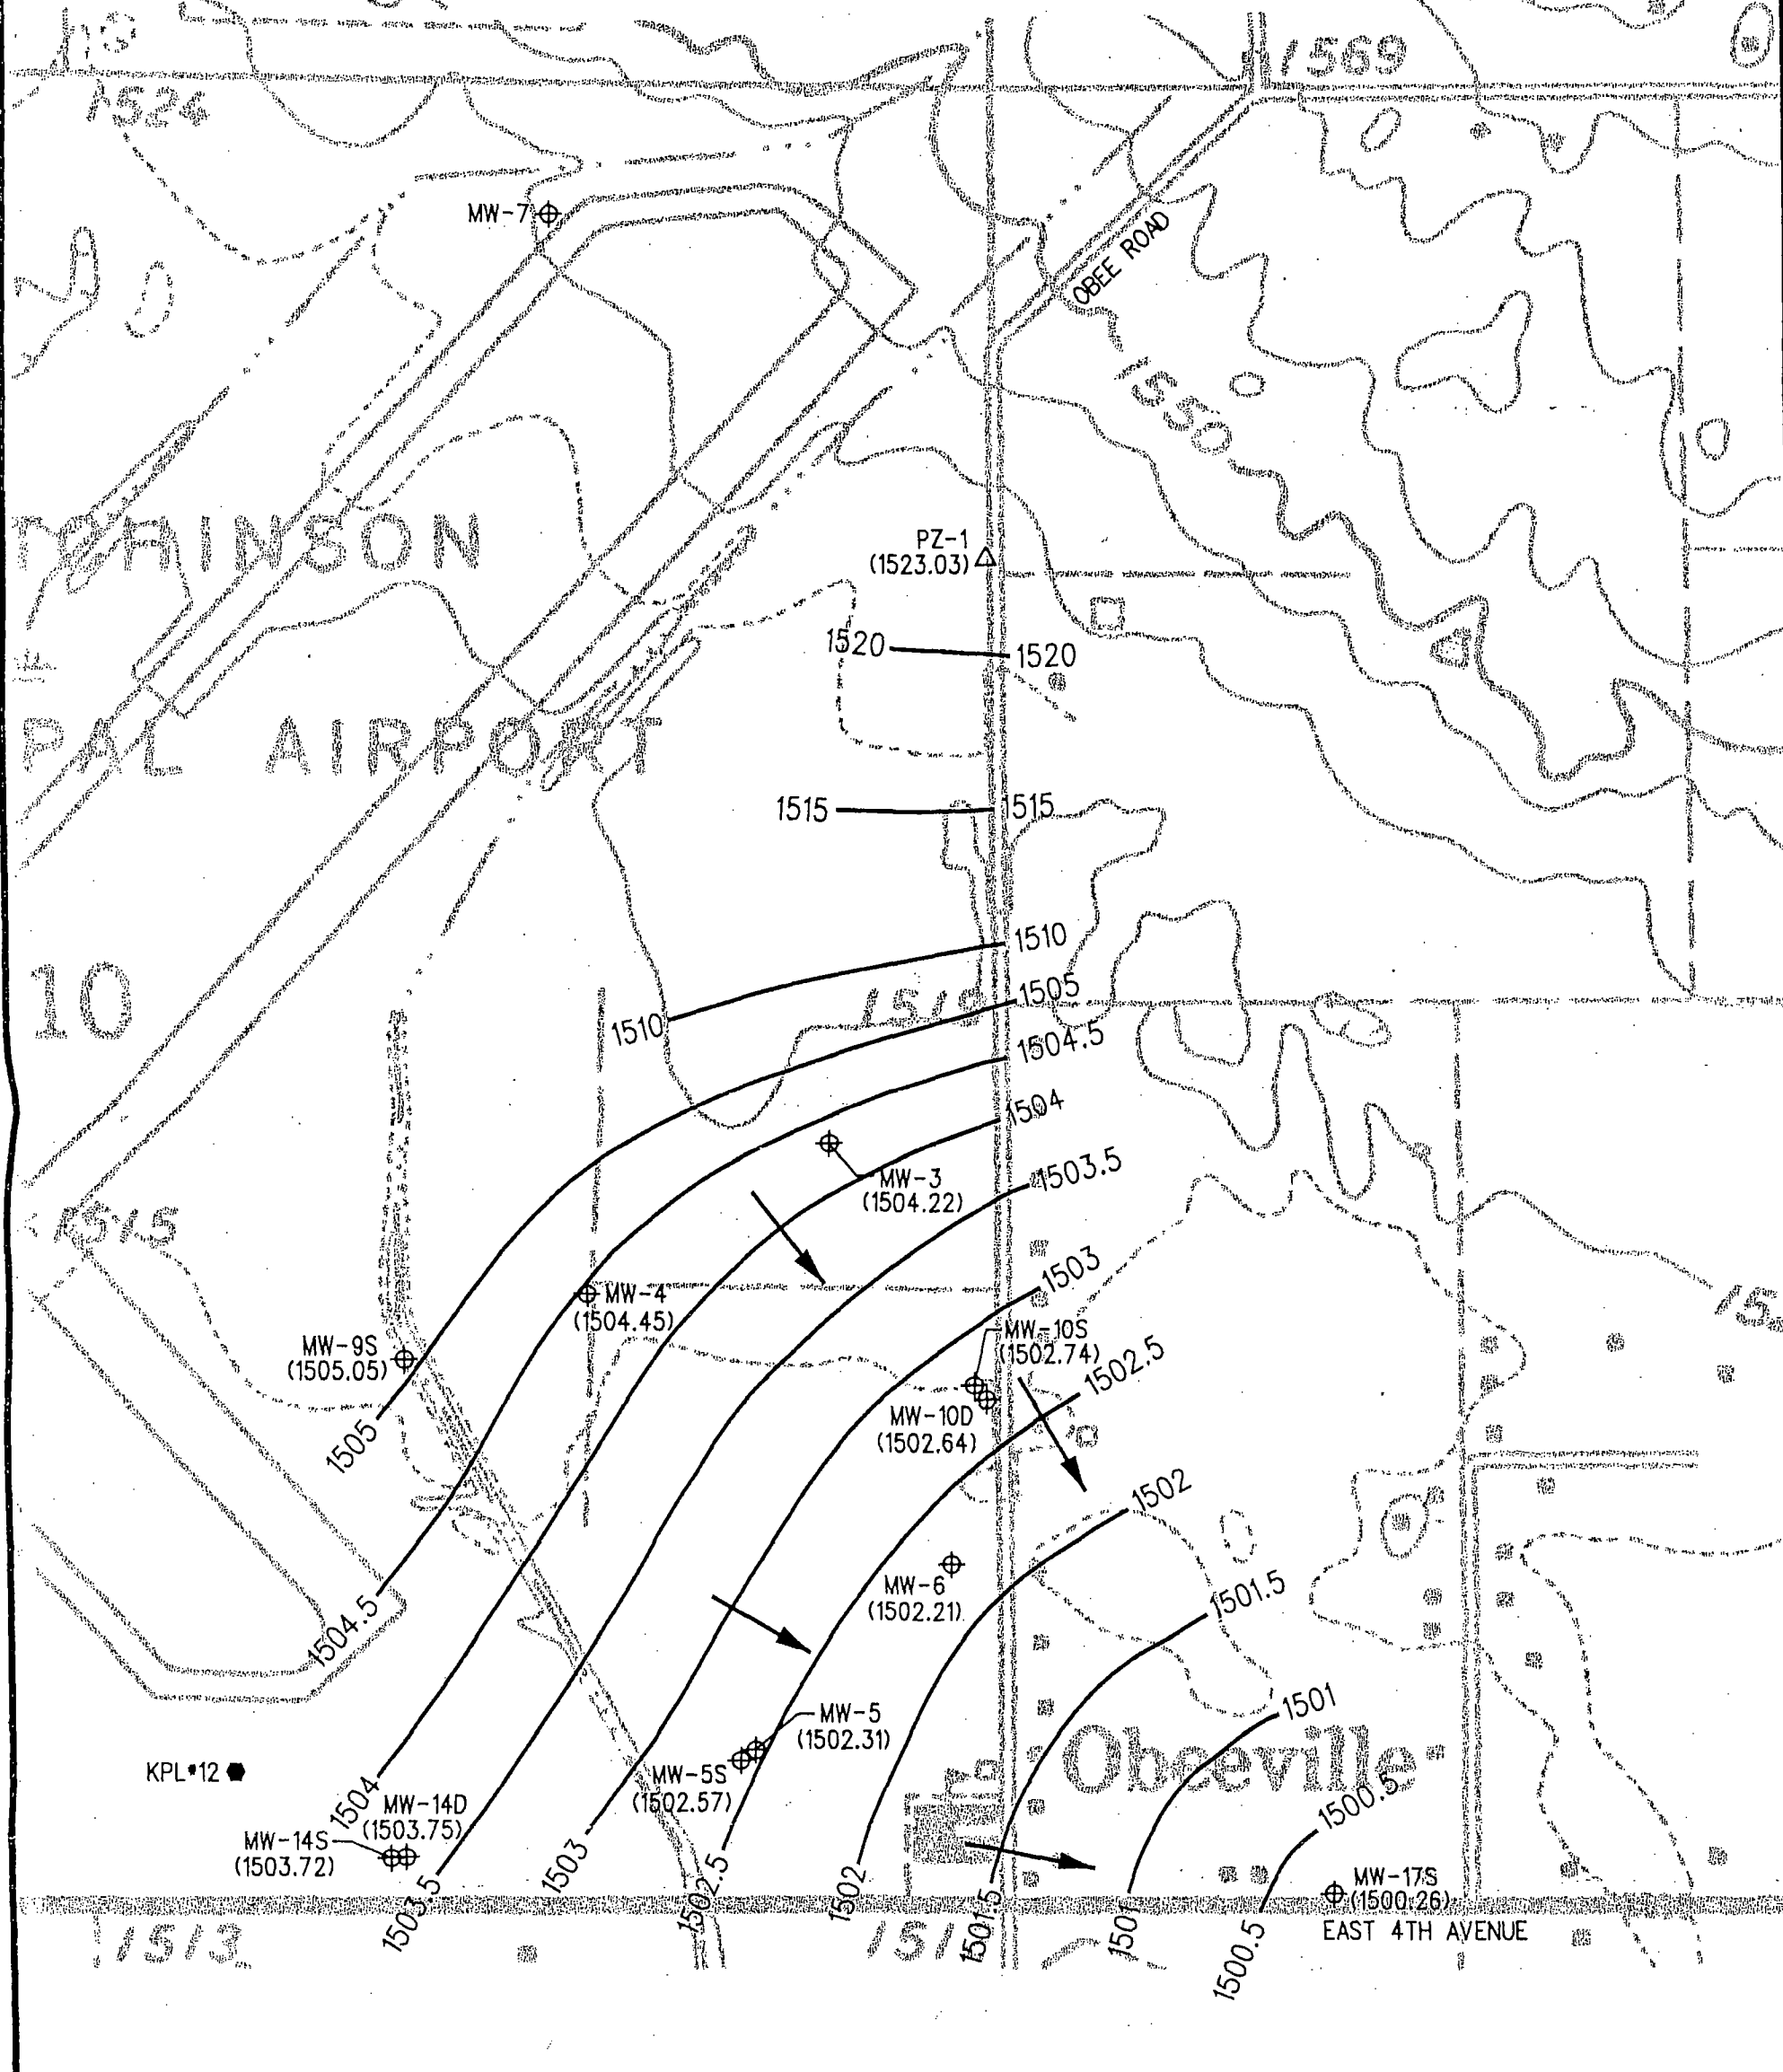
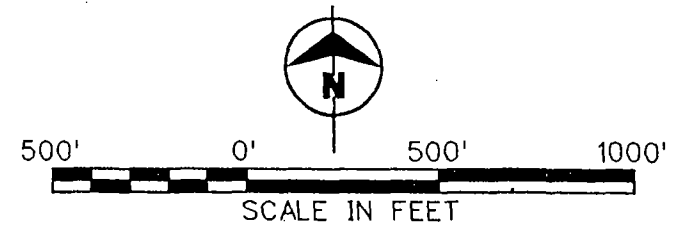
Figure 3
POTENTIOMETRIC SURFACE
JULY 27, 2004

Inspection of the monitoring wells at the Site indicated problems with the security and integrity of a few of the monitoring wells. Monitoring well locations are shown on Figure 3. Wells PZ-1, MW-1, MW-4, MW-5S, MW-5D, MW-6, MW-7, MW10S, MW-10D, MW-14S, MW-14D, MW-15S were located during the site inspection. Wells PZ-1, MW-4, MW-5S, MW-5D, MW-6, MW10S, MW-10D, MW-14S, and MW-14D were found to be in satisfactory condition. These wells were secured by padlocks. The cap on the protective cover for MW-1 is broken and the well is currently unsecured. Well MW-7 was not locked and no padlock was found near the well. Soil around the concrete base for MW-15S has eroded away. MW-3 and MW-9S were not located during the inspection due to heavy vegetation. The City staff sampled MW-3 during the April 2010 sampling event and reported the well is in satisfactory condition and secured with a new lock.

Item	Recommendations/ Follow-up Action	Responsible Party	Oversight Agency	Milestone Date	Follow-up Actions: Affects Protectiveness (Yes/No)
Monitoring Program	Sample monitoring wells once before the next five year review.	City of Hutchinson	KDHE	August 2010	No
Monitoring Program	Plug and abandon damaged monitoring wells MW-1 and MW-15S.	City of Hutchinson	KDHE	August 2010	No
Monitoring Program	Continue inspections of the fence and evaluation of the effectiveness of deed restrictions on an annual basis.	City of Hutchinson	KDHE	August 2010	Yes
