## TIMKEN - HUB UPDATE

There has been an increase of warranty returns on Timken 513138 due to:

# PRODUCT BULLETIN

## Drivetrain - ABS Lamp ON/DTC's Set/Grinding Noise

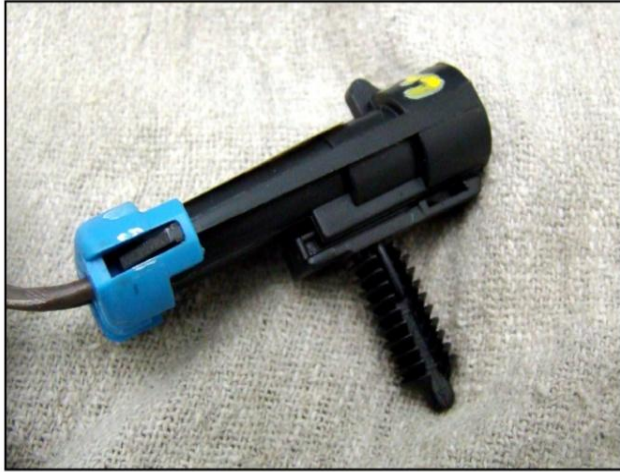
**GMT800 Connector**

Earlier GM models come with oval connector found on Timken # SP500300.

**Sensor Opening: Oval**

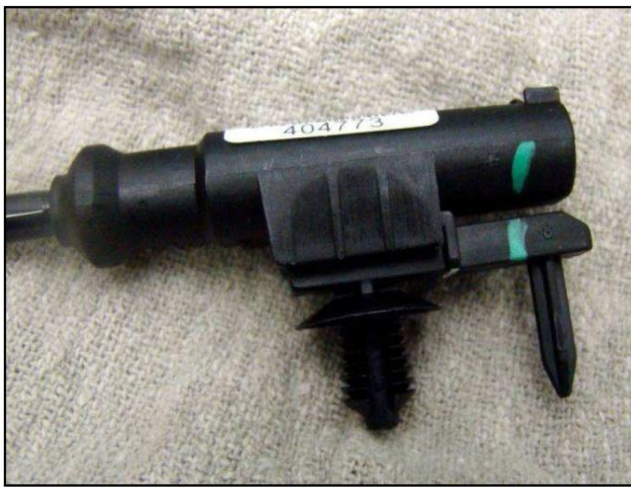
**GMT900 Connector**

This connector can be found on the Timken # SP500301.

**Sensor Opening: Round**

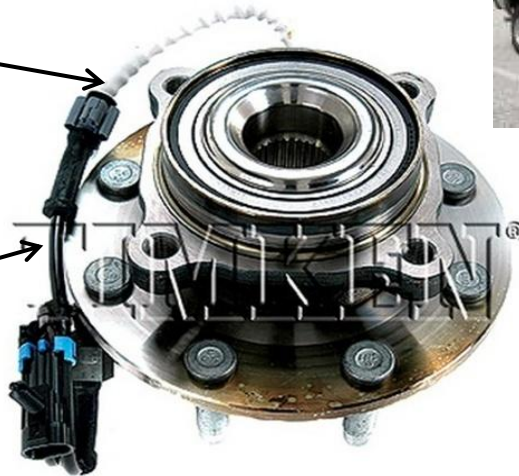
## SP580310/SP580311 - Classic Style (GMT800)

It has come to our attention that GM **"MAY"** have made a mid-model year change to bearing assemblies for SOME 2007 applications listed below.

Both hubs look exactly a like EXCEPT the earlier verison has larger size ABS Sensor Wire and White Boot coming off sensor connection.

**WHITE BOOT COVERING COMING OFF THE SENSOR**

**LARGER DIAMETER ABS SENSOR WIRE**

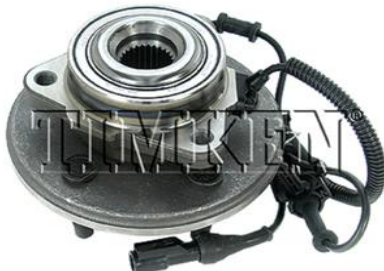
**SP470200 (Sensor cable included)**

Timken is now providing two hub unit bearing solutions for the popular ABS applications shown below. As always, Timken provides the highest quality OE solutions to meet your customer's needs. While many customers desire to utilize the SP470201 hub unit without the sensor cable...we will now provide the optional SP470200 hub unit bearing, with the sensor cable. Having both options available gives your customer the ability to provide the best cost alternative to address the specific repair necessary for their vehicle.
