SUBJECT: **Special Service Campaign (Recall) 80C – Phase 1**
 Certain 2004 - 2006 Model Year Sienna Vehicles Equipped w/Power Back Door (Power Rear Liftgate)

SPECIAL SERVICE CAMPAIGN (SAFETY RECALL) 80C

2004 THROUGH 2006 MODEL YEAR SIENNA
EQUIPPED WITH POWER REAR LIFTGATE STRUTS
(POWER BACK DOOR STAYS)

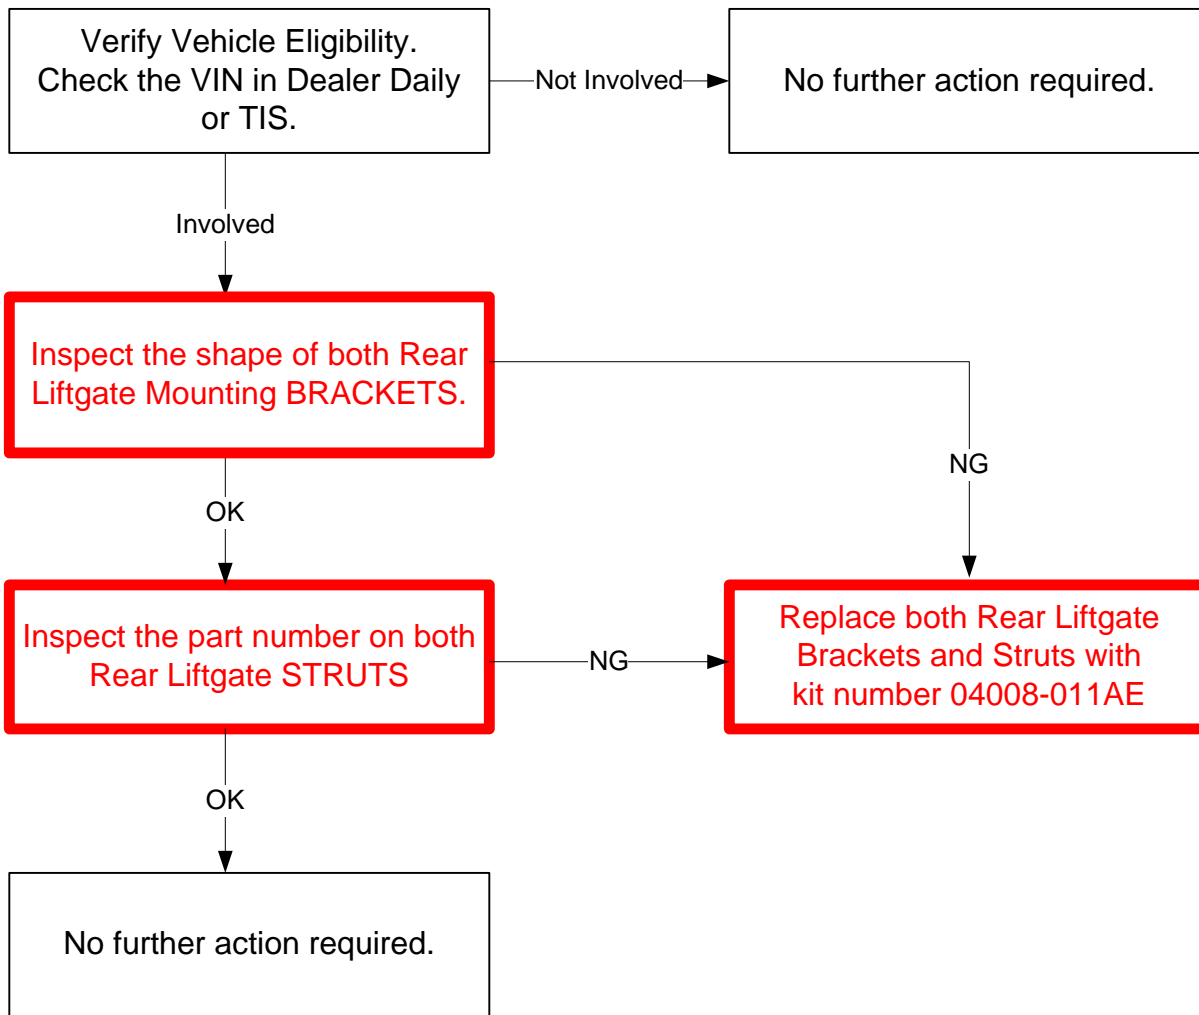
I. OPERATION FLOW CHART

graph TD
    A[Verify Vehicle Eligibility.  
Check the VIN in Dealer Daily  
or TIS.] -- Not Involved --> B[No further action required.]
    A -- Involved --> C[Inspect the shape of both Rear  
Liftgate Mounting BRACKETS.]
    C -- OK --> D[Inspect the part number on both  
Rear Liftgate STRUTS.]
    C -- NG --> E[Replace both Rear Liftgate  
Brackets and Struts with  
kit number 04008-011AE]
    D -- OK --> F[No further action required.]
    D -- NG --> E
