# STORMWATER BEST MANAGEMENT PRACTICES GREATER BALTIMORE SURVEY 2016

Prepared By Richard Klein  
Community & Environmental Defense Services  
410-654-3021 [Rklein@ceds.org](mailto:Rklein@ceds.org) [ceds.org/gbs](http://ceds.org/gbs)  
July 22, 2016

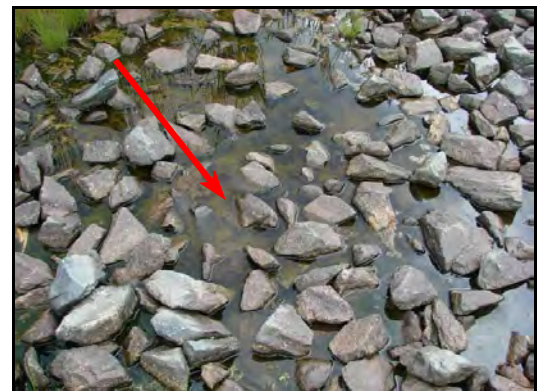
Standing water present in trench more than 48 hours after runoff ended

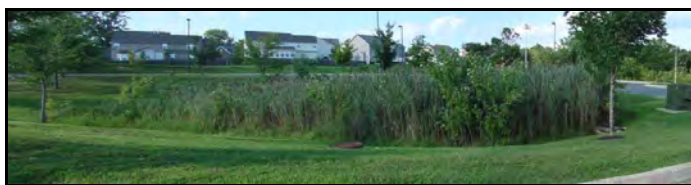
Sand filter overgrown with Phragmites & other wetland plants

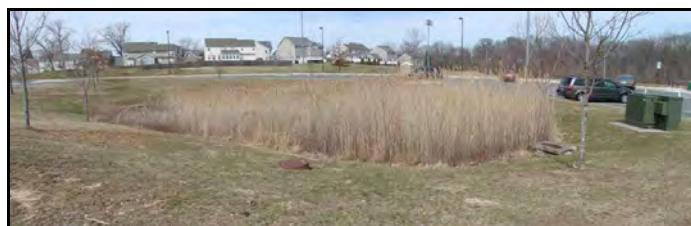
Same overgrown sand filter as it looks in winter

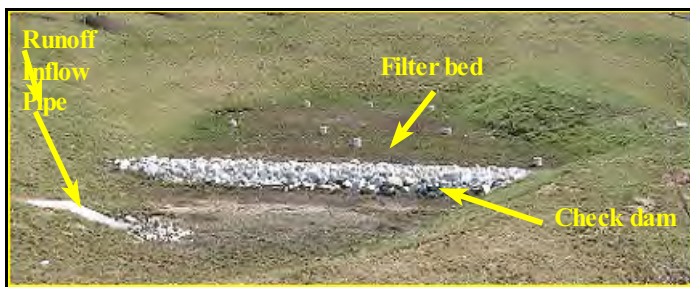
Occasionally a row of earth, stone or rock will be found across sand filters and other BMPs. This check dam will be located between the point where runoff enters and the overflow (outfall) point. The check dam may serve two purposes: 1) to ensure runoff enters the sand filter in a shallow, sheet flow and/or 2) to prevent sediment from reaching the filter surface. If sediment is reaching the filter surface or substantial sediment accumulation has occurred upslope of the check dam, then cleaning is required.

Check dam separating runoff inflow (lower left) from sand filter

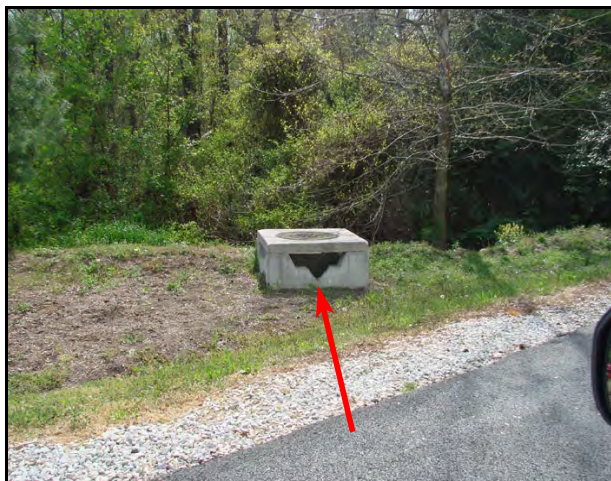
**V-Notch cut to prevent ponding**

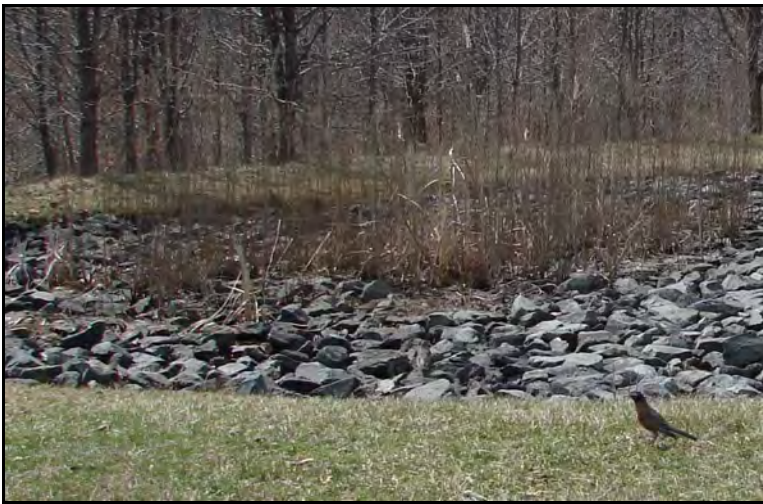
Cattails growing from saturated trench - winter view

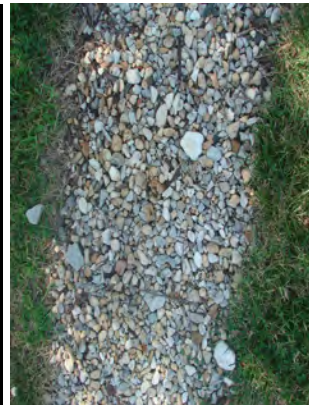
Clean gravel diaphragm

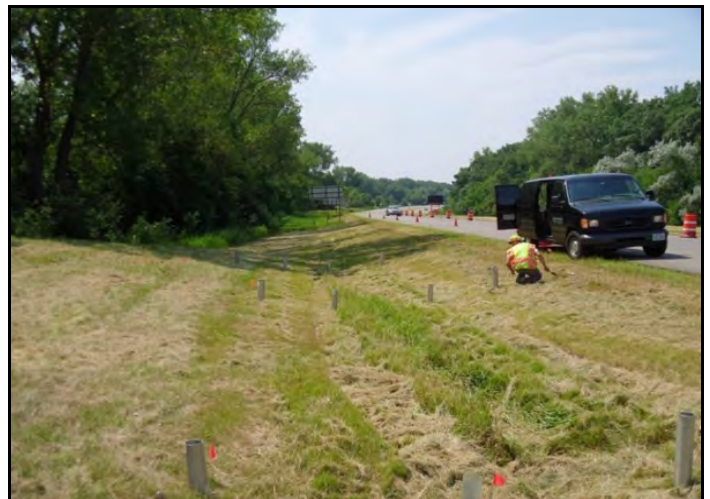
**Grass height in sand filter must not exceed 12; mow minimum three times per year**

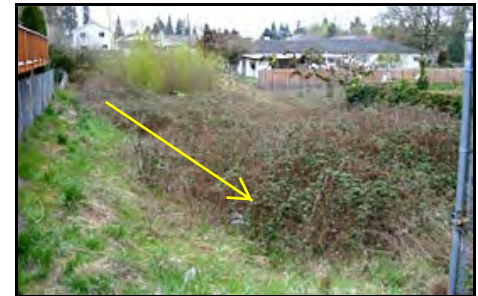
**Swales must be mowed at least twice a year to prevent overgrowth of weeds**
