**Traction Power Electrification System
Investigation
Washington Metropolitan Area Transit Authority
(WMATA)**

FINAL REPORT

Federal Transit Administration
U.S. Department of Transportation
1200 New Jersey Avenue, SE
Washington, DC 20590

December 9, 2016

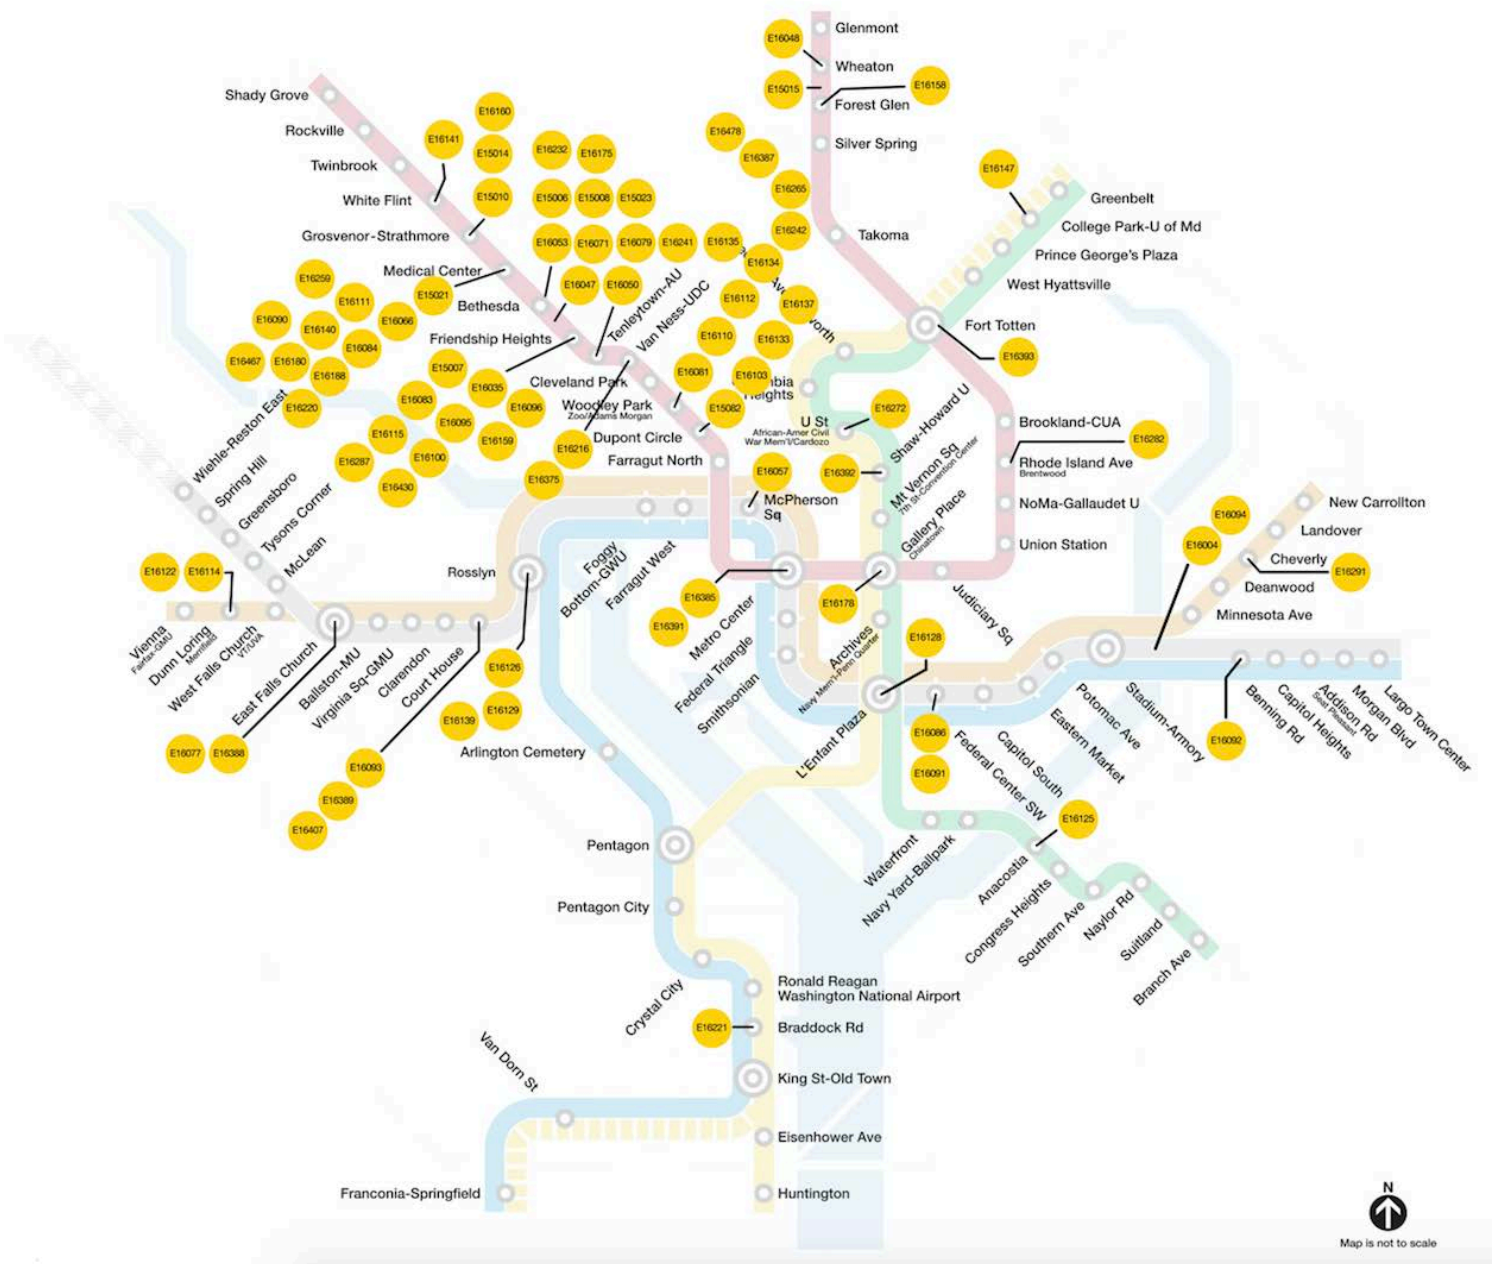
Figure 1: Electrical Arcing Events with Smoke/Fire between October 26, 2015 and October 21, 2016

Figure 1 depicts the location of each of the 70 electrical arcing incidents in the TPE system reported by WMATA between October 26, 2015 through October 21, 2016. Appendix C lists these events by date and location.
