COMPLETION REPORT

**TRANSUCER CALIBRATION  
PLATFORM (TCP) MOORING  
NAVAL UNDERWATER SYSTEMS CENTER,  
SENECA LAKE DETACHMENT  
DRESDEN, NEW YORK**

Completion Report for Transducer Calibration Platform (TCP) Mooring Naval Underwater Systems Center, Seneca Lake Detachment Dresden, New York.

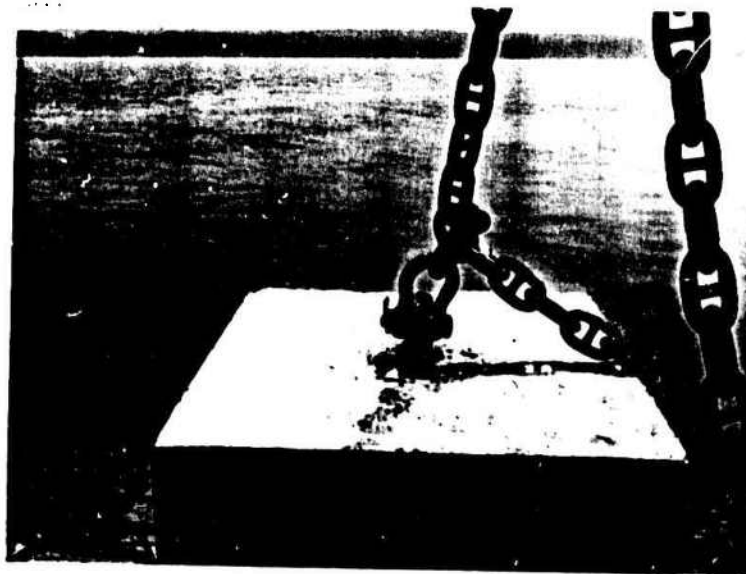
**FIGURE 15**

The sinker was connected on the last half-shot of chain in each mooring leg, one link in from the last full shot (see Figures 15 and 16). The connection was made with a 2 1/2-inch safety shackle back-to-back with a sinker shackle as shown in Detail A of the "as-built" drawing. The nut on the safety shackle was welded in place, and the locking pin on the sinker shackle was peened over. The sinker was lowered to the bottom, then raised 10 feet while a strain was taken on the keedge anchors or pulling lines to ensure that the chain was taut. The sinker was lowered again after all slack was taken out of the chain.

**BACK-TO-BACK 2 1/2 INCH SAFETY SHACKLE  
AND SINKER SHACKLE CONNECTION**
