**North American Society for Trenchless Technology (NASTT)
NASTT's 2016 No-Dig Show**

TA-T2-03

Trenchless Rehabilitation Planning and Design, Using Diagnostic Imaging, Condition Assessment and Multimodal Rehabilitation Techniques: A Case Study

Alex Palmer, Inversa Systems, Fredericton, New Brunswick
Stephen McCormick, Inversa Systems, Fredericton, New Brunswick
Daniel Madore, Via360, Montreal, Quebec

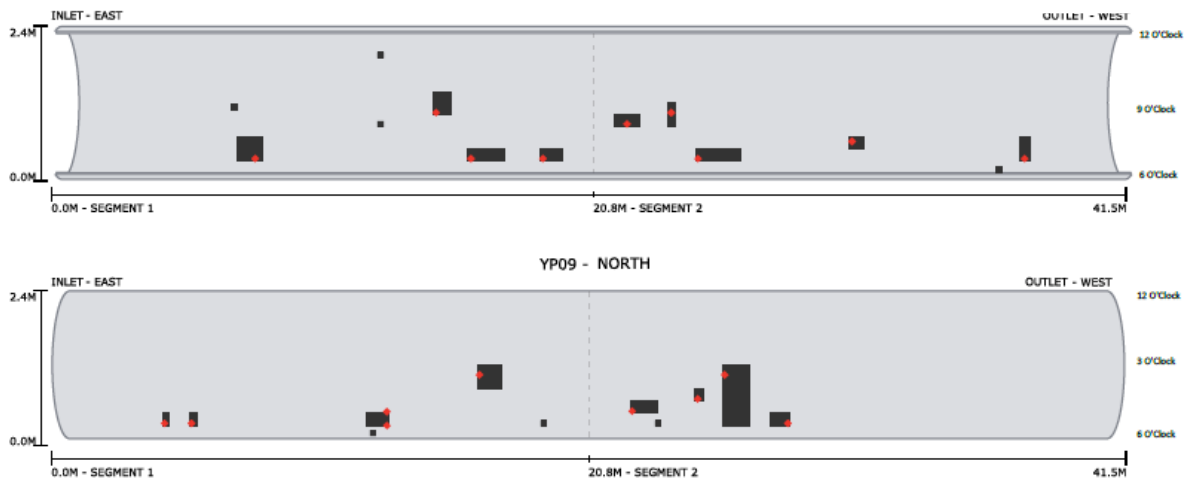
Figure 4. Overview pipe map displaying visual indicators as black squares, acoustic anomalies as black rectangles and BCT image locations as red diamonds.

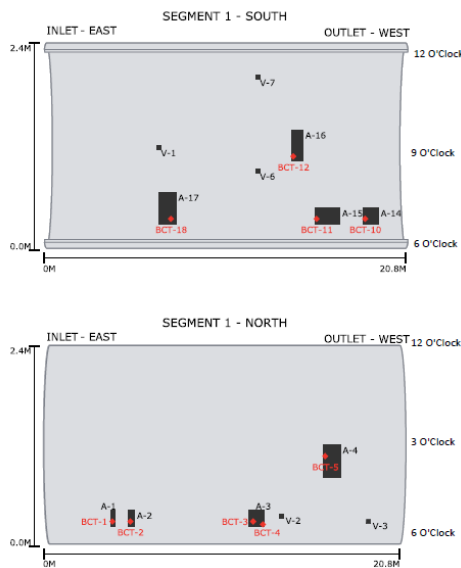
Figure 5. Segmented pipe map displays all pipe characteristics in greater detail with dimensions tabulated.

broken into “segment pipe maps”, as seen in figure 5, to allow for the display of all relevant features. In the example, the dark rectangles represent an acoustic anomaly on the pipe wall. The X coordinates indicate the distance from the inlet of the pipe section and the Y coordinates is measured as a clock position around the pipe barrel with the inspectors back at the inlet. Each corner of the rectangle is given its own pair of coordinates. The exact coordinates and reference points for all anomalies, visual indicators and BCT images are detailed in appendices within each report.
