Troubleshooting Guide

imageRUNNER ADVANCE

8500/6500 Series

April, 2017

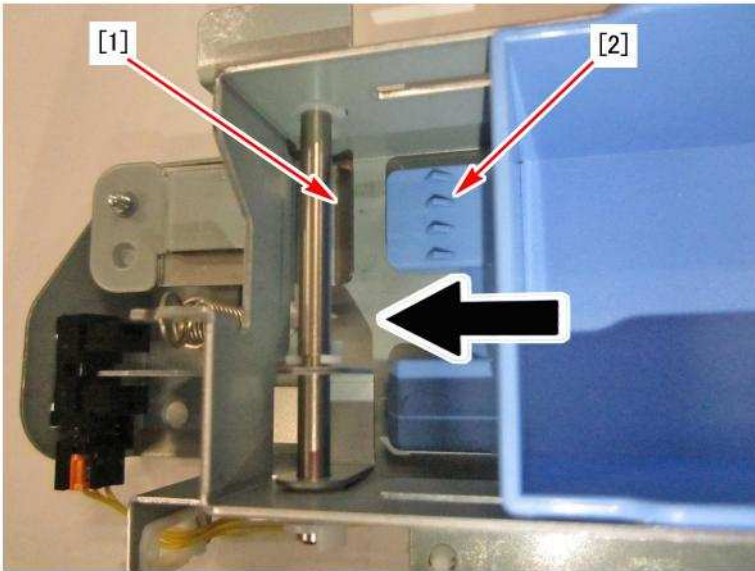
Due to the high position [a] of the leaf spring [2] of the staple collect unit [1], the waste staple case [3] is loosely fixed, the waste staple case is displaced, and the needle chip full sensor [4] detects falsely, which causes the above-mentioned symptom.

If the above-mentioned symptom occurs, add the shim (XD1-1104-635) by following the procedures below. Adding the shim and lowering the position of the leaf spring [1] will fix the waste staple case [2] more firmly and it will become less prone to be displaced.

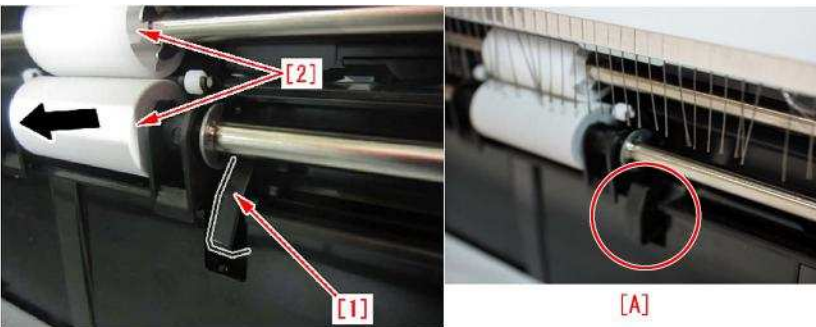
The figure [A] shows a condition where the sensor flag is at a normal position and the figure [B], the sensor flag is pushed towards the back side.

- 1) Turn the main power of the main body off.
- 2) Push the delivery roller [2] of the upper escape tray towards the rear side
- 3) Check if the sensor flag [1] comes back to a normal position by its own weight as shown in the figure [A].

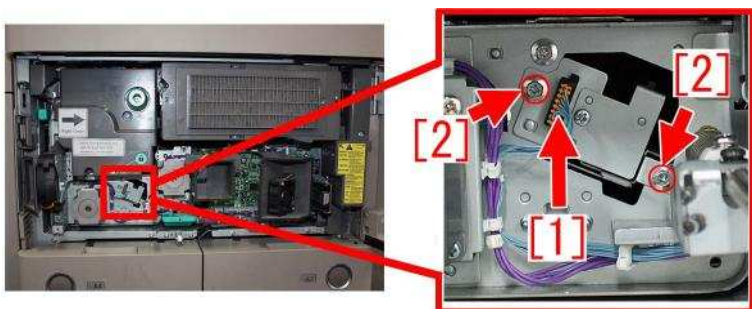
Although, in rare cases the detection flag holder [1] of the photo sensor assembly is loose. For this reason the detection flag comes off, then the detection does not work properly and results in the above mentioned symptom.

When the aforementioned symptom has occurred, prepare a new photo sensor assembly (FM4-0897-010) and replace with it following the procedure below.

- 1) Referring to Service Manual, remove the fixing feed lever, the fixing feed right front cover, and the fixing feed left cover.
- 2) Pull out the connector [1] connected to the photo sensor assembly. Then remove 2 screws [2].

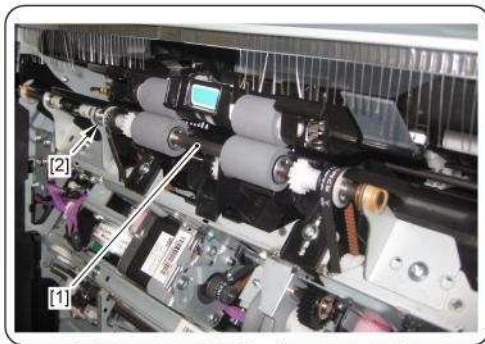
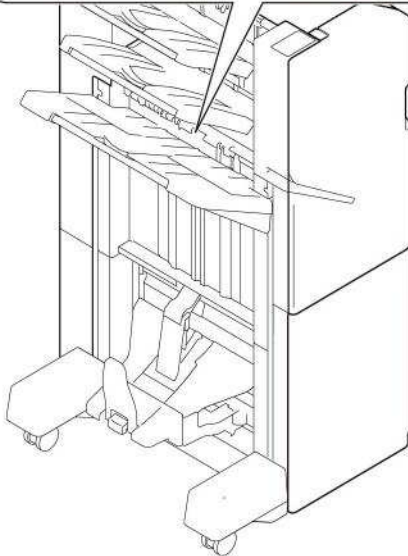
The figure below shows a condition where the bearing [1] has come off.

3) If the bearing [2] of the lower stack delivery roller [1] has come off, reattach the bearing [2] in a proper state and go to the step 4). If the bearing [2] has not come off, then go to the step 8).

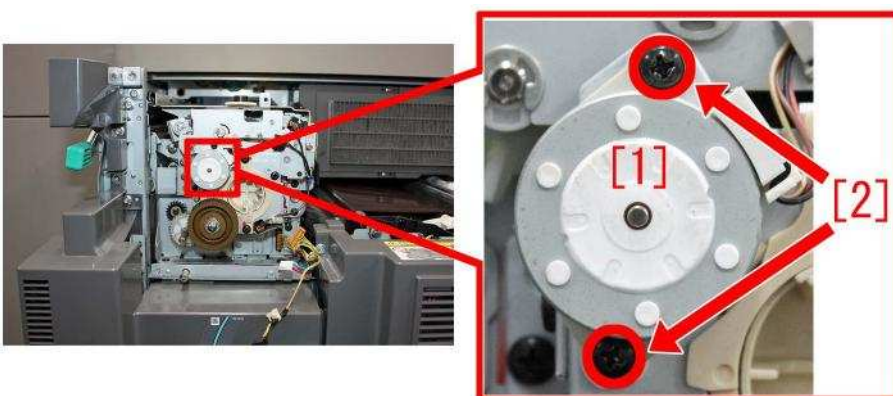
The screws securing the fixing shutter motor are loosened and come off after some endurance time has elapsed and from vibration, then the fixing shutter motor becomes unable to be driven the fixing shutter and ends in the above mentioned symptom.

- 1) Pull out the Fixing Feed Unit.
- 2) Remove the Fixing Front Cover and the Fixing Drive Unit 1.
- 3) Replace the 2 screws [2] that are securing the fixing shutter motor [1] with the screw with washer (XB2-8301-009).

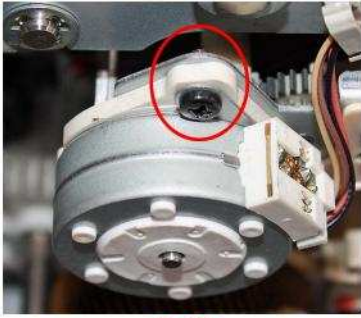
[C]

The Fig.[C] shows the securement with the previous screw and Fig.[D], with the screw with washer.

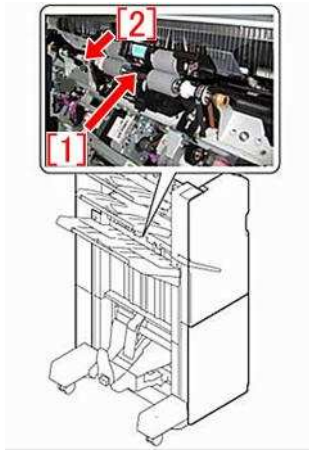
2) Operation failure of the front/rear tray auxiliary guide due to large clearance of the mount of the lower delivery roller [1] dislocating the bushing [2] on the rear side.

2) If the bushing [2] on the rear side of the lower delivery roller [1] is detached from the supporting plate, go to the step 3). If the bushing [2] is not detached, go to the step 7).

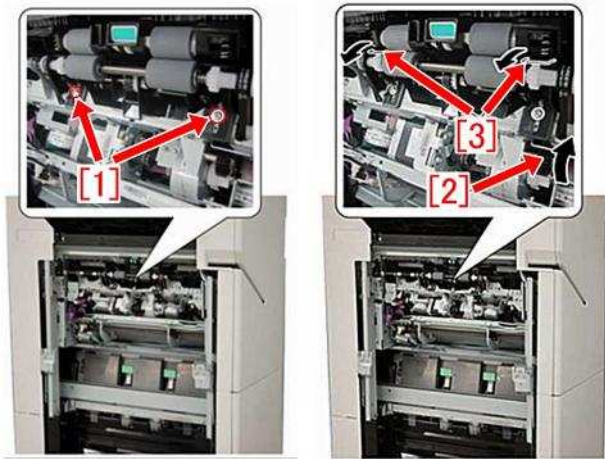
1) Operation failure of the front/rear tray auxiliary guide due to shift in engagement of the rack and the pinion [2] of the front/rear tray auxiliary guide [1]

7) Loosen the 2 screws [1], rotate the gear [2] in an arrow direction with a hand, pull out the front/rear tray auxiliary guide [3] for approx. 10 mm, and then tighten the 2 screws [1].
