Turkish Airlines 1951
25 February 2009, Schipol Airport
(EHAM)

SYST 560

Accident Turkish Airlines 1951

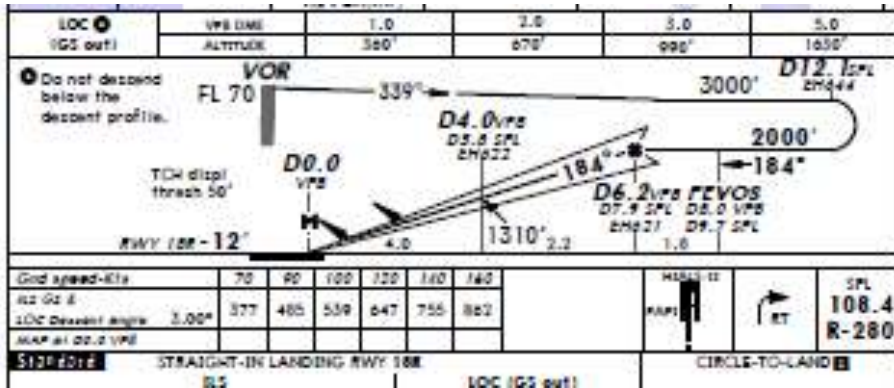
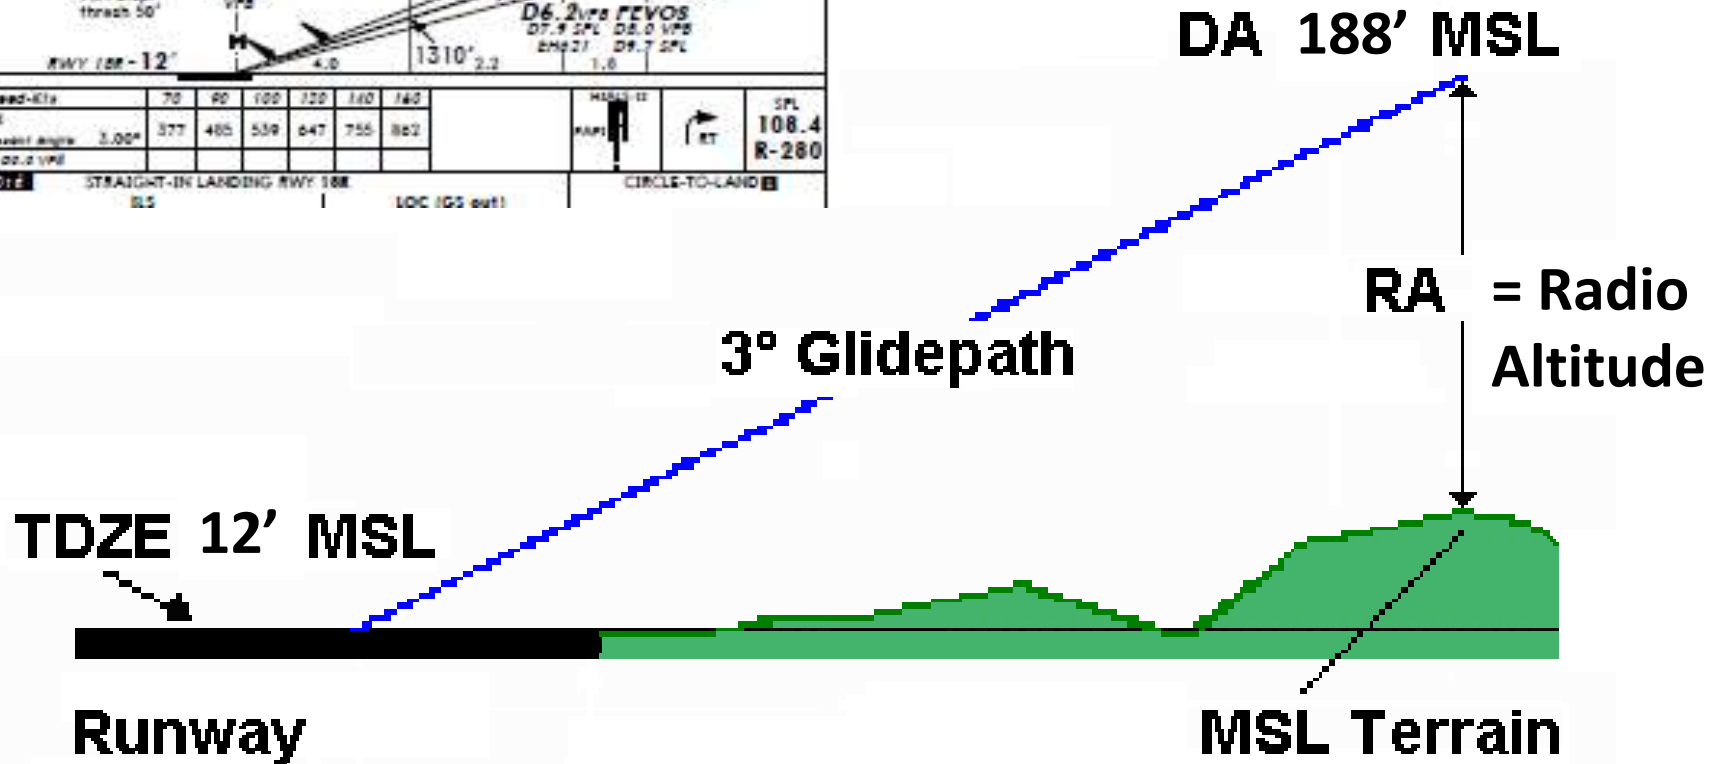
Approach

- Flight 1951 was late
- Low visibility
- Flight crew
 - F/O – Trainee (line flying under supervision)
 - 17th flight
 - Captain – Instructor
 - Safety Pilot (1st 20 flights)
- Unstable approach
 - Capture localizer at 5.5 nm from runway threshold
 - High and fast on glideslope
- Radio Altimeter on Captains side malfunctioned

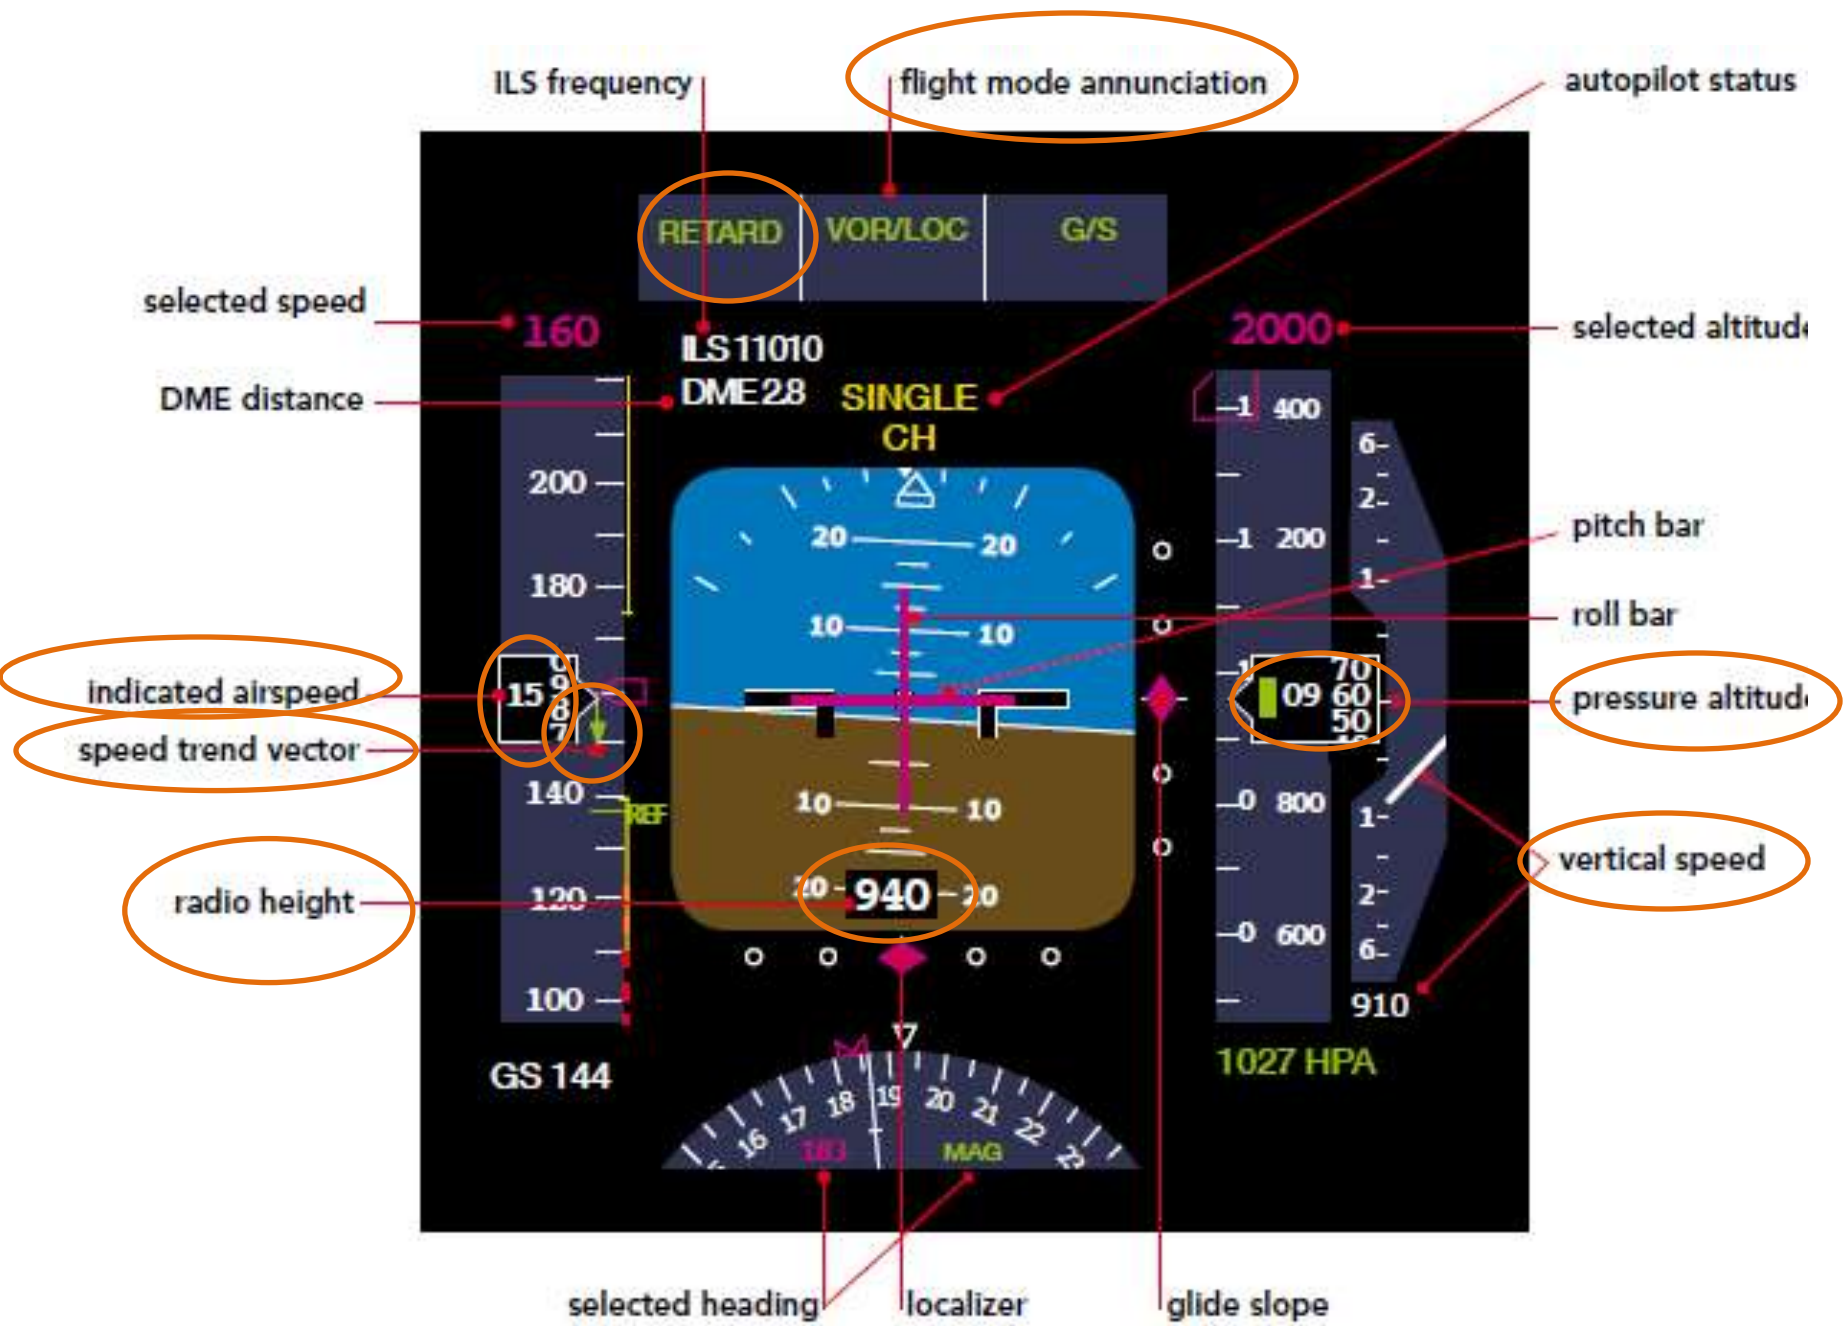
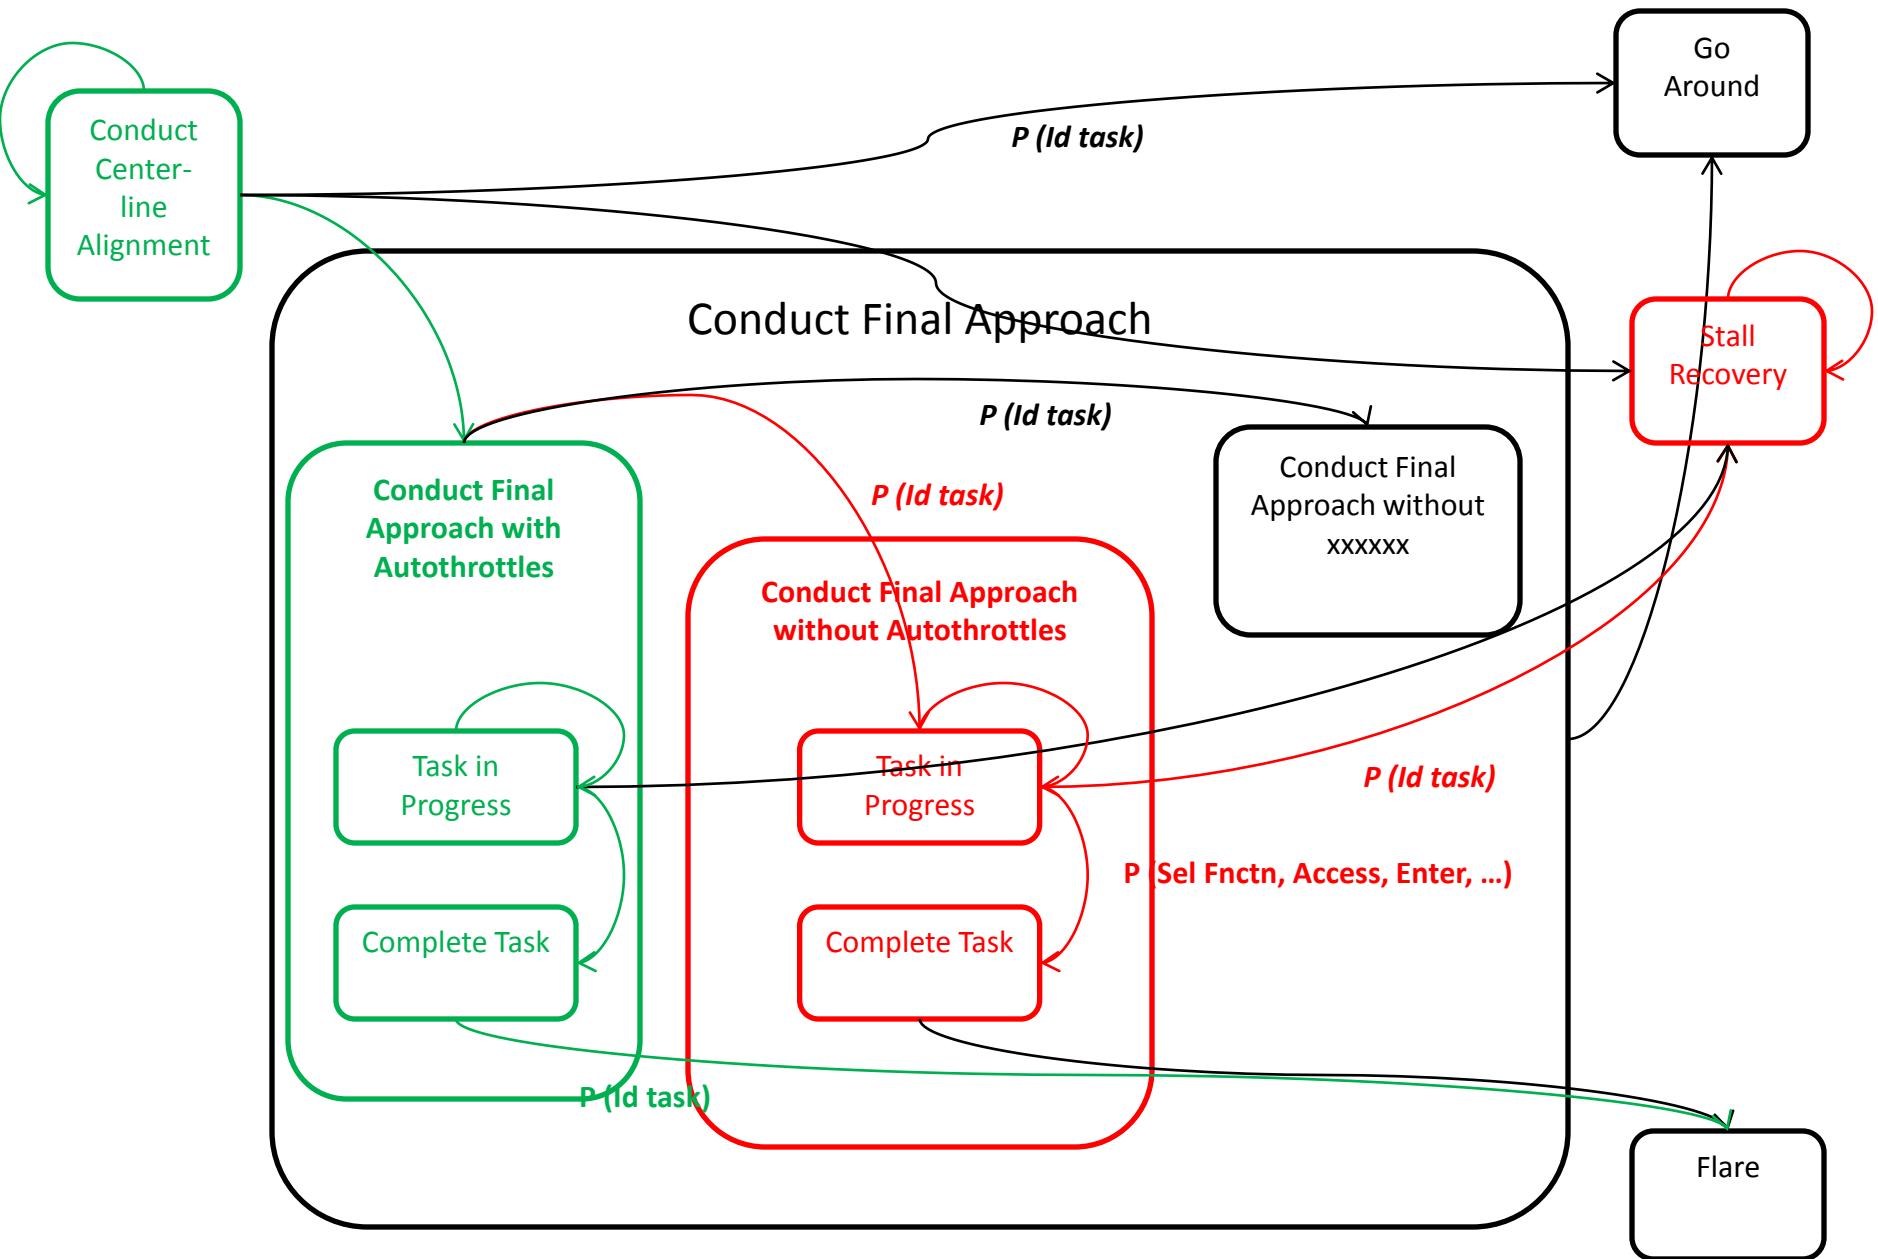
High and fast
V/S mode selected
Throttle lever retards to
idle (as it should)

Continued deceleration
through 144 knots (as it
should), but throttles
remain at Idle (instead of
adding thrust)
