**U.S. ARMY CORPS OF ENGINEERS
INSTITUTE FOR WATER RESOURCES
RISK MANAGEMENT CENTER
PRELIMINARY LESSONS LEARNED FROM OROVILLE INCIDENT**

DATE: 7 April 2017

PURPOSE OF PAPER: Review of Oroville Dam Spillway Incidents, USACE Current Methodology for Evaluating Similar Spillway Potential Failure Modes, and Identification of any Systematic Shortcomings in USACE Practice.

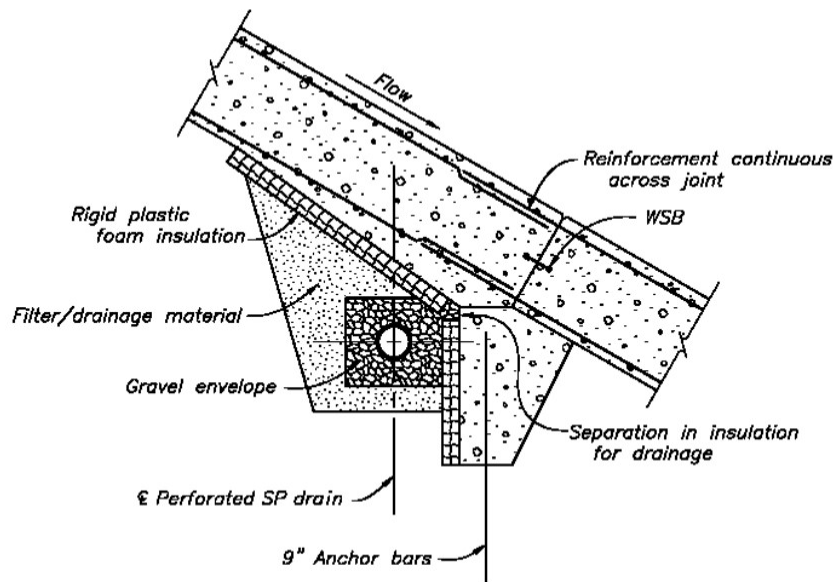
Figure 11. Suggested Joint Details from Best Practices (anchor bars should go well into competent rock, slab thicknesses should be adequate to accommodate reinforcement, and foam insulation would only be used in cold climates where ice jacking could be an issue)
