USE OF CATENARY CABLES TO PREVENT PROGRESSIVE COLLAPSE OF BUILDINGS

FINAL REPORT

**REPORT NUMBER: UCB/CEE-STEEL-2001/02
DEPARTMENT OF CIVIL AND ENVIRONMENTAL ENGINEERING
COLLEGE OF ENGINEERING
UNIVERSITY OF CALIFORNIA AT BERKELEY**

Report to the Sponsors: General Services Administration / Skilling Ward Magnusson Barkshire

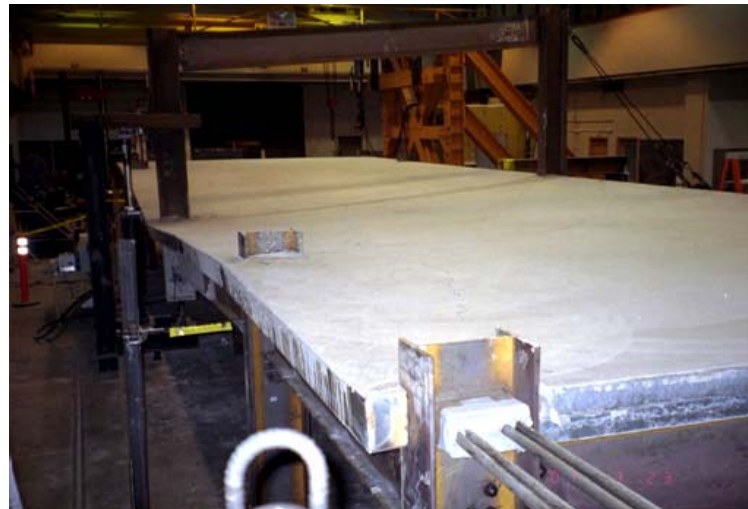
Figure 4.2. Specimen at the end of Test 1-19

speed possible for the actuator). As the structure lowered, there were a series of groans, pings and pops from the structure. These could possibly be attributed to separation between the concrete slab and the metal decking, cracking of the concrete, and bending of the entire slab. The test column dropped a total of 19.8 inches before the test was stopped. The test was terminated when the actuator load neared 100 kips, and had exceeded the design displacement. The specimen was held at maximum load briefly before being released down to zero load in the actuator. Displacement at zero load was 15 inches. The entire test took approximately 30 seconds from start to finish. The actual drop of specimen over 19.8 inches took about 11 seconds. Figures 4.2 and 4.3 show the specimen at the end of Test 1-19.

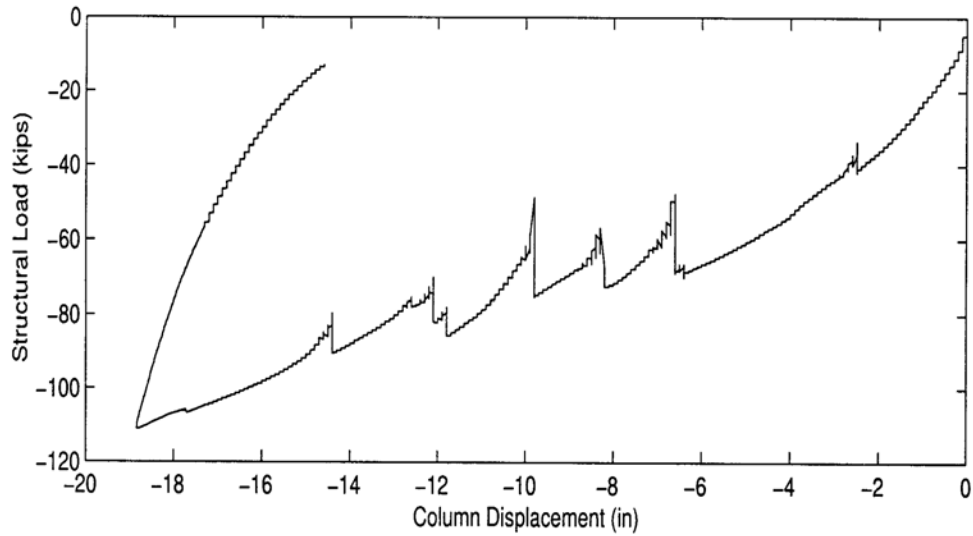
Figure 5.1. Variation of Force in the Column and Its Displacement, Test 1-19 (Virgin Specimen)

The force-displacement plot for Test 1-19 is shown in Figure 5.1. The force in the vertical axis is the load in the top portion of Column C1 after removal of its lower portion. The displacement in Figure 5.1 is the downward movement of the joint on top of the removed column (Column C1). On this plot, it is apparent that there were six noticeable jumps during the loading. Due to the large size of the test specimen, and the difficulty of viewing all portions of it at once, determining how those six “jumps” (in the plot) occurred was difficult. However, from the video gathered and witness observation, some possibilities can be put

The first discontinuity occurred very quickly in the test, and was most likely either local buckling of web of Beam B1-C1 at its B1 end and/or local buckling of web of Beam C1-D1 at its D1 end. It is also possible that slippage occurred at the horizontal or vertical shear planes of the bolted connections. For clarity, the column labeling is reprinted below in Figure 5.2.

The second, third and fourth discontinuities (steps in the curve) in Figure 5.1 all appeared quite sharp. These occurred within a total of five seconds of each other. By studying the video of the test, it seems most likely all three were due to bolt failures. The second and fourth seem to have come from the beam seat area and bolt failure there. The noises in the video seem to indicate the third one overall was at the beam seat of C1.

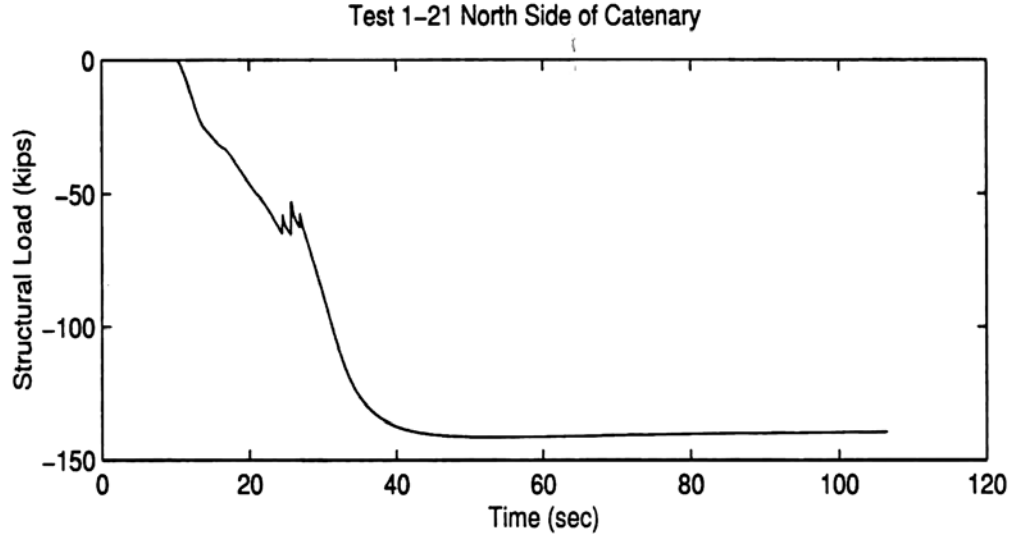
Figure 5.6. Variation of Force in the Column and Its and Displacement, Test 1-21

Figure 5.6 shows load versus displacement plot for this test. Three discontinuities in the data occurred during Test 1-21, all very close together and all following the equivalent time of the fourth discontinuity, in Test 1-19. From evidence in the video, the bolts lost at joint C1 were most likely the causes of the first two discontinuities. A loud bang was heard at the time of the third discontinuity. The incident was off camera and may have been due to sliding of the bolts in the shear tab or a sharp buckling of the web of beams at location B1, C1, C2 or D1.

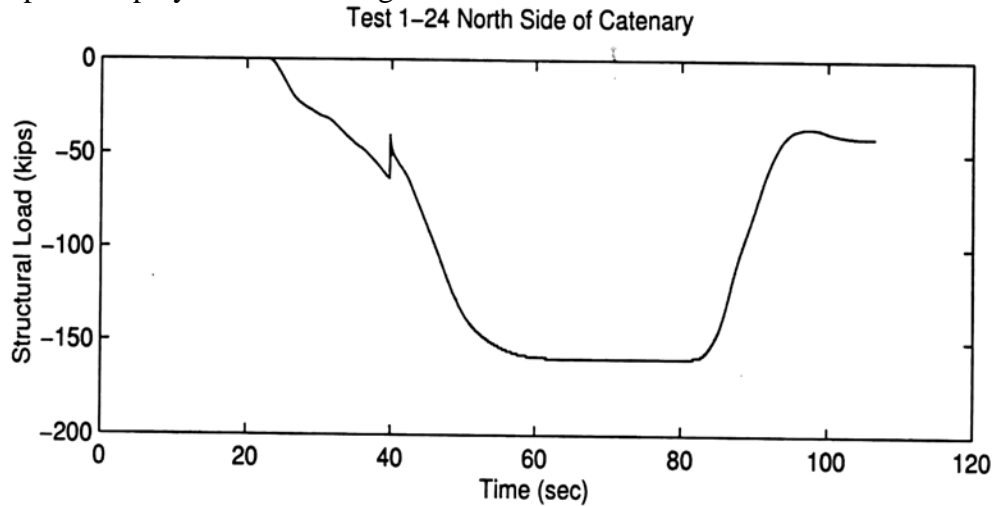
Figure 5.7. Variation of Force in the Column and Its and Displacement, Test 1-24

Figure 5.7 shows force versus displacement for this test. Only one major spike occurred during this experiment. The video was quite good on this test, and in fact, it was descriptive enough to show that the north horizontal bolt failing followed shortly by the south bolt. The structure deformed with little load increase until shortly after this failure, when the stiffness was picked up by the structure again.

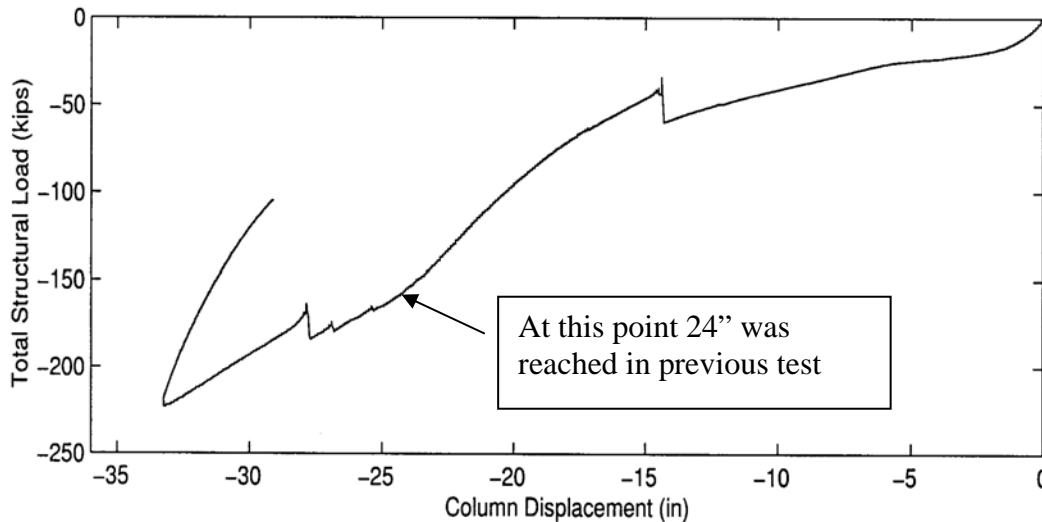
Figure 5.8. Variation of Force in the Column and Its Displacement, Test 1-35

Figure 5.8 shows force versus displacement for this test. As the structure groaned and stretched plastically back to the last point of deformation, the top row of horizontal bolts in the beam seat failed creating the first major discontinuity, seen in Figure 5.8.

Following this event, the structure began to pick up the stiffness again. The gain in stiffness can be attributed to the fact that after failure of top row of bolts in the seat angles, the angle legs bent and created a path for additional Catenary action.

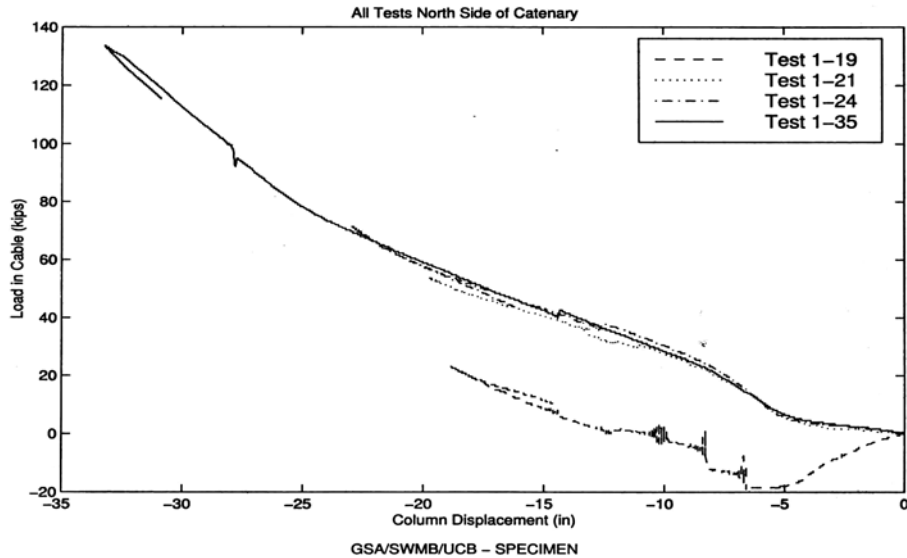
Figure 5.10. Variation of the Force measured in the Cable for All Four Tests

It is interesting to note that in Figure 5.10, the curve corresponding to Test 1-19 shows compression force developed in the cable up to a column displacement of about 5 inches. This can be because initially as the column started going down, the system was acting in bending. At this early stage and in this first test of virgin specimen, the cables due to bond between the cable and concrete, were acting as reinforcement within the slab and developing compression. When the column displacement reached about 5 inches, apparently, the bond between the cable and concrete broke and cable started developing Catenary axial tension independent of stresses in the concrete. During the subsequent tests since the bond between the cable and the concrete was not there, the cable did not develop compression, see Figure 5.10.

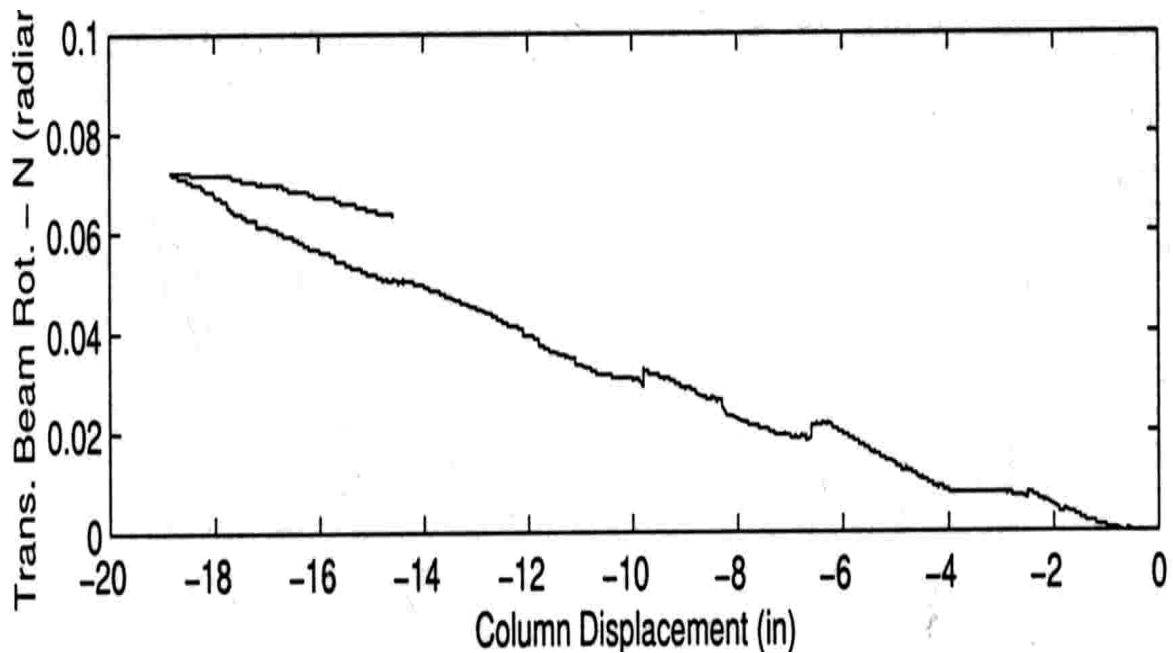
Figure 5.11. Variation of Transverse Beam End Rotation versus Time for Test 1-19

One of the interesting findings of these tests was that the long-slotted bolt holes provided at both ends of transverse beam C1-C2, worked very well and permitted almost free rotation of the transverse beam as the column was going down. Figures 5.11 show end rotation of Beam C1-C2 at its C2 end for Tests 1-19 and 1-35. As can be seen, the rotation of beam end was almost linear which indicated that end rotation took place primarily by bolt slipping and traveling inside the long slot of the shear tab connections. The long-slotted connections were able to rotate up to about 0.13 radians without any visible damage to the

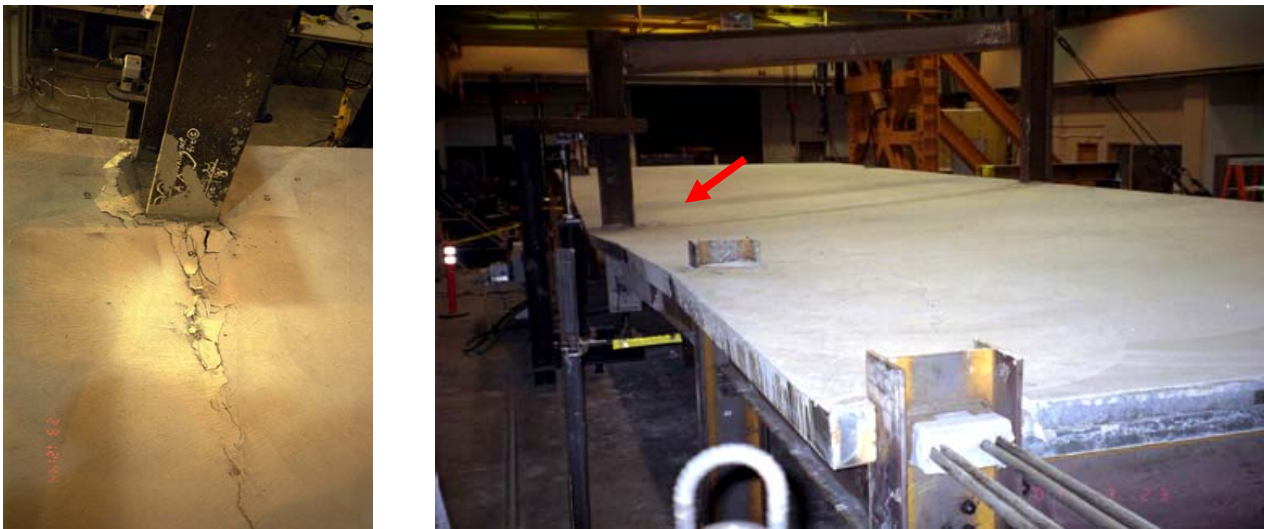
Figure 6.2. Appearance of Slab at the End of 19-Inch Drop Test

The main damage to the specimen was in the form of cracking of the deck concrete (minor cracks), failure of the bolts connecting the beams on frame line 1 to the joint that was dropped, and buckling of the web and flange at the far end of these beams. Table 6.1 shows maximum displacement and maximum force at that displacement for all four tests. The results of the four tests in terms of load in the middle column versus the drop of the top joint of that
