A report from the NIOSH Fire Fighter Fatality Investigation and Prevention Program

Volunteer Fire Fighter Dies After Running Out of Air and Becoming Disoriented in Retail Store in Strip Mall Fire—North Carolina

Report # F2016-07

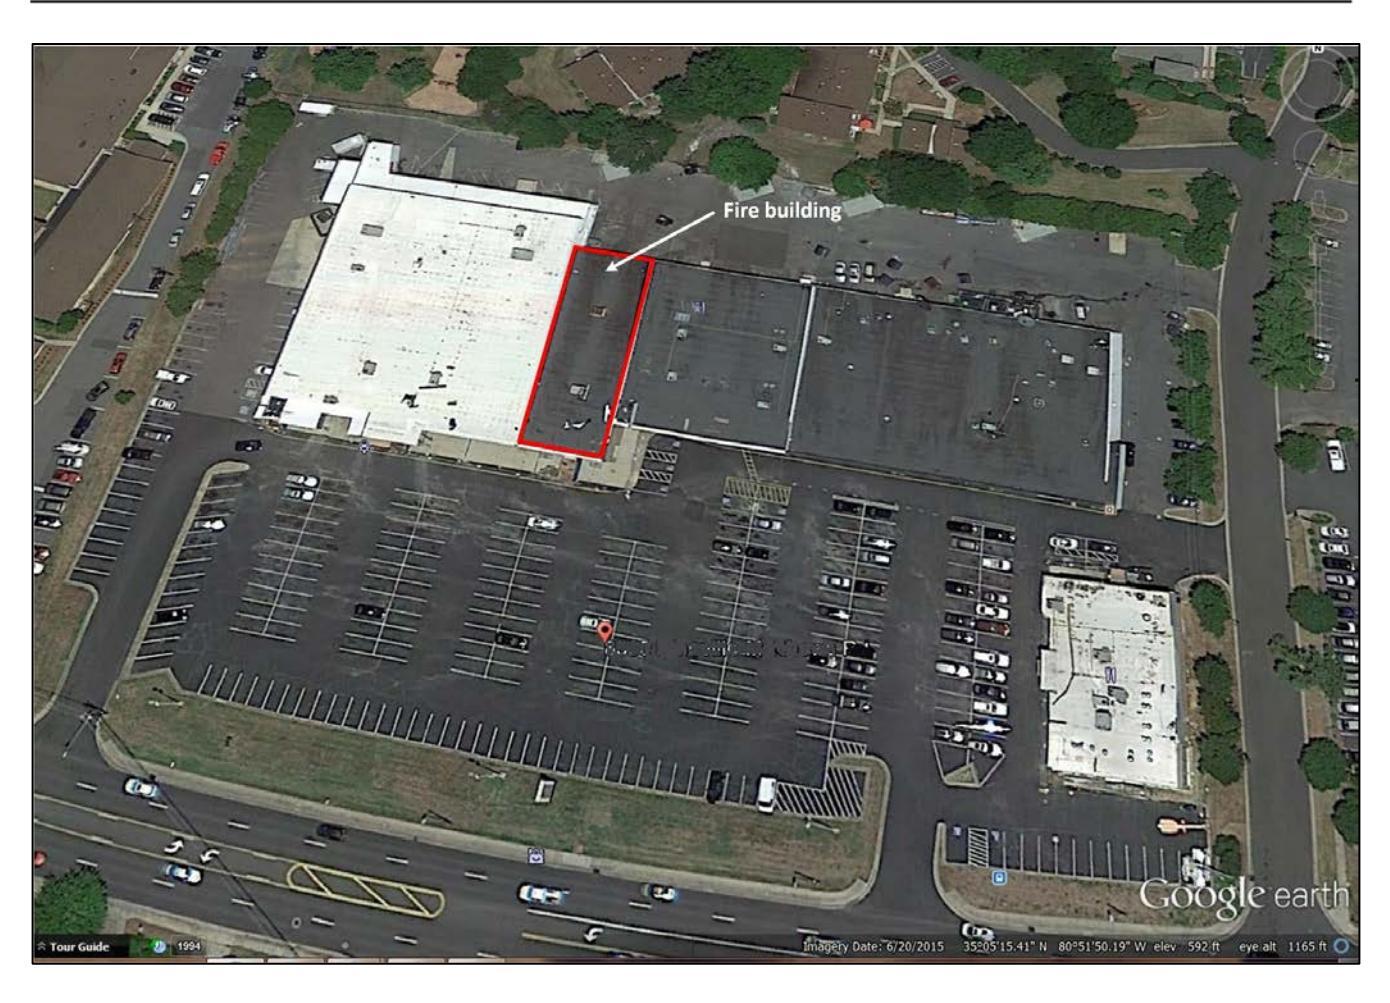
The building was part of a 70,000-square-foot commercial strip mall complex. The strip mall complex was originally built in 1978 (see Photo 1).

Photo 1. Overhead view of commercial strip mall where incident occurred. The fire building was a retail golf store where the 20-year-old fire fighter was fatally injured (fire building is highlighted in red). (Photo adapted from Google Earth.)

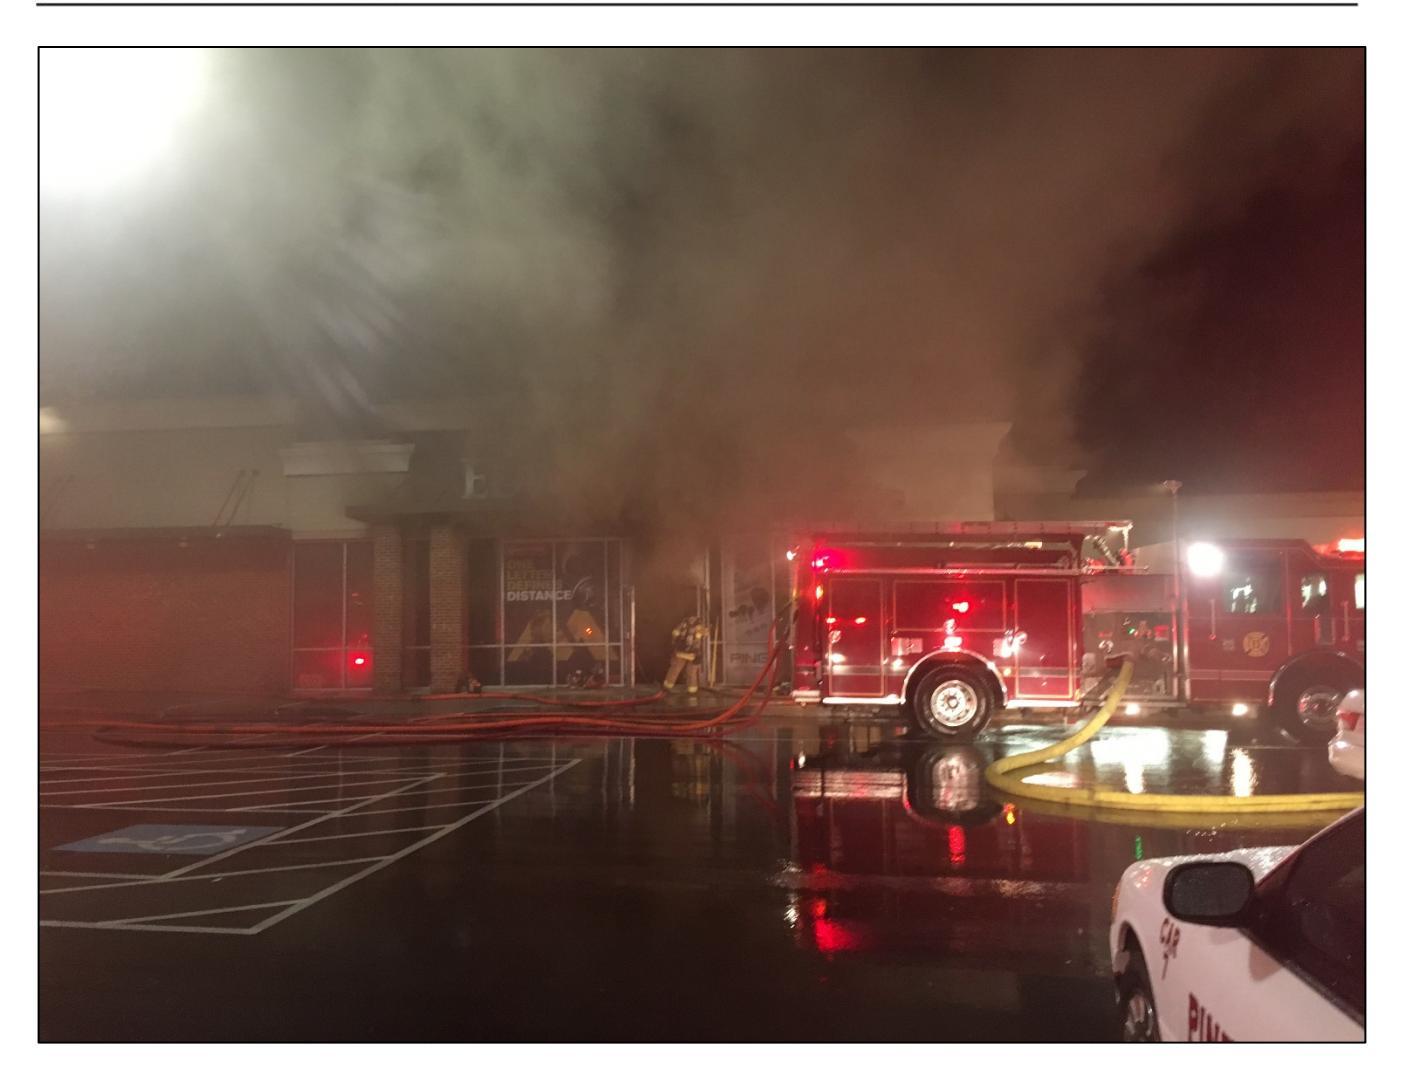
The Department 7 fire chief responded from his home in his fire department vehicle and drove past the front of the strip mall building to get a visual size-up of the exterior. He did not see any smoke on this initial drive around and radioed Dispatch that nothing was showing. He parked his fire department vehicle in front of the strip mall (Side Alpha) in the parking lot (see Photo 5) and assumed incident command. The city police department was already on-scene and established good traffic control. A police officer radioed that smoke was visible through the plate-glass front windows. The fire chief radioed the in-coming Engine 3 from Department 2 (automatic mutual aid) and directed them to reverse lay from Department 7 Engine 3 which was located at Side Alpha near the front door (see Photo 5), to the

Photo 5. Location of Engine 3 and Chief's vehicle on Side A of fire building. (Photo courtesy of County Fire Marshal's Office.)

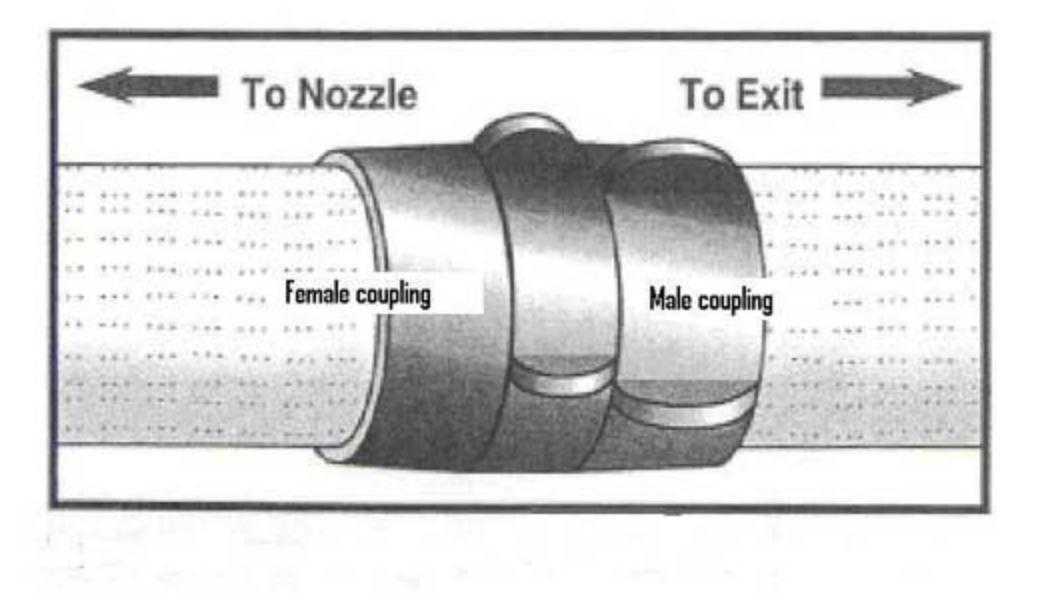
Diagram1. Hose couplings will indicate the direction toward the exit. (Adapted from IFSTA *Essentials of Fire Fighting*, 4th Edition.)

In this incident, Engine 3 Fire Fighter 2 ran low on air and told his crew members that he needed to get out. He began following the hoseline but soon lost contact with the hoseline due to the arrangement of the display racks in the store. The other crew members attempted to calm him down. The Engine 3 lieutenant also ran low on air and stated that he would take the fire fighter outside. The Engine 3 lieutenant and fire fighter again began to follow the hoseline outside. The lieutenant turned around to check on the fire fighter and noticed that he was standing up and soon disappeared into the near-zero visibility conditions within the store. The lieutenant soon lost contact with the hoseline. Both Fire Fighter 2 (the victim) and lieutenant ran completely out of air. The Engine 16 crew heard the lieutenant yelling for help, was able to locate him, and assist him outside. The Engine 3 Fire Fighter 2 was located about 2 minutes later. Fire Fighter 2 was immediately transported to a hospital but did not survive his injuries. The lieutenant was treated and released.

Hoselines can be the last line of defense and the last chance for a lost fire fighter to find egress from a burning building. According to the USFA Special Report, Rapid Intervention Teams and How to Avoid *Needing Them*, the basic techniques taught during entry-level fire-fighting programs describe how to escape a zero-visibility environment using only a hoseline [USFA 2003]. However, as years elapse from the time of basic training, fire fighters may overlook this technique. Exiting a structure in zero visibility should be simple, fast, and easy for a fire fighter with a hoseline based on training and experience to build muscle-memory. A fire fighter operating on a hoseline should search along the hose until a coupling is found. Once found, the fire fighter can "read" the coupling and determine the male and female ends. The IFSTA manual Essentials of Fire Fighting teaches that the female coupling is on the nozzle side of the set and the male is on the water side of the set. In most cases, the male coupling has lugs on its shank while the female does not. Once oriented on the hose, fire fighters can follow the hoseline in the direction away from the male coupling which will take them toward the exit (see Diagram 1)[IFSTA 1998, NIOSH 2009]. A fire hose can also be marked in a number of ways that will indicate the direction to the exit, including the use of raised arrows and chevrons that provide both visual and tactile indicators. Fire departments may use a variety of techniques to train fire fighters on how to identify hoseline couplings and the direction to the exit, based on the model of hose used by the department. The key point is that this training needs to be conducted and repeated often so that fire fighters are proficient in identifying the direction to the exit in zero-visibility conditions while wearing gloves, when the hose is entangled, and with various obstructions present. This procedure should be incorporated into standard operating procedures, trained upon, and enforced on the fireground.

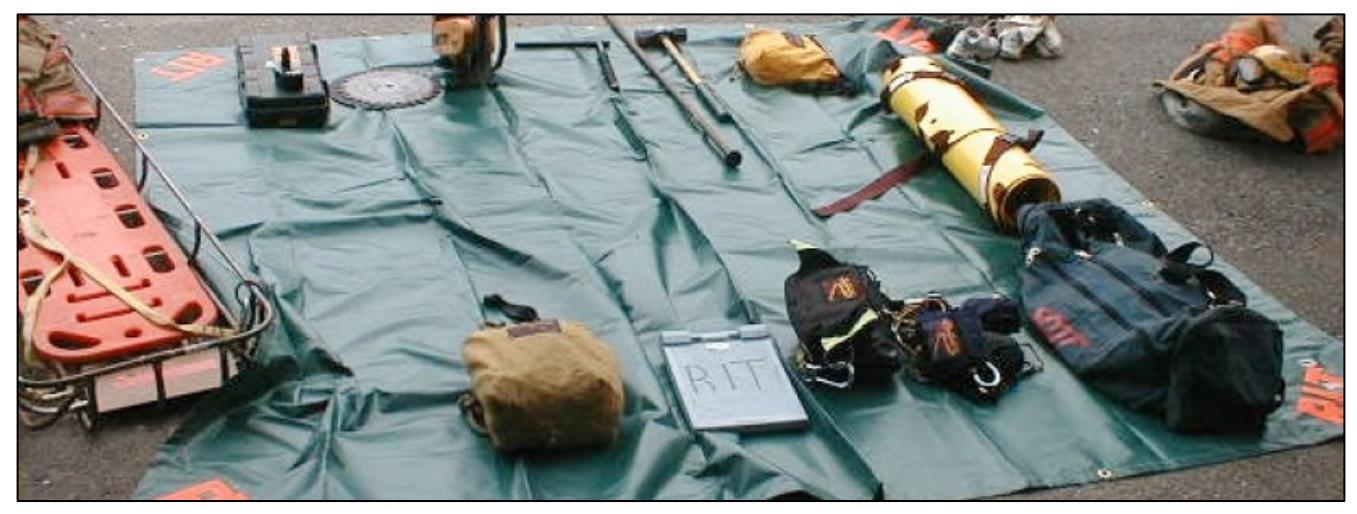
Photo 8. This is an example of the equipment needed for rapid intervention crew (RIC) operations. One of the most important pieces of equipment is the strobe light, which can be used to identify/mark an exit in a building in the event a rapid egress is needed by a fire fighter or fire fighters.

It is important to stage all necessary RIC equipment in an expedient manner (see Photo 8). The RIC officer (equipped with a thermal imager), accompanied by one member of the RIC, should perform an incident scene survey while the remaining RIC members assemble the RIC equipment. If the size of the structure negates a 360-degree survey of the building, this fact should be relayed to the incident commander as soon as possible. This should be a benchmark for Command to designate another RIC in order to effectively cover all sides of the building.
