Woltz Residence Defect List

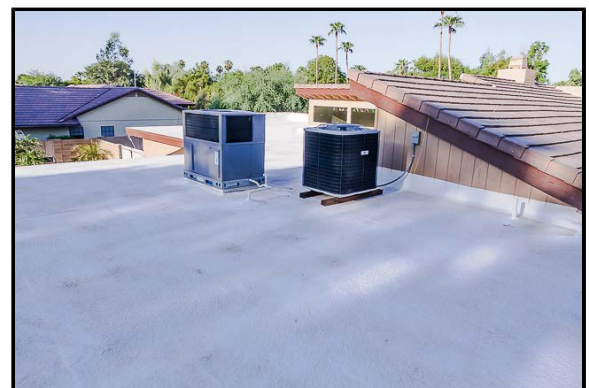
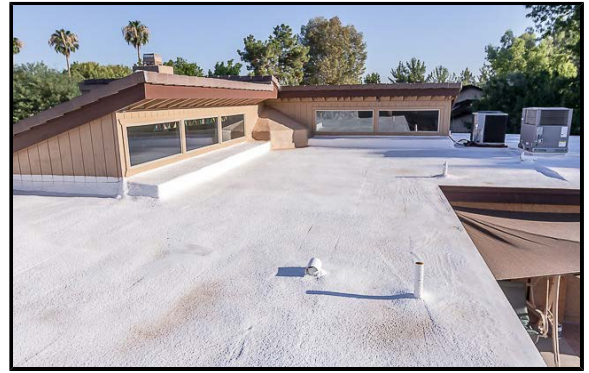
In this case installing 7 tons for 2300 sq-ft of living space is detrimental and among the problems caused are:

- Increased Installation costs
- Reduced operating efficiency due to equipment short-cycling
- Excessive wear
- Increased maintenance and shorter equipment life
- Humidity control and Indoor Air Quality problems
- Temperature swings
- Poor air circulation resulting in hot and cold spots
- Increased Equipment Noise
- Increased operating costs

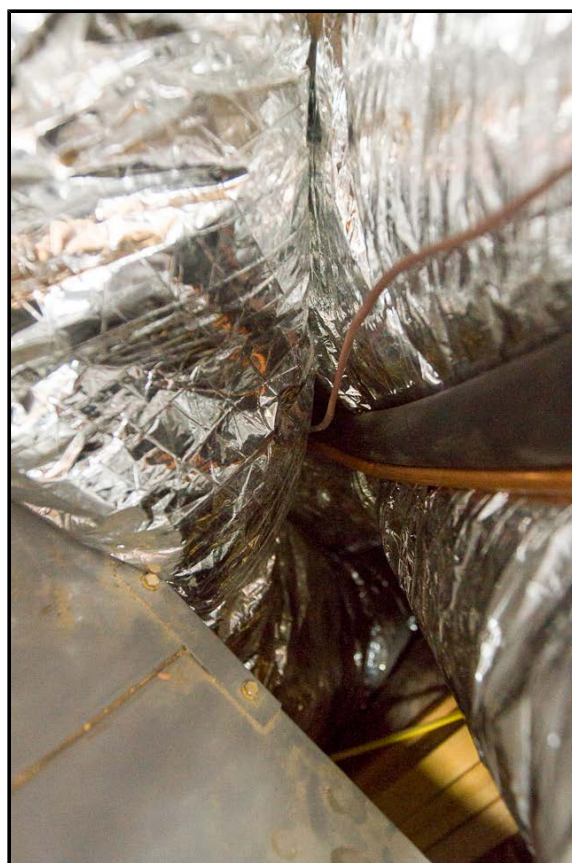
HVAC 5 ton Split System - Master Closet Attic Space Inadequate
