EPA/600/R-97/063
October 1997

Evaluation of the Implementation of Operations and Maintenance Programs in New Jersey Schools

John R. Kominsky, Ronald W. Freyberg
Environmental Quality Management, Inc.
Cincinnati, Ohio 45240

Donald R. Gerber, Gary J. Centifonti
Environmental Health Services
New Jersey Department of Health
Trenton, New Jersey 08625

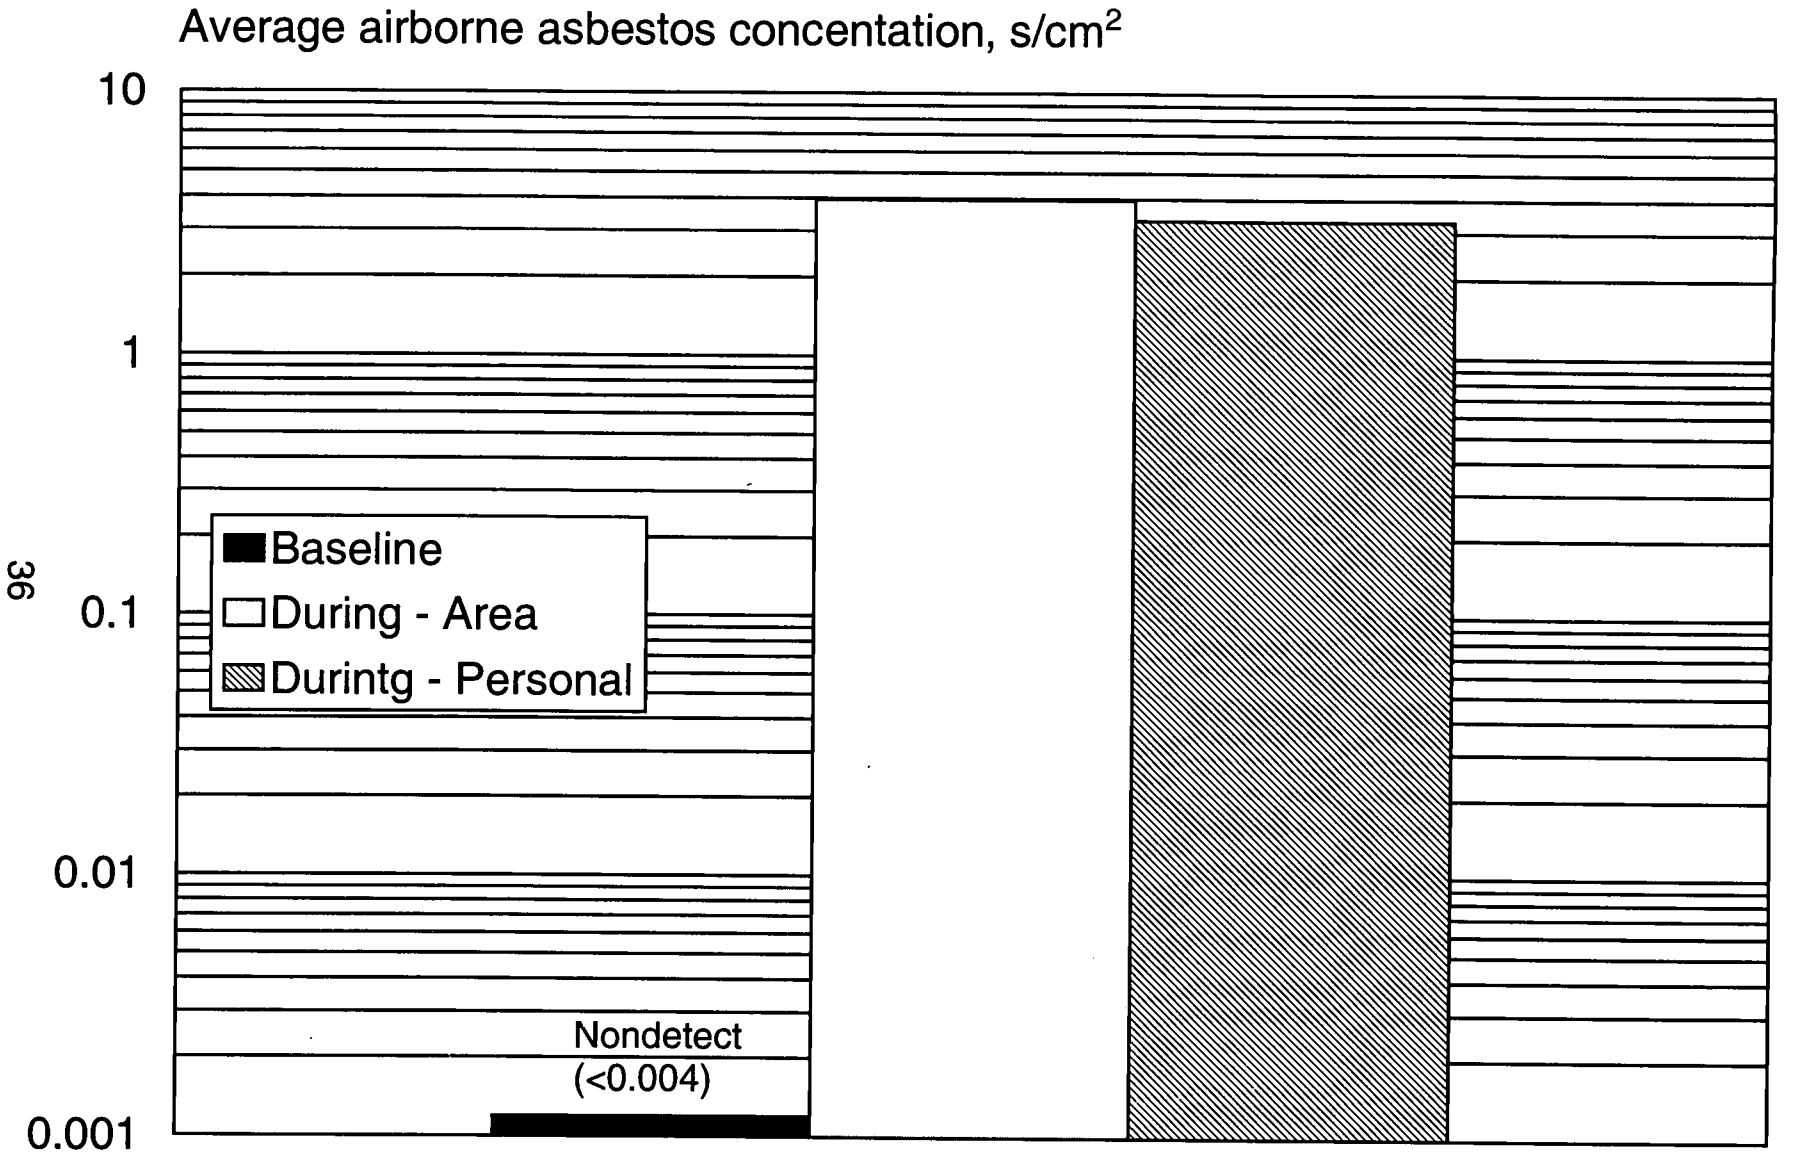
Figure 8. Average airborne asbestos concentrations before and during wet-stripping of resilient floor tile at Site A.

The airborne asbestos levels measured during wet-stripping of the resilient floor tile were three orders of magnitude higher than the levels measured during the other O&M activities. These elevated levels during wet-stripping of resilient floor tile are consistent with those levels measured during other studies involving the same floor care maintenance practice.[7,8] Additionally, a study previously conducted on the spray-buffing of resilient floor tile demonstrated that this common maintenance procedure increased airborne asbestos concentrations at the majority of the study sites.[9]

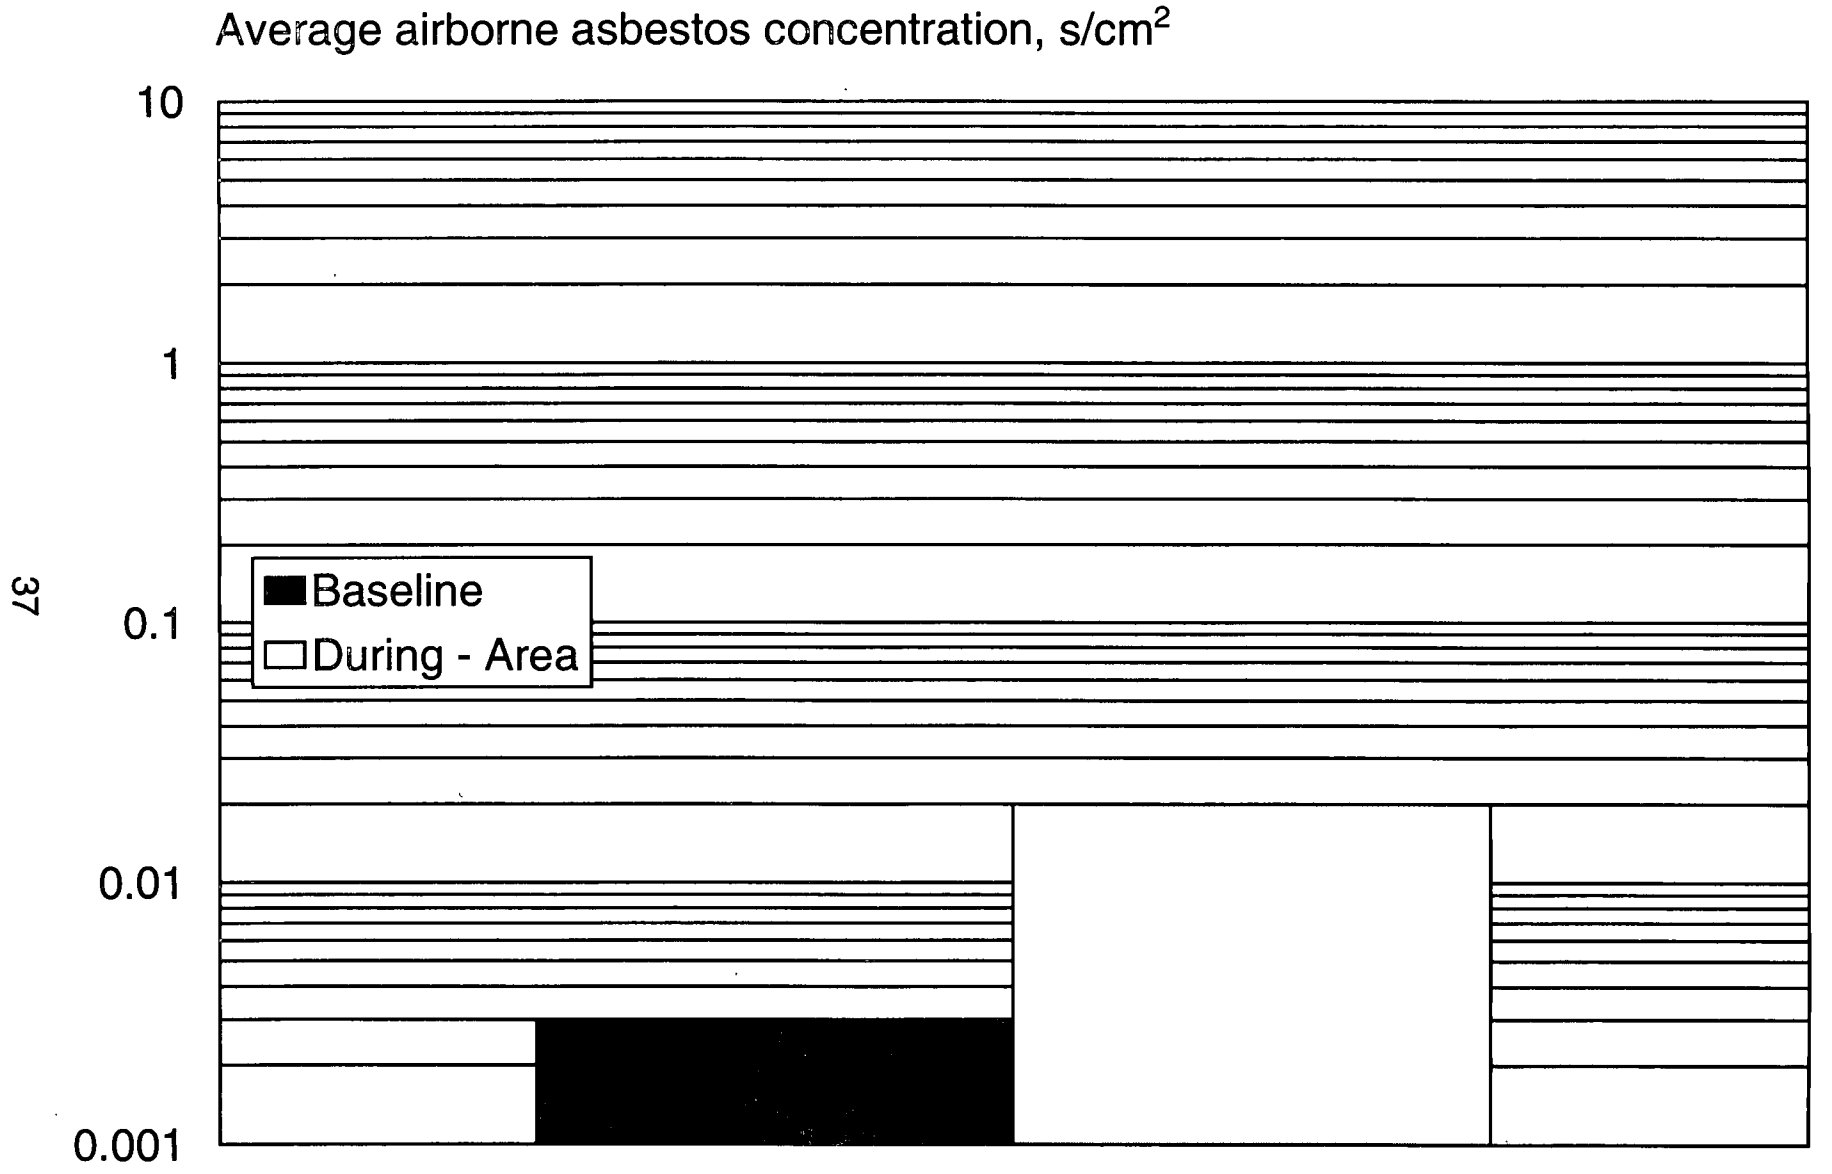
Figure 9. Average airborne asbestos concentrations before and during rennovation at Site C.

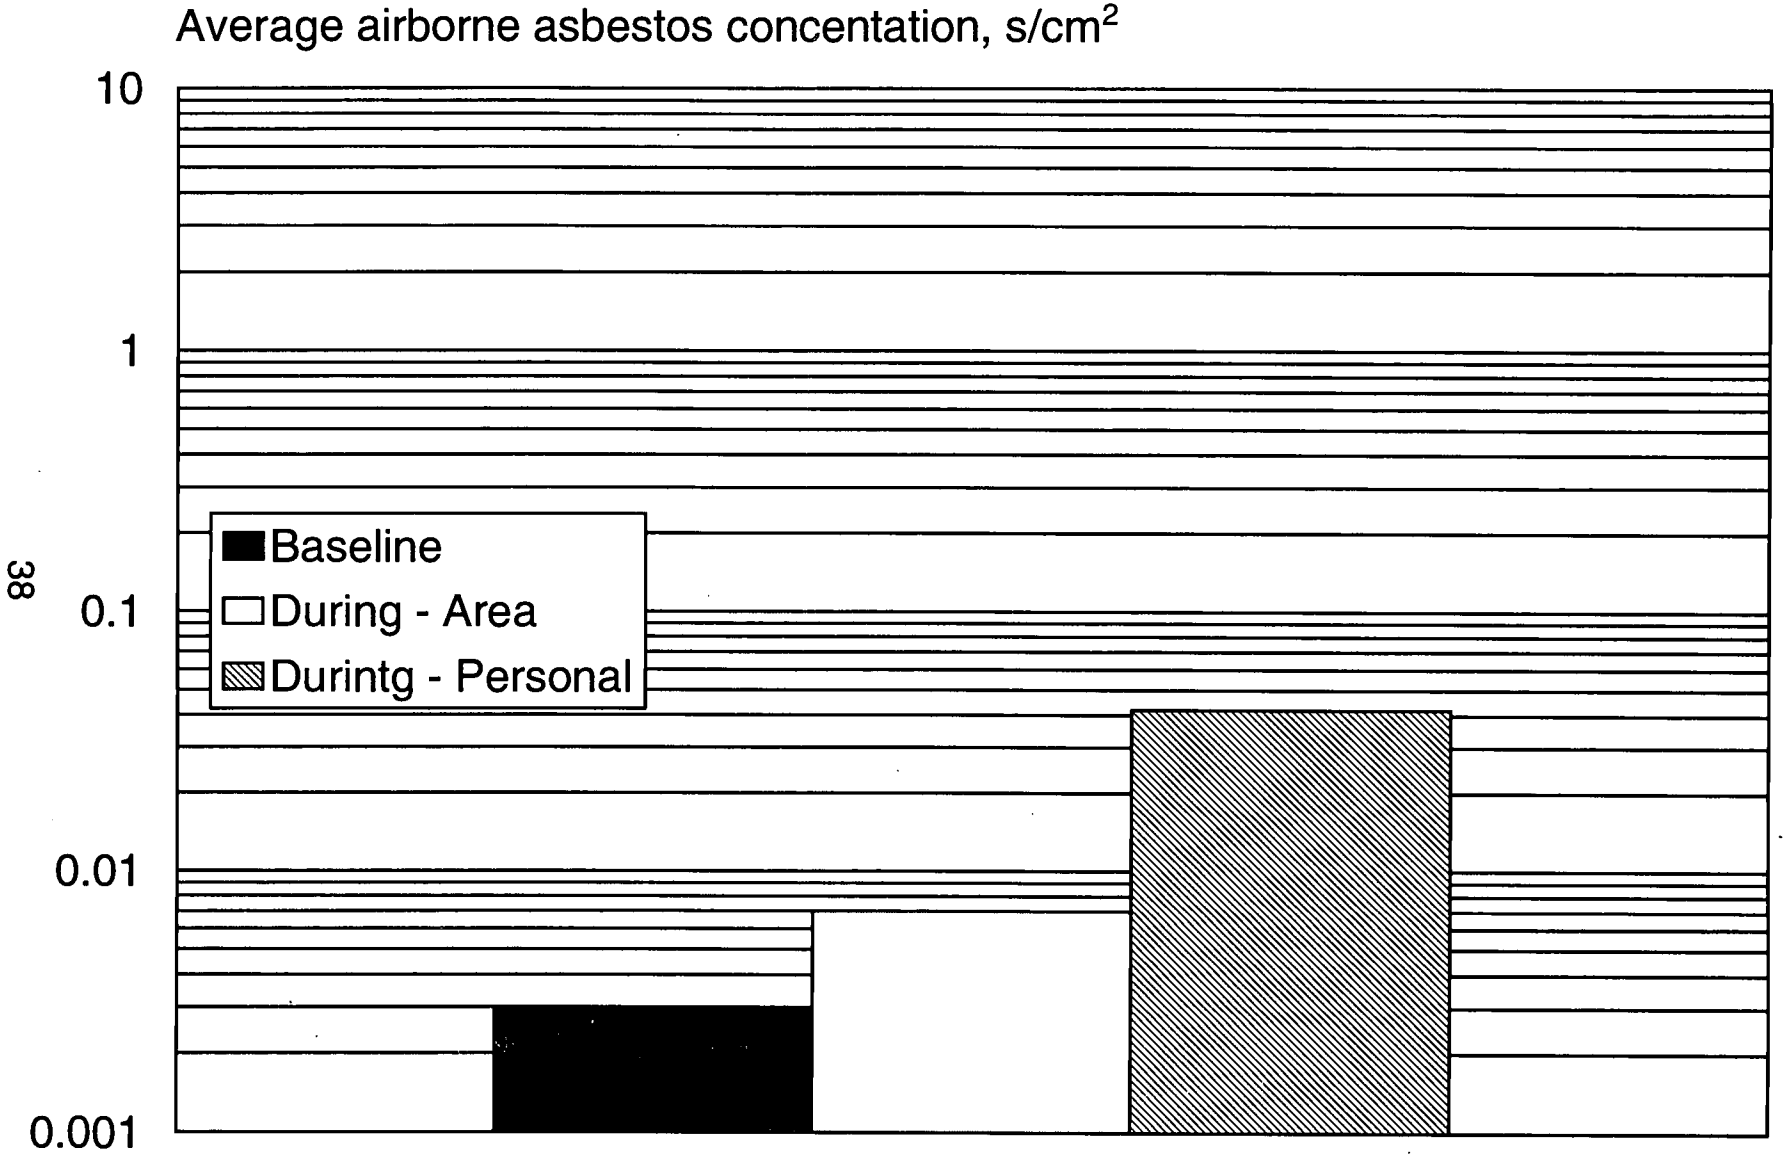
Figure 10. Average airborne asbestos concentrations before and during changing filter and vacuuming air handling unit at Site F_1.

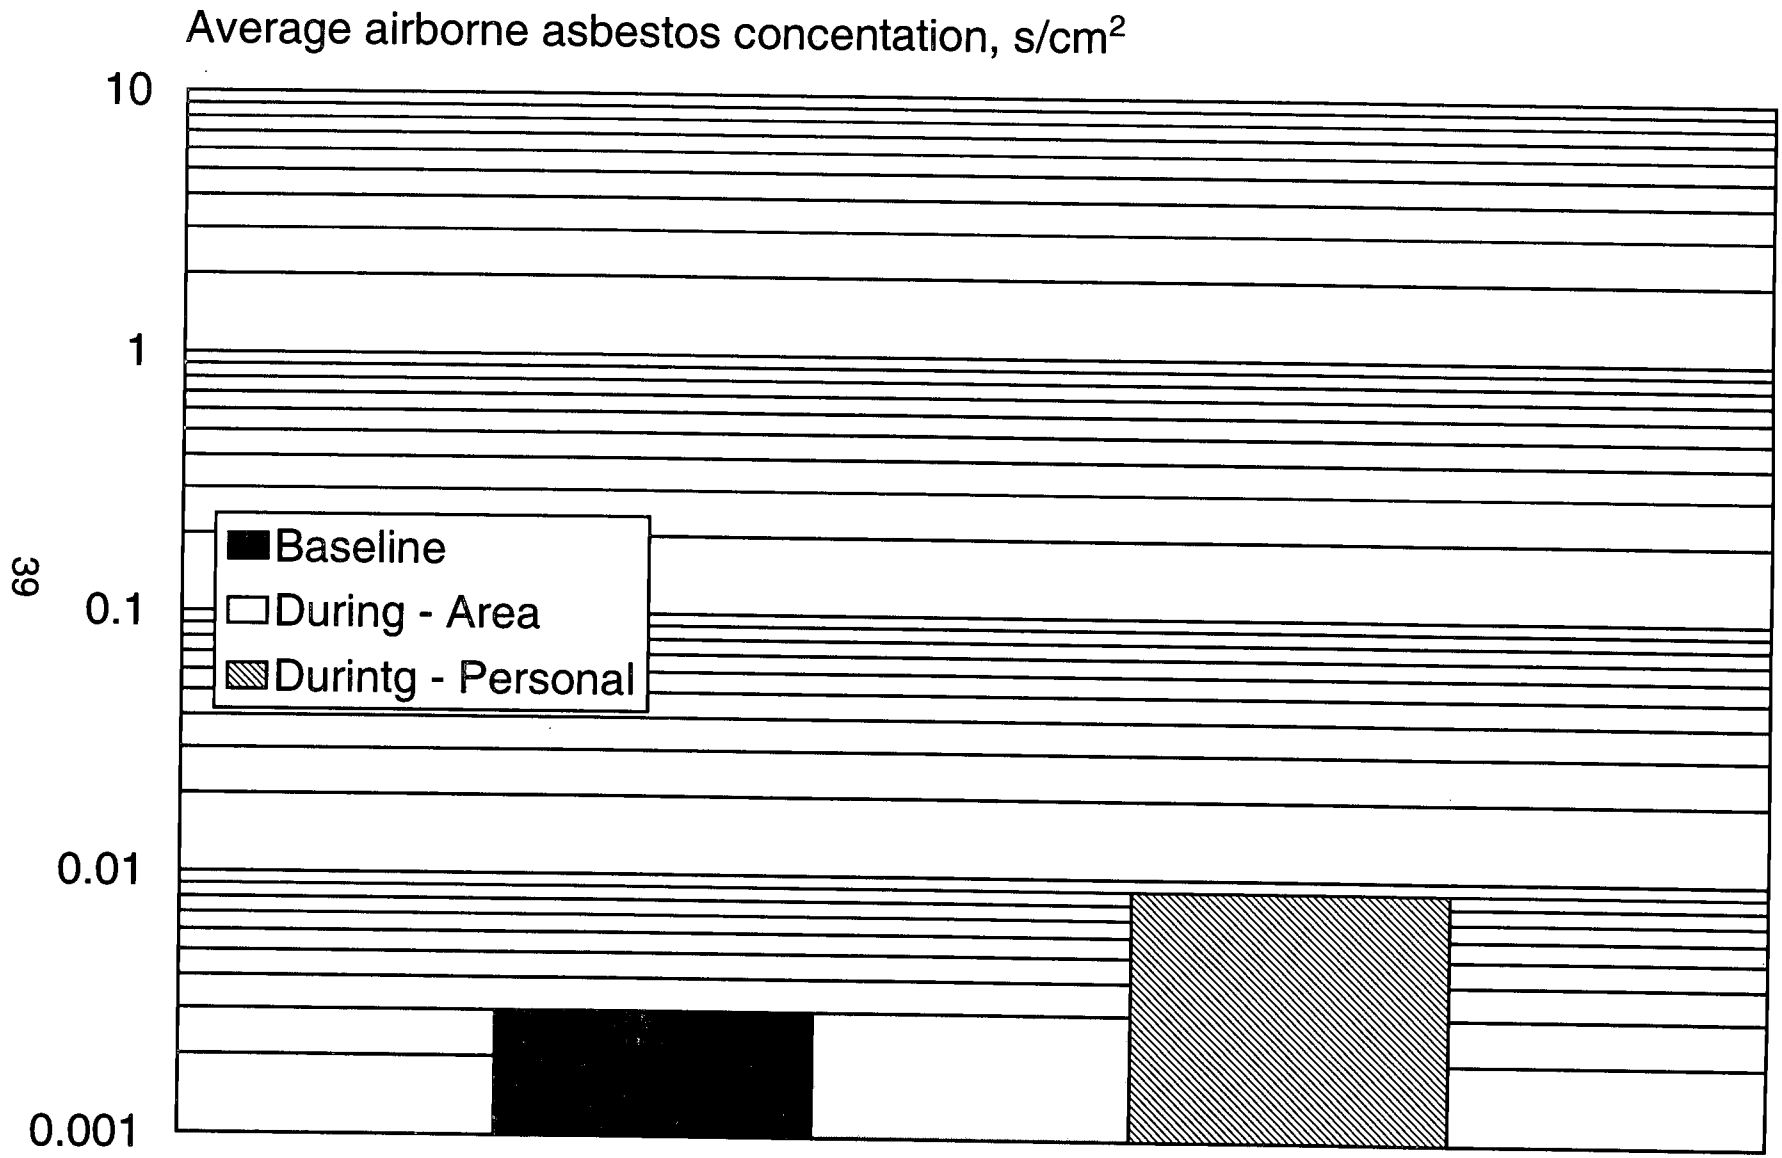
Figure 11. Average airborne asbestos concentrations before and during installation of smoke detector wiring as Site F_2.

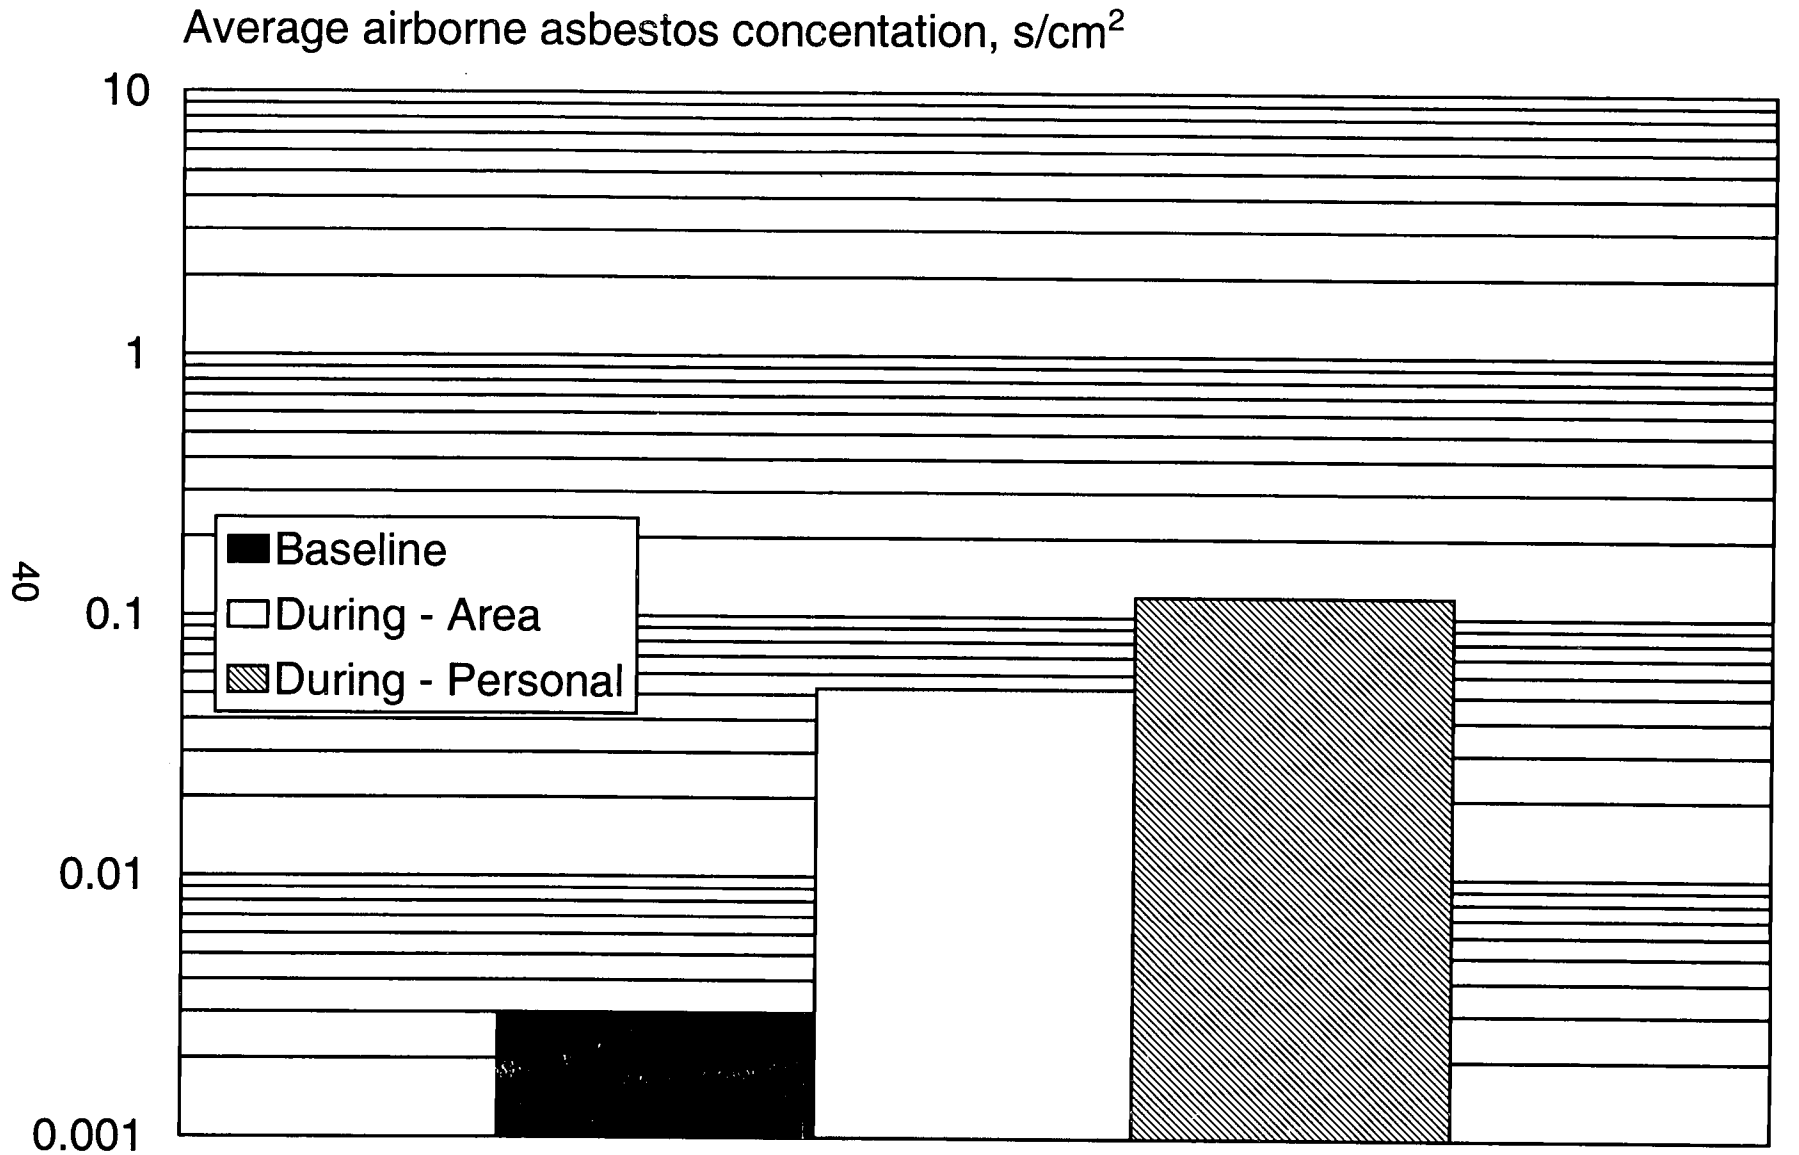
Figure 12. Average airborne asbestos concentrations before and during installation of fire alarm system at Site H.
