SERVICE BULLETIN

EC10-014

2005 - 2006 ALTIMA WITH QR25DE ENGINE AND 50 STATE EMISSIONS; MIL ON WITH DTC P0420

APPLIED VEHICLE: 2005-2006 Altima (L31)

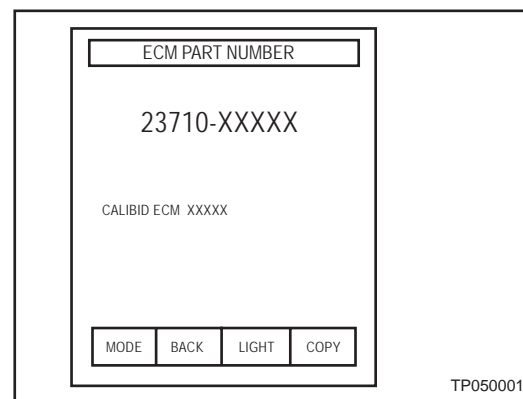
- Figure 1 is an example of the ECM P/N printout.
- You will use the ECM P/N to see if this bulletin applies.
- Leave C-II connected to the vehicle at this time.

- Use the ECM P/N printout (see example on Page 2, Figure 1):

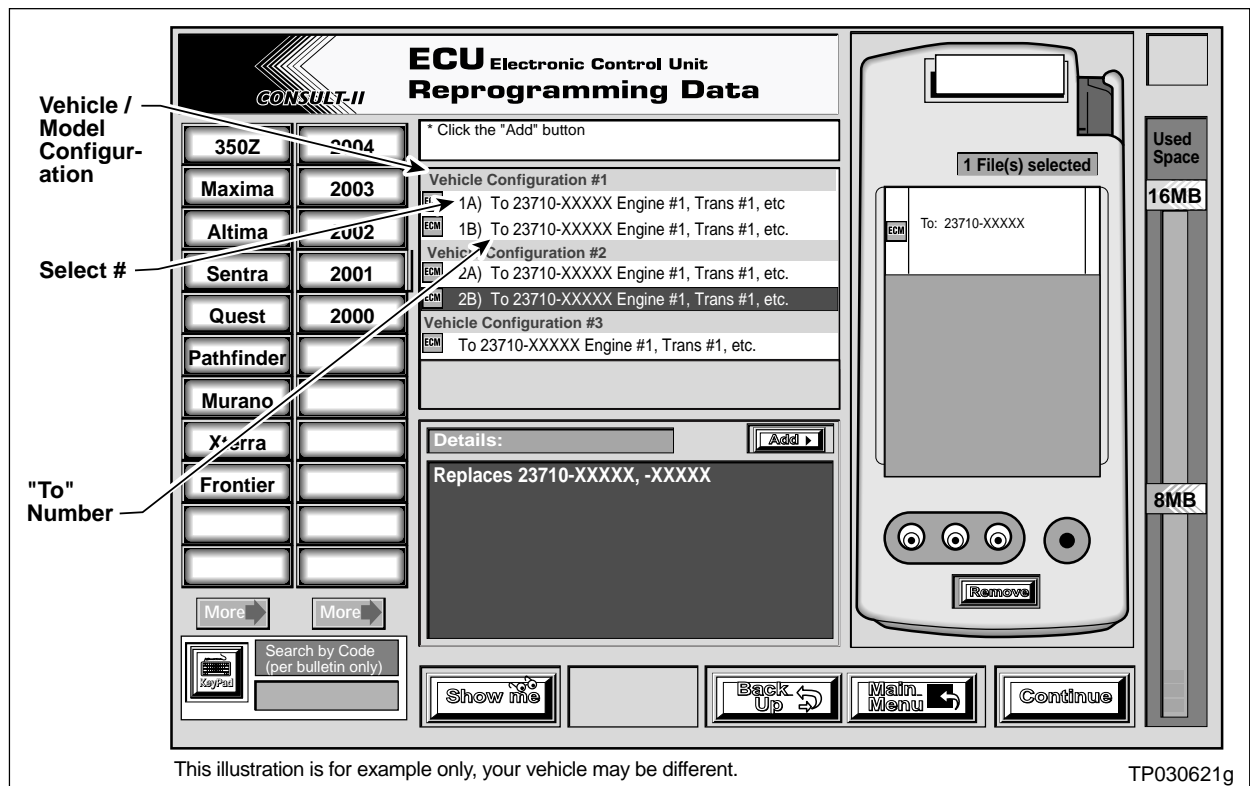
Figure 5

1. Select vehicle model and model year (Example: Altima 2005).
2. Select the correct Reprogramming Data:
 - a. Locate the specific "Vehicle Configuration" (Example: A/T, ASCD).

NOTE: Vehicle Configuration may include items such as engine type, transmission type, and vehicle options such as ASCD, TCS, ABS, etc.
 - b. Select (click on) the "To" number for your Vehicle Configuration for the Reprogramming Data. (Write the "To" number on the repair order.)

NOTE: The "To" number will read: 23710-XXXXX.
3. Click on the "Add" button.
 - This will add the selected data to the "File(s) Selected" list.
4. Click on "Continue" and follow the on-screen directions to perform "data transfer" (download) from ASIST into C-II.

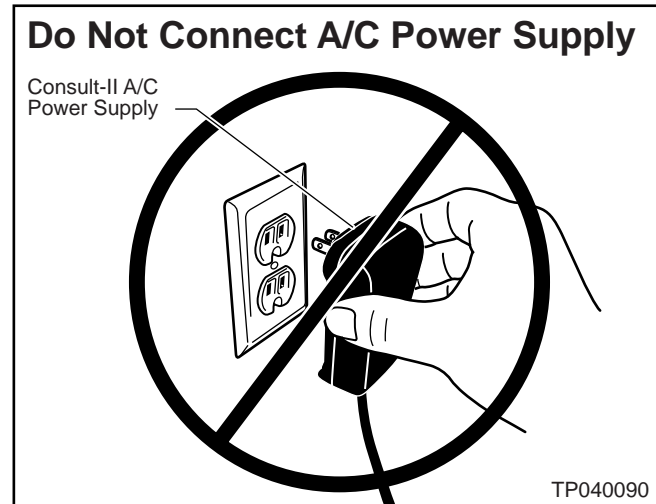
Figure 6

1. Connect a battery charger to the vehicle's battery.
 - Set the charger to a low charge rate (trickle charge).

CAUTION: For number 2 below, and number 3 on the next page, **DO NOT** connect the C-II AC power supply.

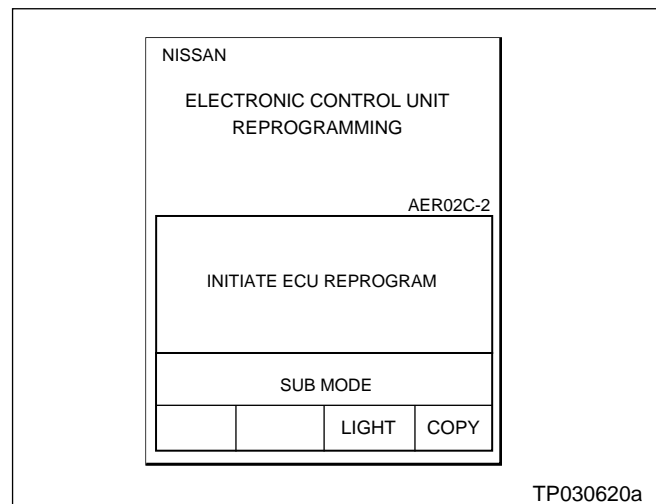
Figure 7

2. Press **SUB MODE** (see Figure 7) then:
 - a. From the listed items, find and select **BATTERY CHARGE**

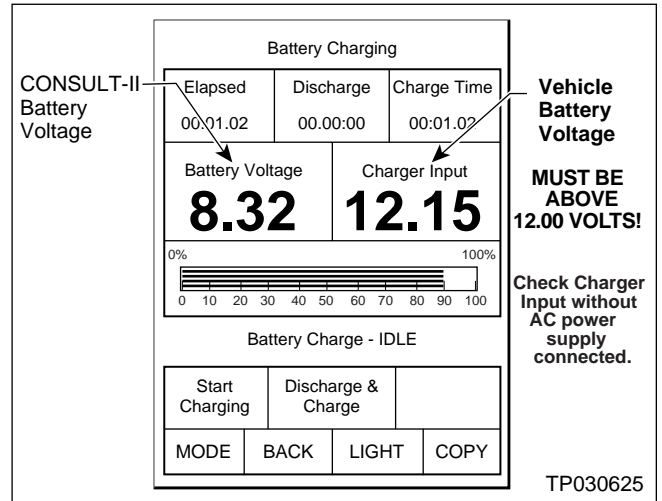
Figure 8

3. Check the C-II “Charger Input” reading (see Figure 8).

- **“Battery Voltage”** is the voltage level of the CONSULT-II battery.
- **“Charger Input”** is the voltage level of the vehicle’s battery. **(It must be above 12 volts.)**

CAUTION: If the “Charger Input” is below 12 volts:

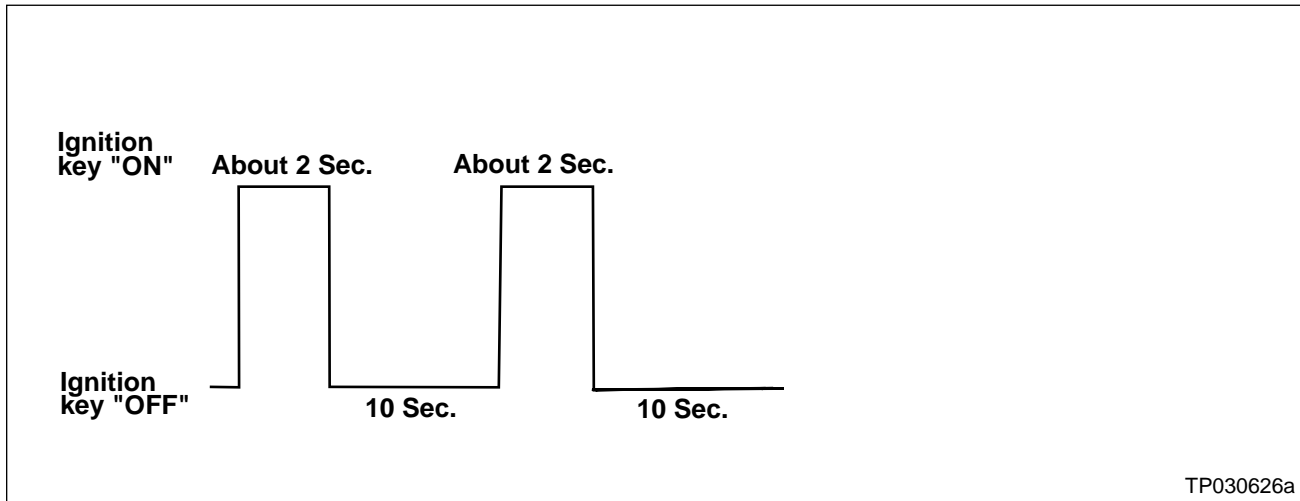
Figure 9

1. Turn the ignition switch "OFF" and C-II “OFF”.
2. Wait more than 10 seconds, and then:
 - a. Turn the ignition switch "ON" for 2 seconds, and then
 - b. Turn the ignition switch "OFF" again for 10 seconds (see Figure 9).
 - This will reset ECM “self learned” Data.
