2010 Chevrolet Equinox

The 2010 Chevrolet Equinox has a completely new look and upgraded design. This vehicle will be the leader in its segment in styling, comfort and fuel economy.

2010 Buick LaCrosse

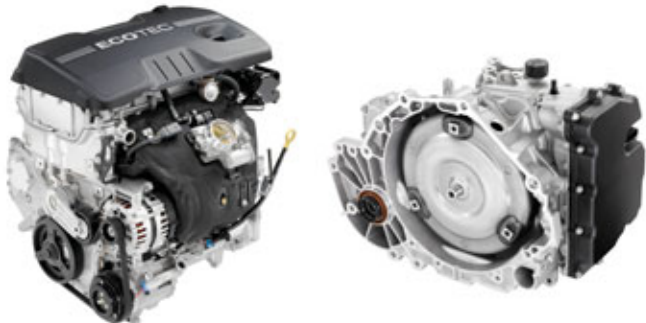
2.4L SIDI VVT 4-CYLINDER ENGINE (RPO LAF)

This is the standard engine on all models. It provides 182 horsepower and 174 lb.-ft. of torque and is available in both front- and all-wheel-drive configurations. Fuel economy of 21 mpg city/30 mpg highway is expected to be segment leading on the highway (10.1 L/100 km city and 6.7 L/100 km highway, Canada). And the 18.5-gallon (71 L) fuel tank allows a 564-mile (1059 km) range.

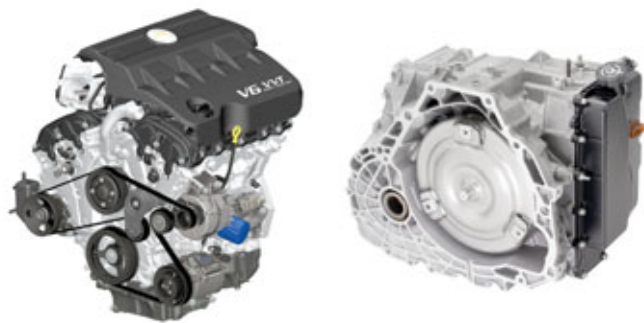
3.0L SIDI VVT V6 ENGINE (RPO LF1)

This engine is available on LT and LTZ models. It offers 264 horsepower and 214 lb.-ft. of torque, is available in both front- and all-wheel-drive configurations and has a 3500-lb. towing capacity. It provides 18 mpg city and 25 mpg highway (11.9 L/100 km city and 8.1 L/100 km highway, Canada). And the 20.9-gallon (79L) fuel tank allows a 520-mile (975 km) range.

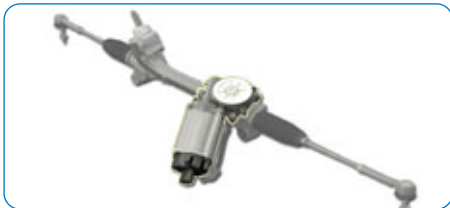
RACK-MOUNTED ELECTRIC POWER STEERING - EPS

A REPS (rack-mounted electric power steering) system is used on models equipped with the 2.4-liter VVT direct-injection four-cylinder engine, primarily for buyers interested in more fuel efficiency. EPS eliminates the need for a power steering accessory drive that runs off the engine, reducing associated parasitic losses.

Due to its rack-mounted configuration (as opposed to column mounted) and input torque sensor, the steering system delivers more precise reaction to steering inputs and better overall on-line center fee, both of which contribute to the vehicle's unexpected performance balance.

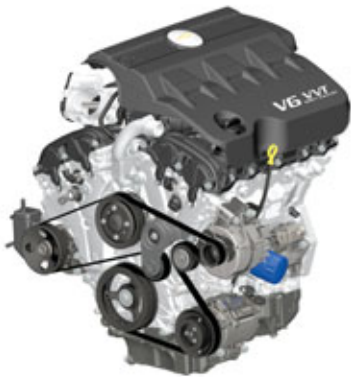
3.0L SIDI VVT V6 ENGINE (RPO LF1)

This engine is available on CX and CXL models. It offers 255 horsepower and 217 lb.-ft. of torque, and is available in both front- and all-wheel-drive (CXL) configurations. It provides (estimated) 18 mpg city/27 mpg highway (CX) (11.1L/100 km city and 7.4 l/100 km highway, Canada). And it uses regular gasoline.

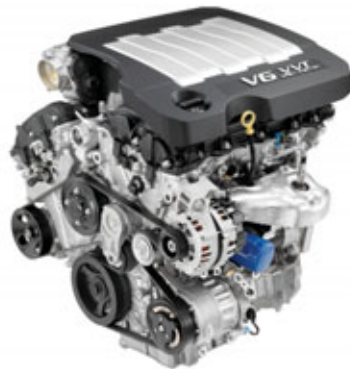
3.6L SIDI VVT V6 ENGINE (RPO LLT)

This engine is available on the CXL. It offers 280 horsepower and 259 lb.-ft. of torque. It provides (estimated) 17 mpg city/26 mpg highway (11.8 L/100 km city and 8.3 L/100 km highway, Canada).

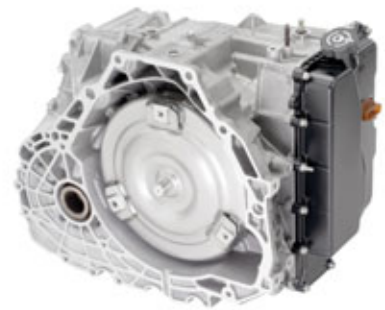
6T70 SIX-SPEED HYDRA-MATIC AUTOMATIC TRANSMISSION

This transmission is standard with both engines. All gearing is inline with the engine crankshaft, resulting in shorter overall vehicle length, lower powertrain height and more interior room. This transmission features adaptive shift controls, automatic grade braking and tap up/tap down capability. It requires minimal maintenance due to 100,000 mile (160,000 km) DEXRON® VI fluid.

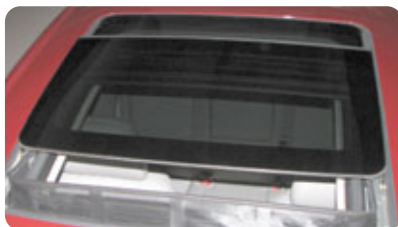
PANORAMIC SUNROOF

An available panoramic sunroof provides additional interior light for front and rear passengers, using a movable front panel and stationary rear panel.

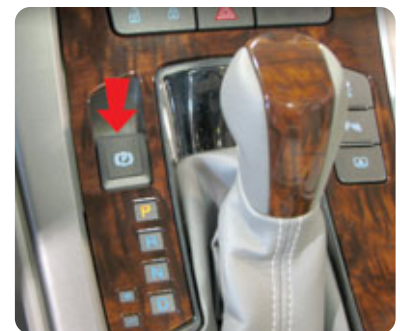
The conventional mechanical park brake is replaced by an innovative button-controlled system with a switch in the center console. The system has two warning lights identified as PARK and (P) and three Driver Information Center (DIC) messages. In case of insufficient electrical power, the EPB cannot be applied or released.

The PARK light is used for all apply and release functions as well as "hard" failures which require the vehicle to be towed to the dealer. The (P) light is used only to indicate there is a problem with the Park Brake System. The vehicle can be driven to the dealer, but is functioning at a reduced level.

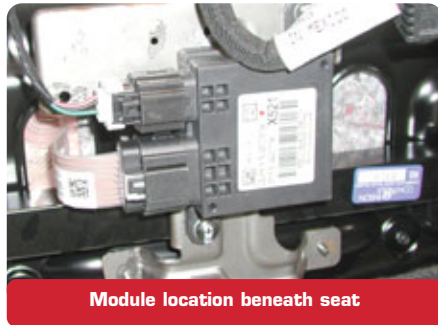
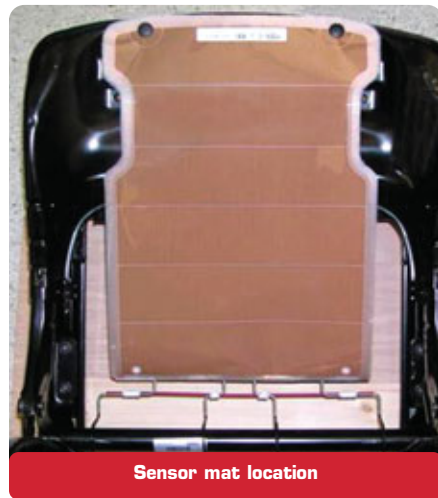
There are two components that make up the PPS – the module and sensing mat. The module and sensing mat are part of the seat.

The module is mounted under the seat pan and the sensing mat is assembled between the seat foam cushion and seat pan. The sensing mat converts the front passenger occupant's size and weight into an electrical signal that the module reads and determines the passenger's classification.

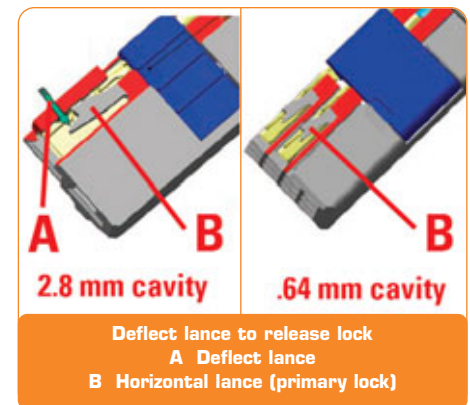
Place the tip of the Terminal Release Tool onto the connector lance and deflect to release the lock. Holding the lance in the released position, slightly pull on the suspect terminal to remove it from the connector housing.

Deflect lance to release lock
A Deflect lance
B Horizontal lance (primary lock)

According to feedback from the service community, the Terminal Release Tool 12094429/J-38125-12A does not effectively release the terminal for this connector family. Terminal Release Tool 15315247/J-38125-553 is more effective for both 0.64 and 2.8 terminal sizes and replaces the current tool.
