EVALUATIONS OF PRESERVATIVE ENGINE OIL CONTAINING VAPOR-PHASE CORROSION INHIBITOR AND A SIMPLIFIED ENGINE PRESERVATION TECHNIQUE

INTERIM REPORT
BFLRF No. 269

By
E.A. Frame
Belvoir Fuels and Lubricants Research Facility (SwRI)
Southwest Research Institute
San Antonio, Texas

December 1990

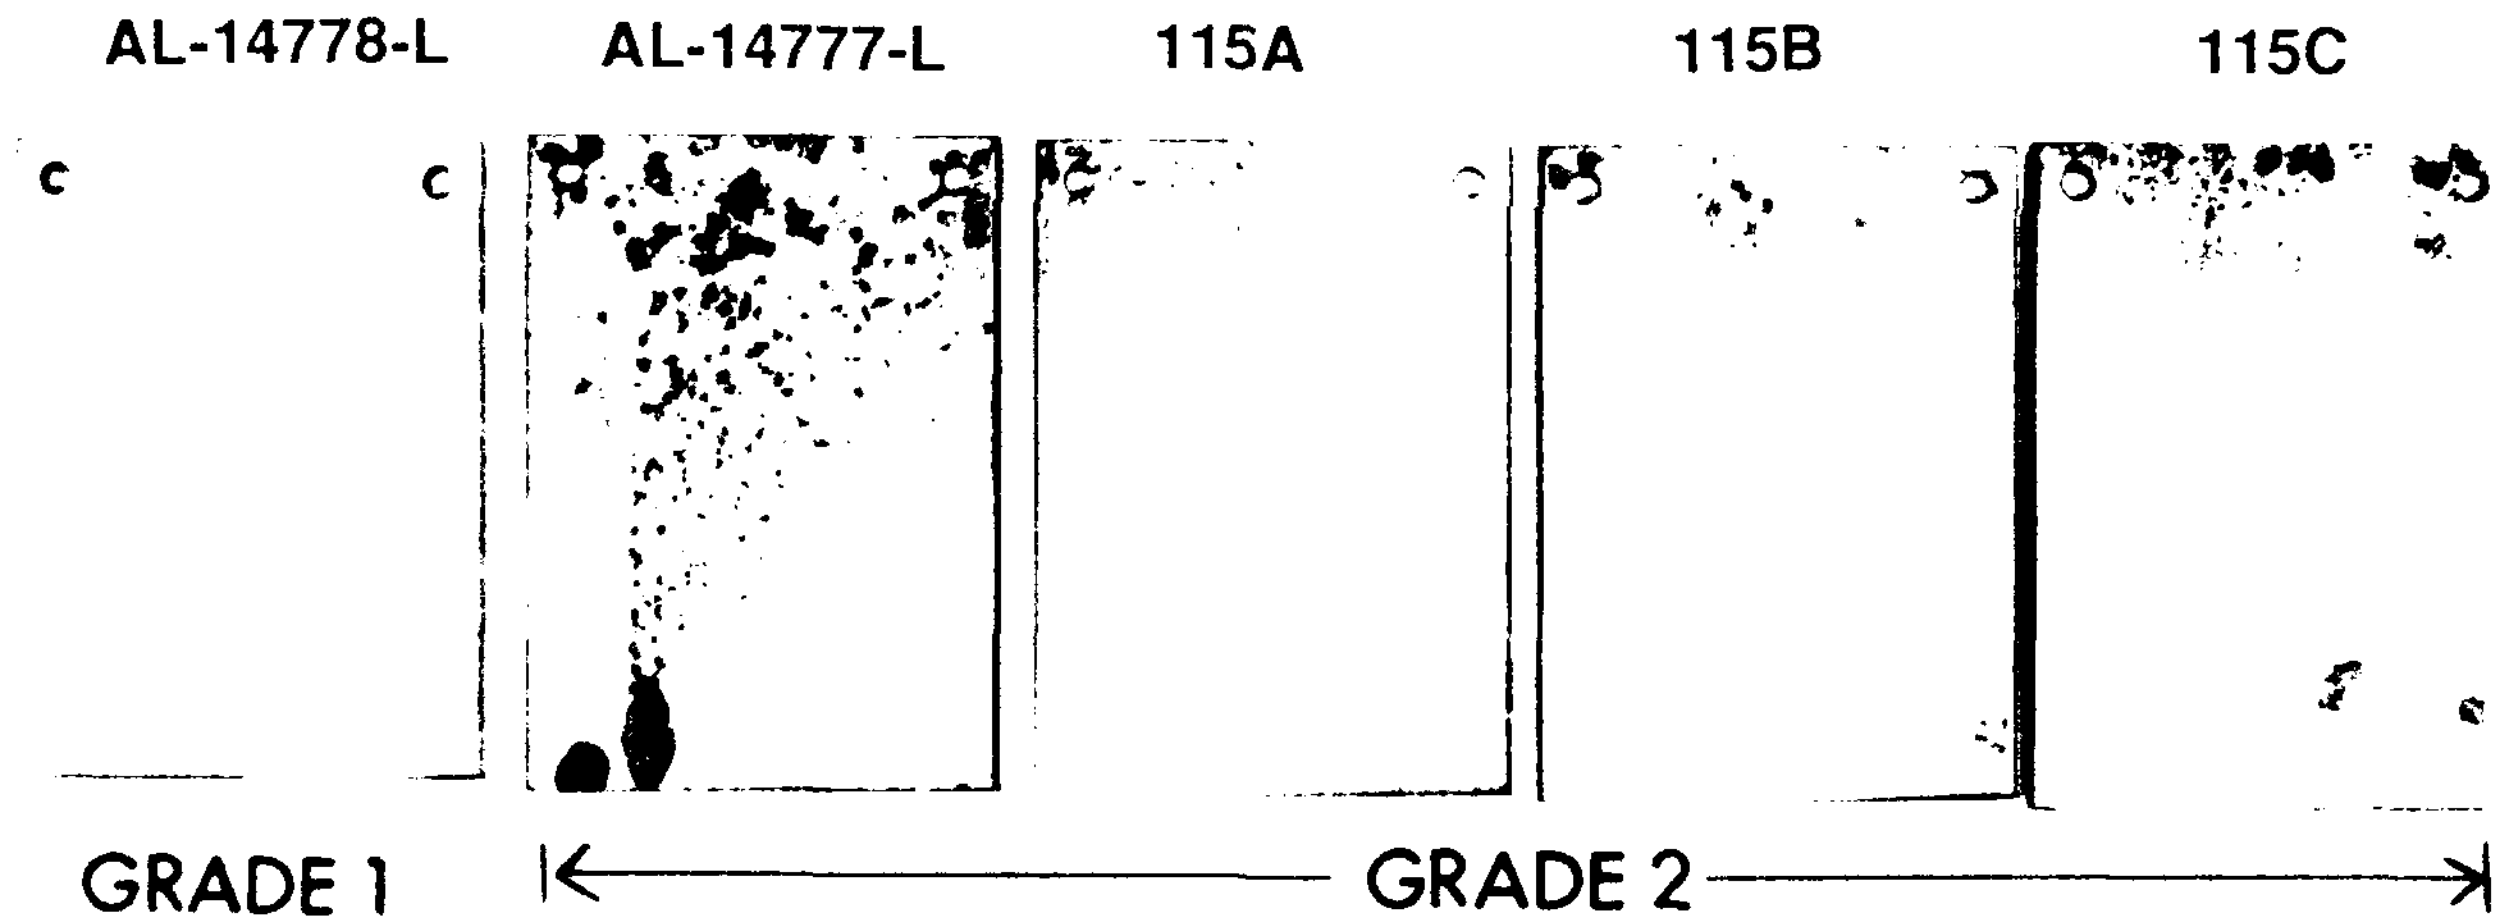
Figure 2. **VPP test results**

The first VCI additive investigated was coded "additive VCI-V." Blends of additive VCI-V at 1, 3, and 5 vol% were made in MIL-L-21260 SAE-30 grade oil (AL-14777). Oil AL-14778 is a MIL-P-46002-qualified product and was included in the VPP test for reference information. TABLE 3 shows the complete physical and chemical inspection properties for the MIL-L-21260 SAE-30 grade oil, the MIL-P-46002 product, and blend 115A (5 vol% VCI-V). Additive VCI-V contributed barium and nitrogen to the finished oil and raised the total base number. TABLE 4 shows the blend composition and test results for the Humidity Cabinet and Vapor Phase Protection (VPP) tests. All oils evaluated passed the 30-day Humidity Cabinet test. Test panels from the VPP test are shown in Fig. 2. In the VPP test, MIL-P-46002 oil passed the grade 1 conditions, while oil blend 115A (5 vol% VCI-V) was a borderline (BL) fail. All other oils failed the grade 1 conditions. Tested at grade 2 conditions, the MIL-L-21260 oil still failed; however, Oil 115A (5 vol% VCI-V) passed, and Oil 115B (3 vol% VCI-V) was a borderline (BL) pass.

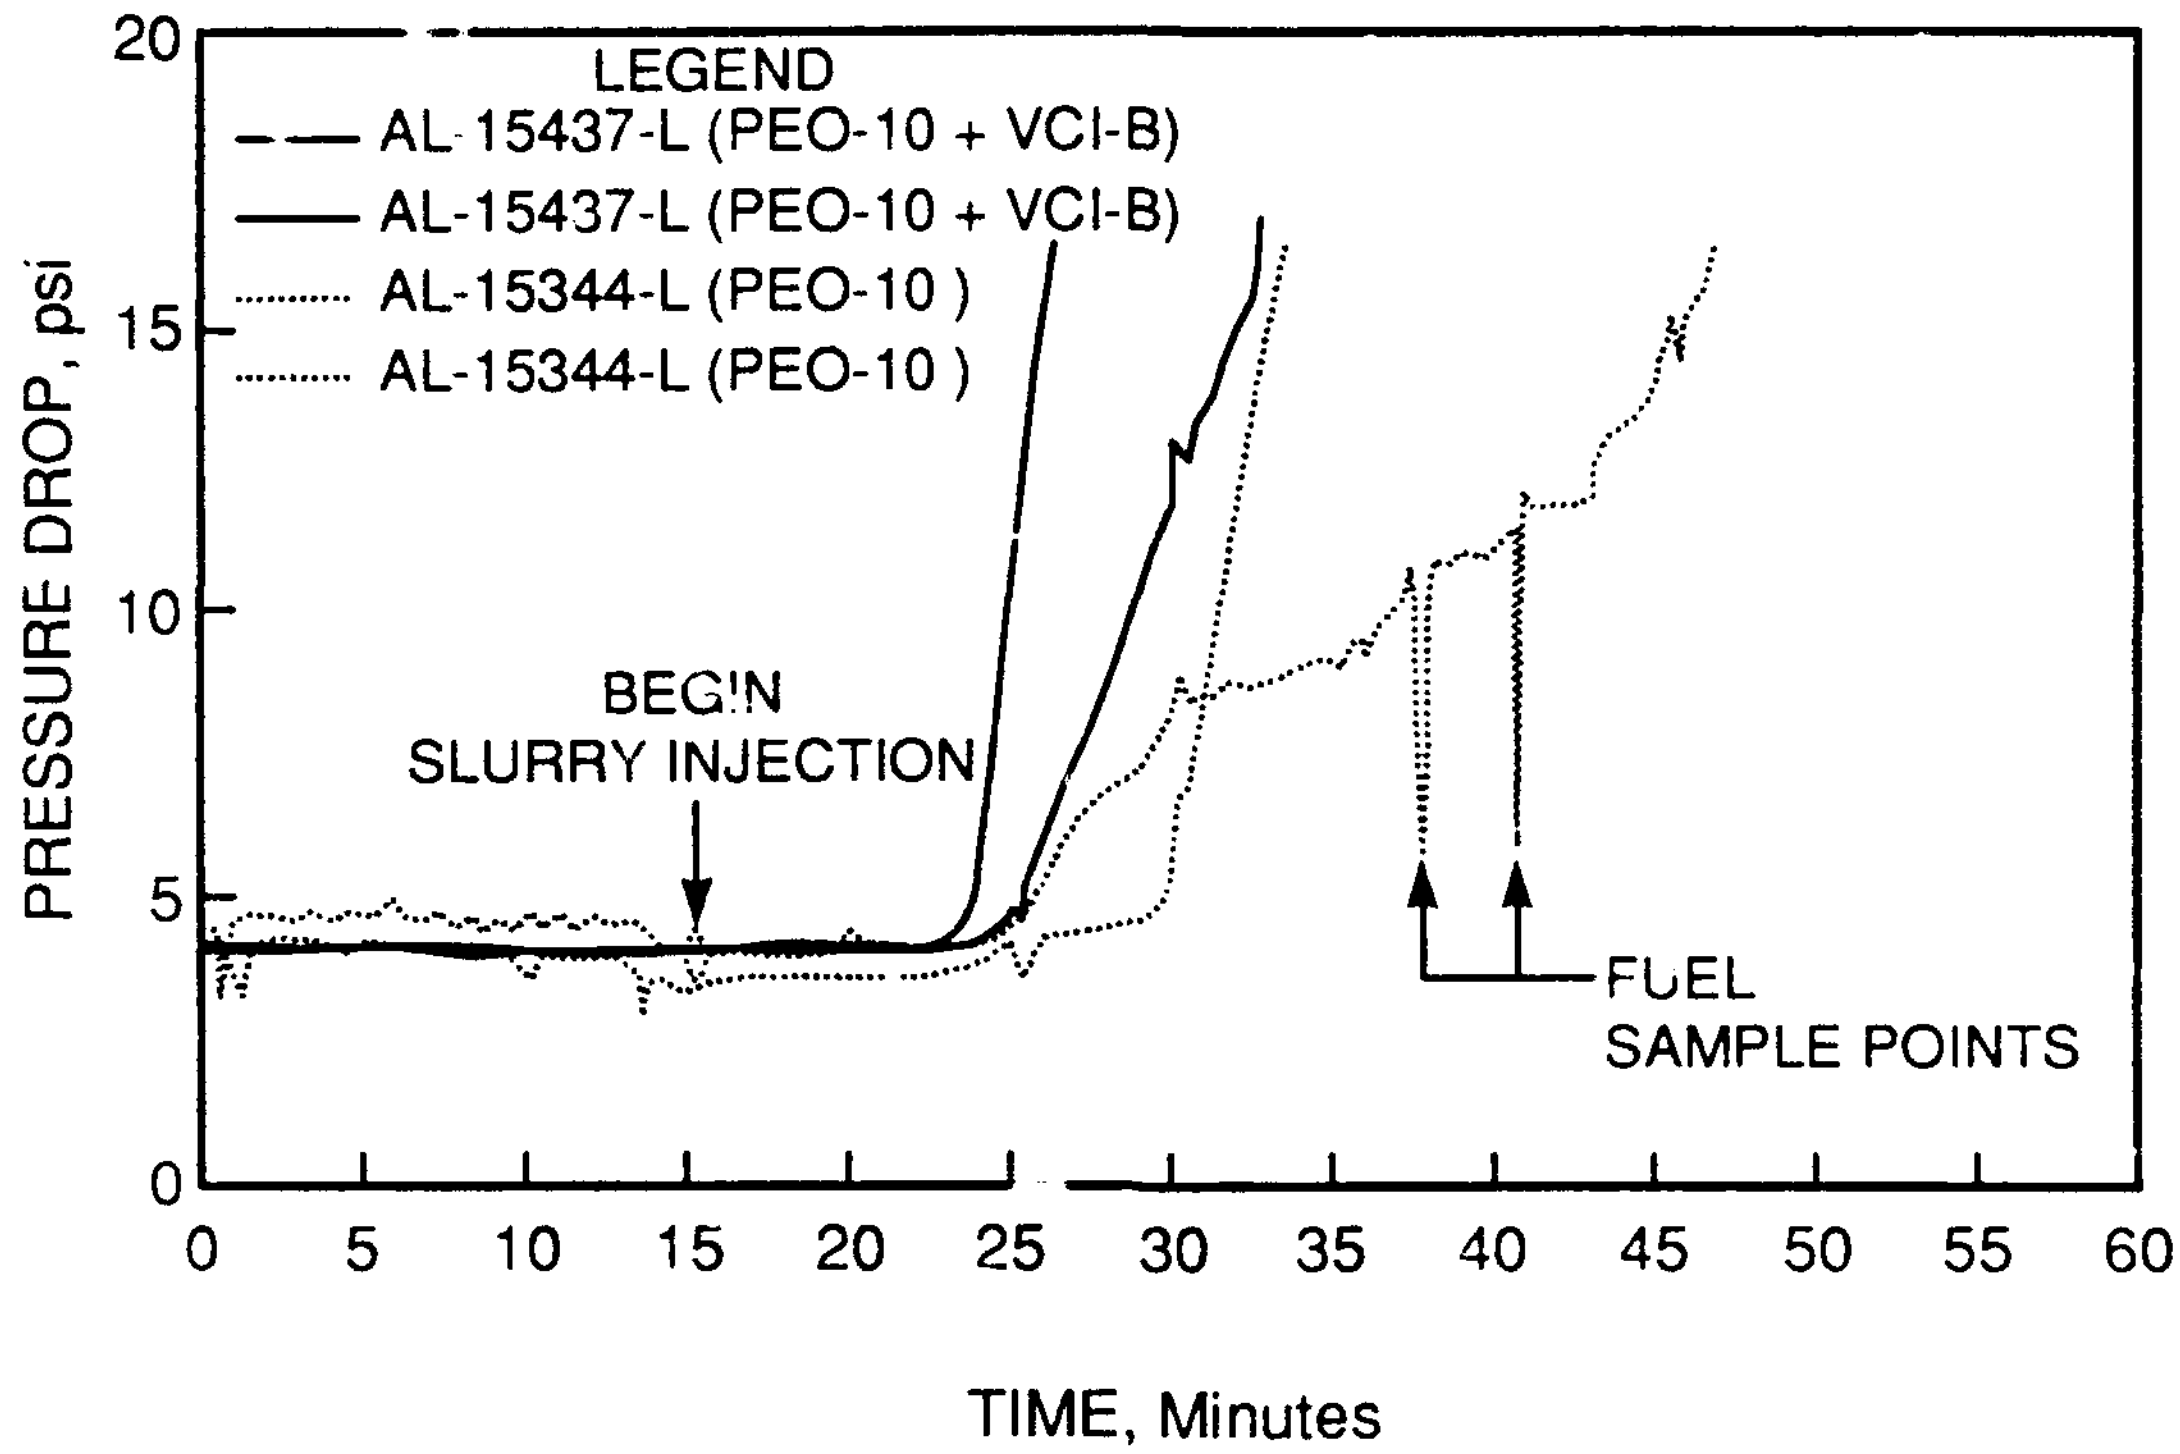
Figure 18. Time to 15-psi pressure drop
(Storage for 1 year at ambient phenolic resin filter)

TABLE 11 shows the summarized results for time to a 15-psi pressure drop. An increased time to the standard 15-psi pressure drop was observed for all fuel filter types in both oil types with increased storage duration. A representative time-to-pressure drop plot is shown in Fig. 18. No substantial effects were observed with respect to the presence of VCI-B additive.

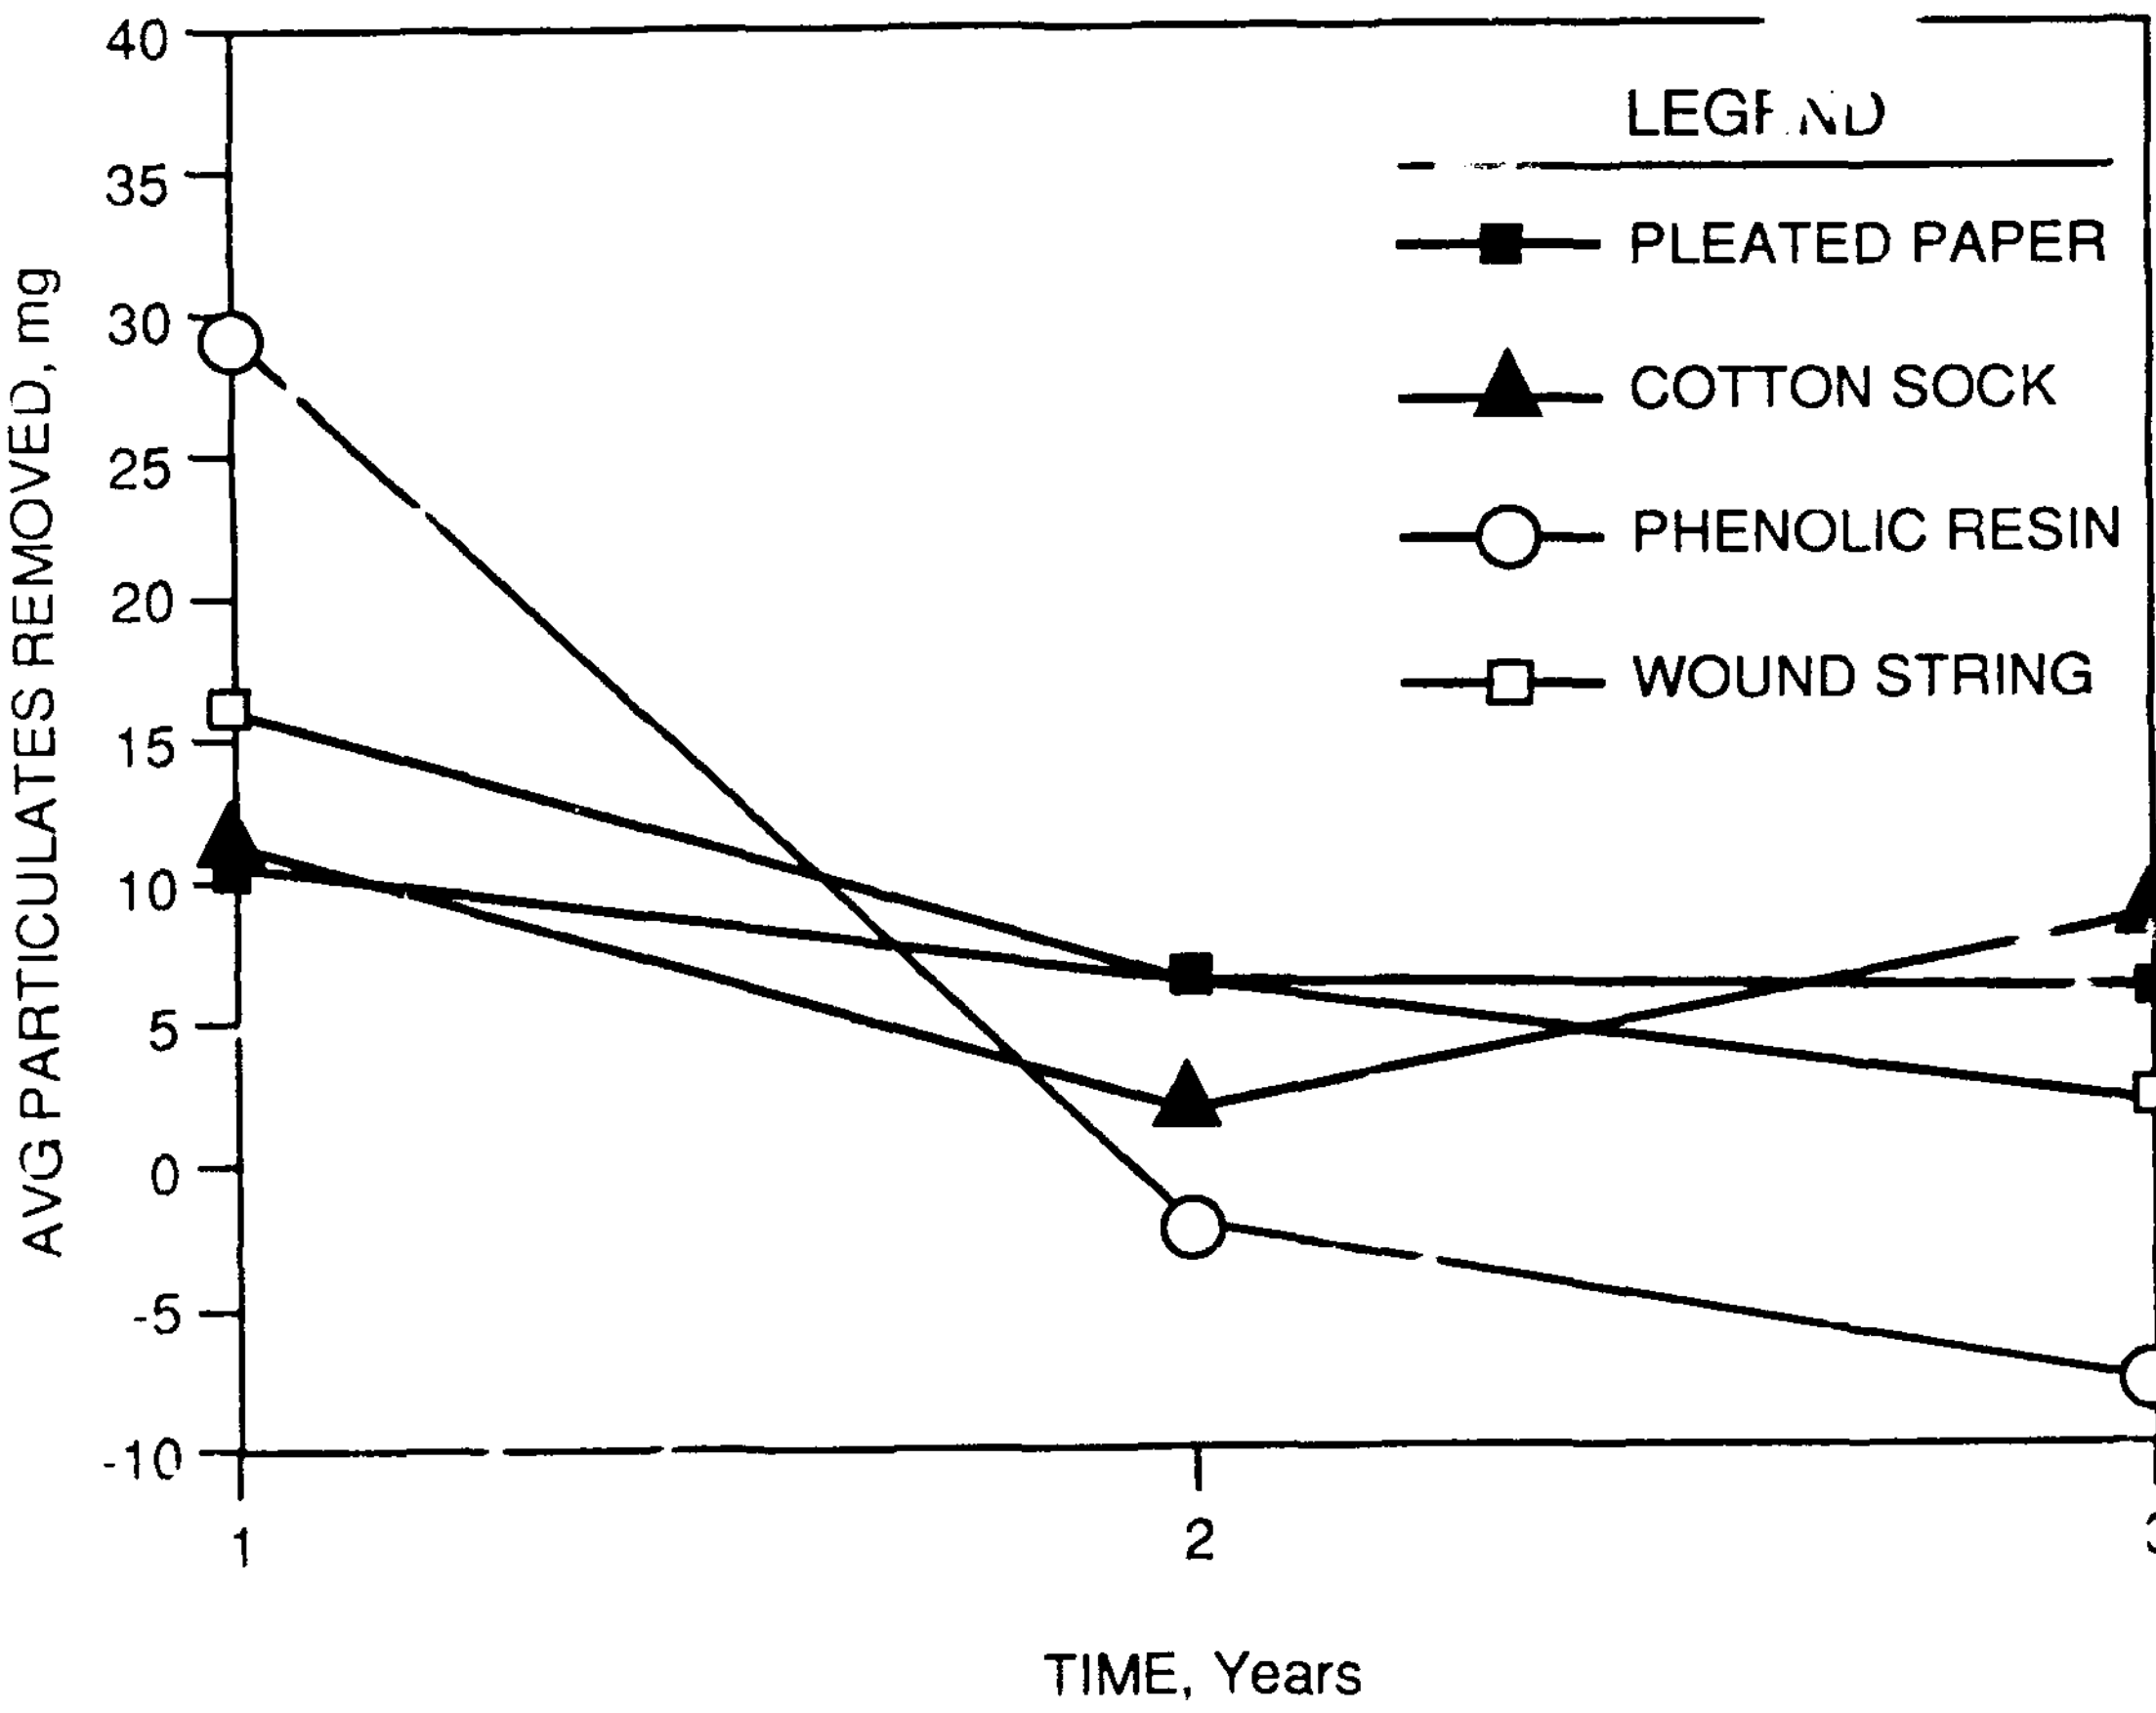
Figure 19. Filter storage evaluation — PEO-10

TABLE 12 and Figs. 19 and 20 show average particulates removed/unit time after 1, 2, and 3 years of storage. The most evident effect was a decrease in average particulates removed with increased storage duration for all four filter types. At 3 years the pleated paper and cotton sock filters stored in PEO-10 had slightly better particulates removal than those exposed to VCI-B, while the phenolic resin and wound string had better particulate removal when VCI-B was present. For years 2 and 3, the phenolic resin filters stored in PEO-10 actually added material to the particulate content. In summary, after 2 and 3 years of exposure to either oil, filter particulate removal was substantially decreased.

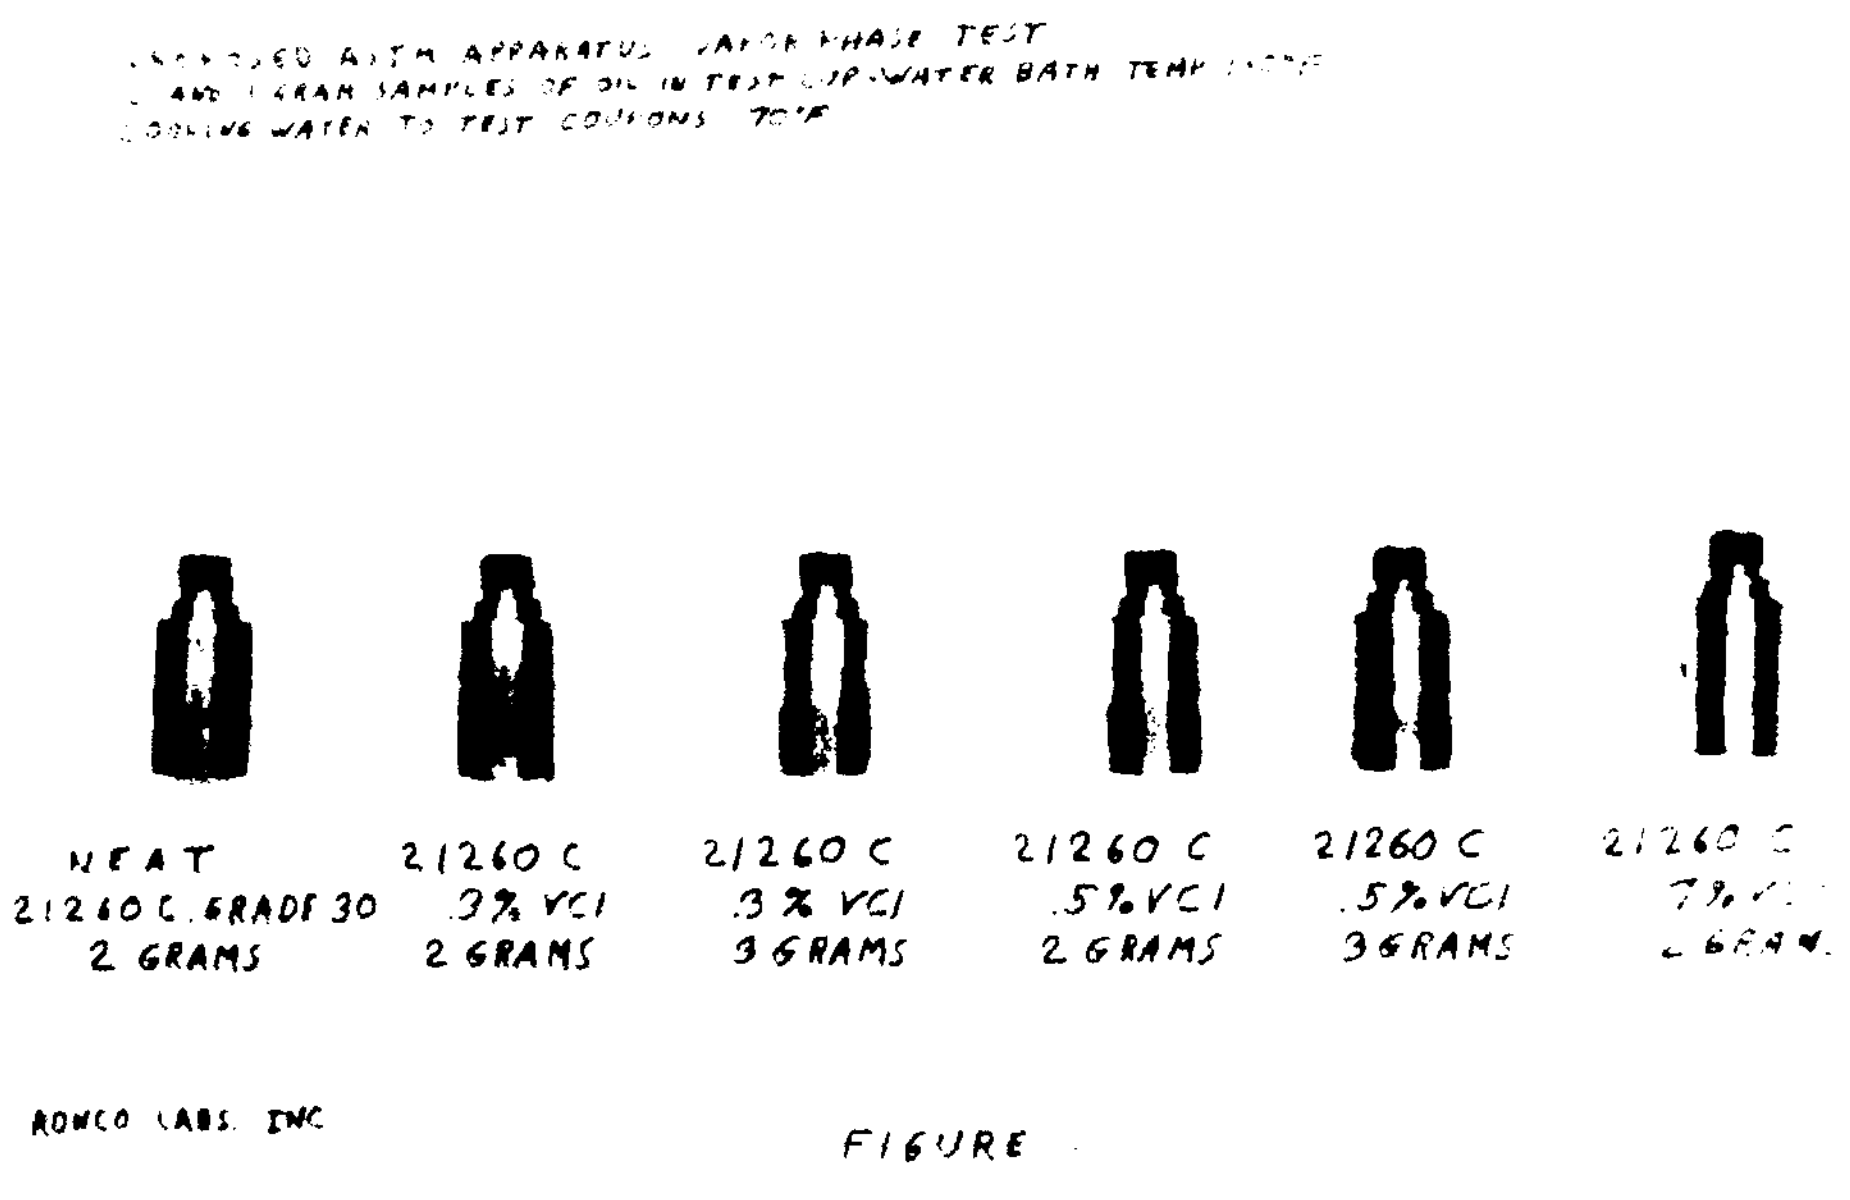
Figure 4

One reaction product tested successfully in concentrations as low as .3% (weight). While the .3% coupon was not corrosion-free, the increment of improvement over the neat 21260 was highly significant. Testing at the .5% (weight) level showed additional improvement over the .3%, and the .7% (weight) formulation was completely free of rust (Figure 4).

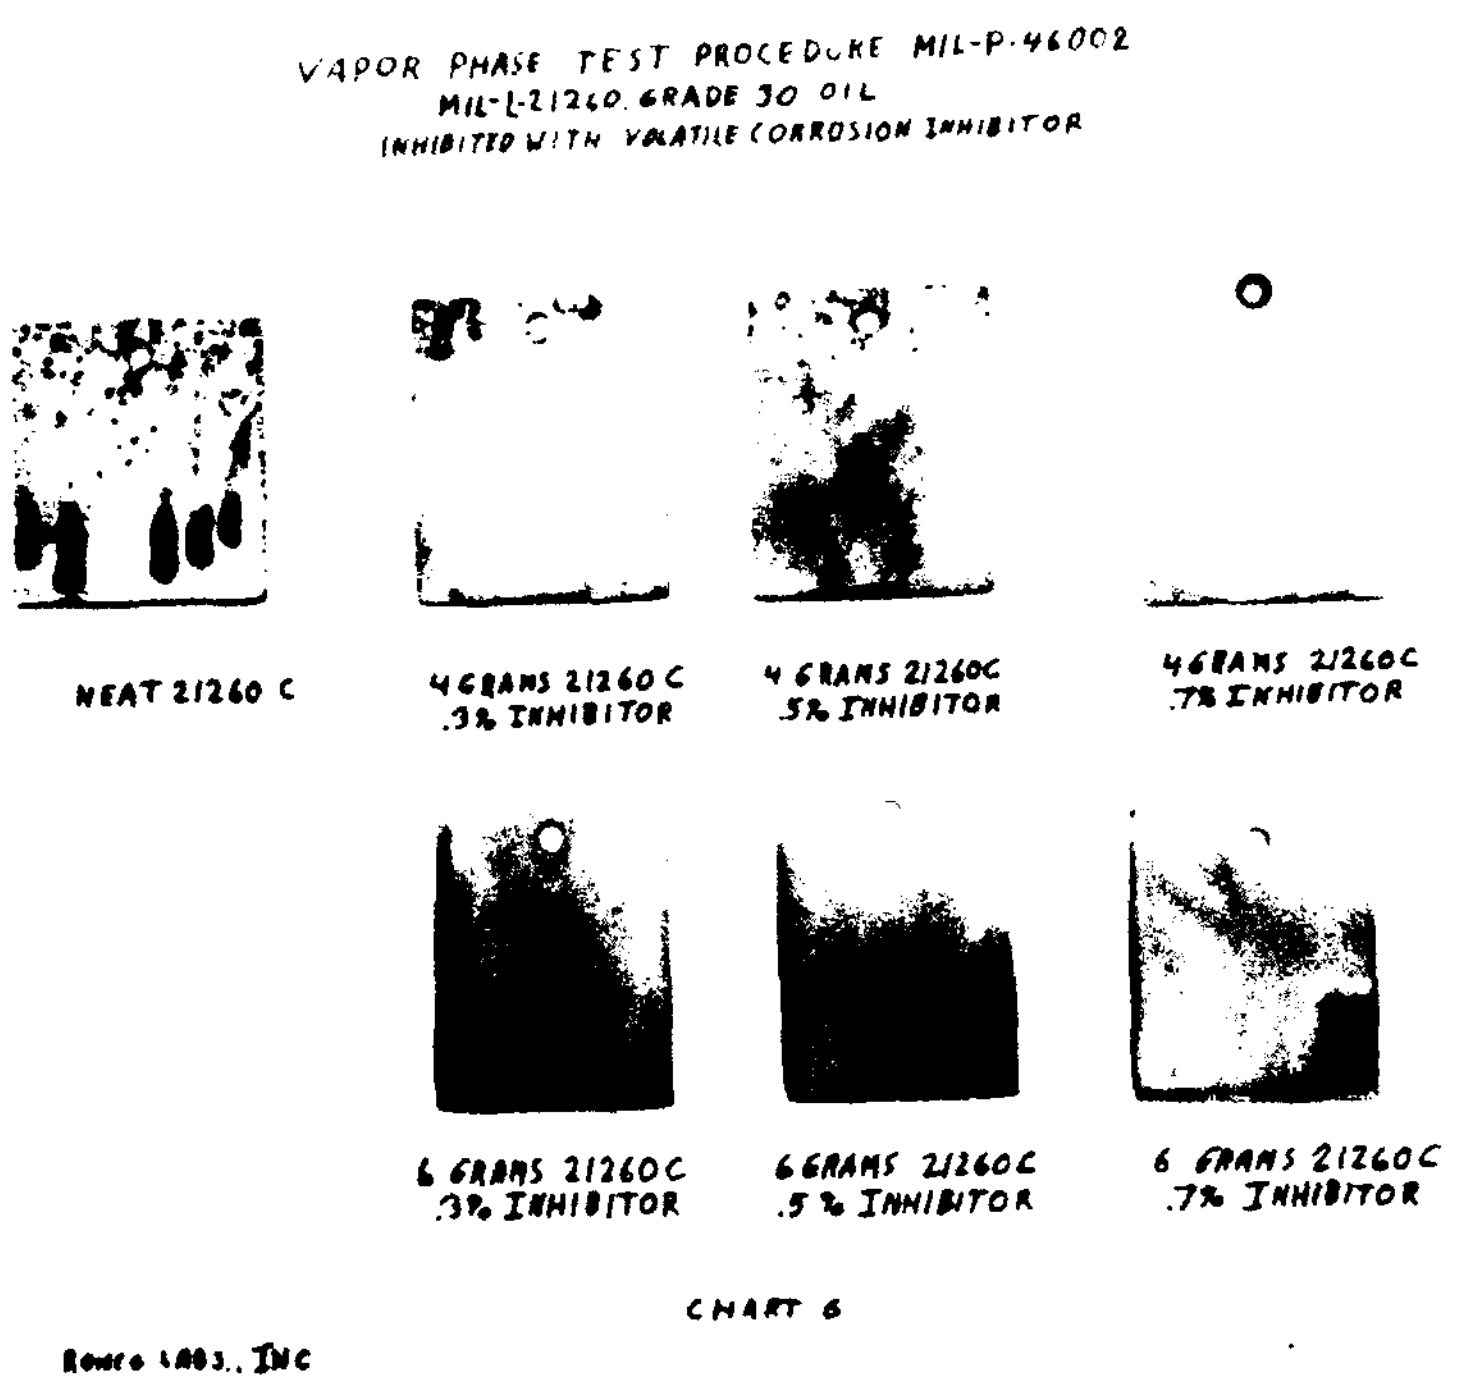
Figure 5

At this juncture, it was suggested by Southwest Research Institute that we test the formulation in the procedure as noted in the MIL-P-46002. It was indicated that our material at .3% to .7% was not expected to perform in this test situation as would a qualified MIL-P-46002 at 6% to 8% (weight) concentration of the VSI inhibitor. However, it was suggested that there should be some improvement over the performance of the neat 21260. The test was performed and the results indicated (Figure 5). It can be seen that the increment of improvement even at .3% over the neat 21260 is dramatic. Four grams of test oil were used, which corresponds to the requirements for Grade 2 of MIL-P-46002. However, when we ran this test using 6 grams of oil, the results are close to passing the vapor phase test of MIL-P-46002. Considering the difference in viscosity of the Grade 2 of MIL-P-46002 and the Grade 30 of 21260, I suggest the correct sample size for the 21260 should be about 7 grams. (It cannot be seen on Figure 5, but there are a number of very tiny dots of rust on the 6-gram sample coupon).
