# HDR Brachytherapy

Patient Safety Focused Quality Assurance

# Module 2.9: HDR unit malfunction (USA)

# Lessons to be Learned from Misadministrations

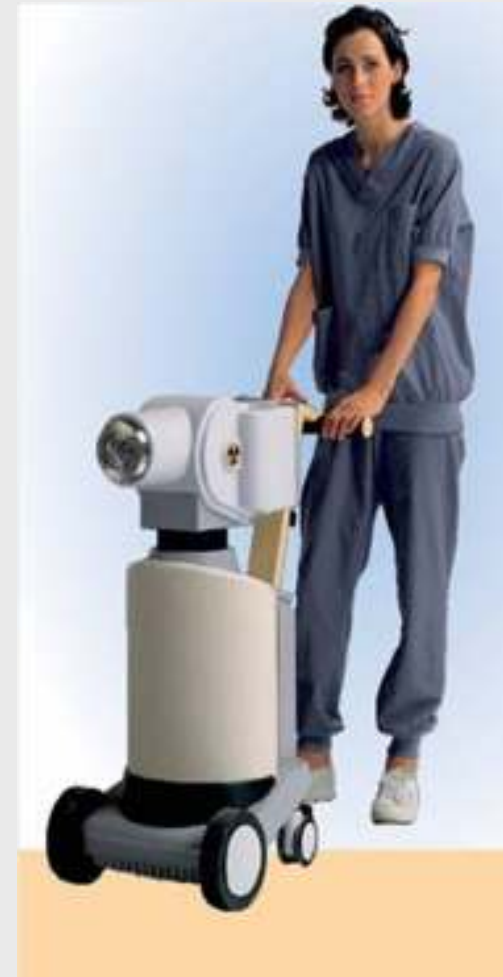
- A small and mobile source housing installed in shielded treatment room
- Remote control console
- Source is  $^{192}\text{Ir}$ , with nominal activity of 10.0 Ci
- Source is attached to a wire
  - can be extended under remote control through one or more catheters in succession into the patient
- A second wire with a dummy source
  - used first to verify the pathway through the catheter and to verify positions etc...

Example of HDR unit

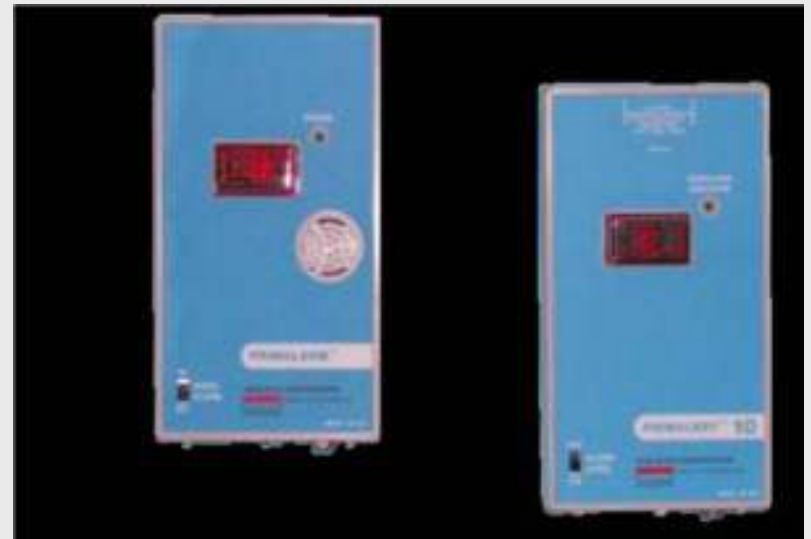
Typical room monitor system

- An area radiation alarm indicated high radiation levels, but was ignored
- Both sound and sign alarm
- The staff reported that the alarm “often malfunctioned” and were used to ignoring it

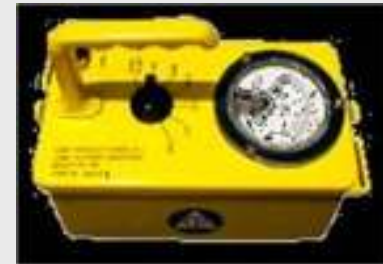
Typical hand held meters

- A survey meter was available but was not used to confirm or rule out the area alarm's signal
- The HDR console reported that the source was "safe"
- The patient was transported back to her nursing home

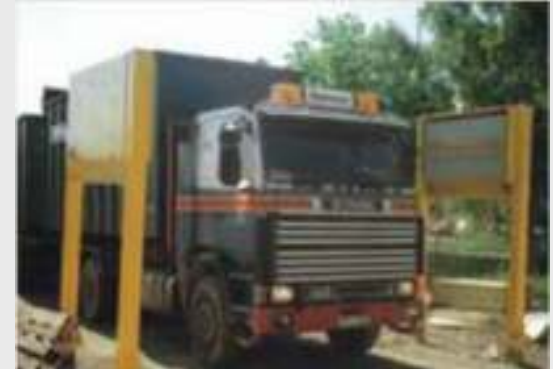
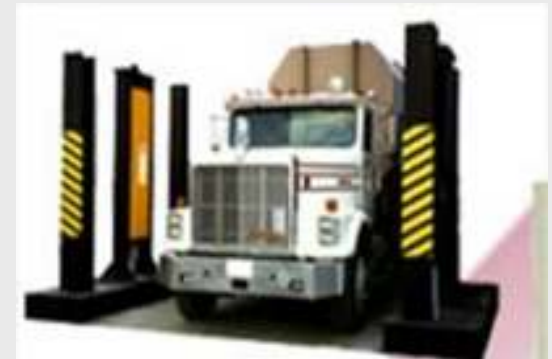
Typical vehicle meters

- A radiation detector at the Warren facility identified radiation emissions from the trailer, and the facility ordered the trailer to return to Carnegie
- The trailer remained at the Carnegie facility until Monday, 30 Nov. 1992

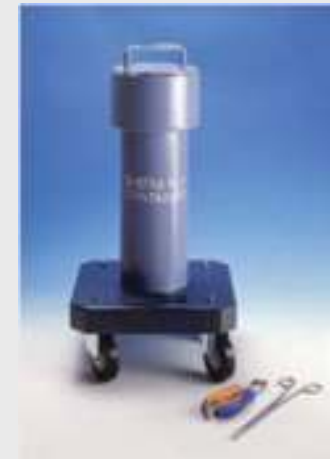
Typical emergency container
