A Collins S-Line Troubleshooting and Repair Adventure

Gary White – W5GW

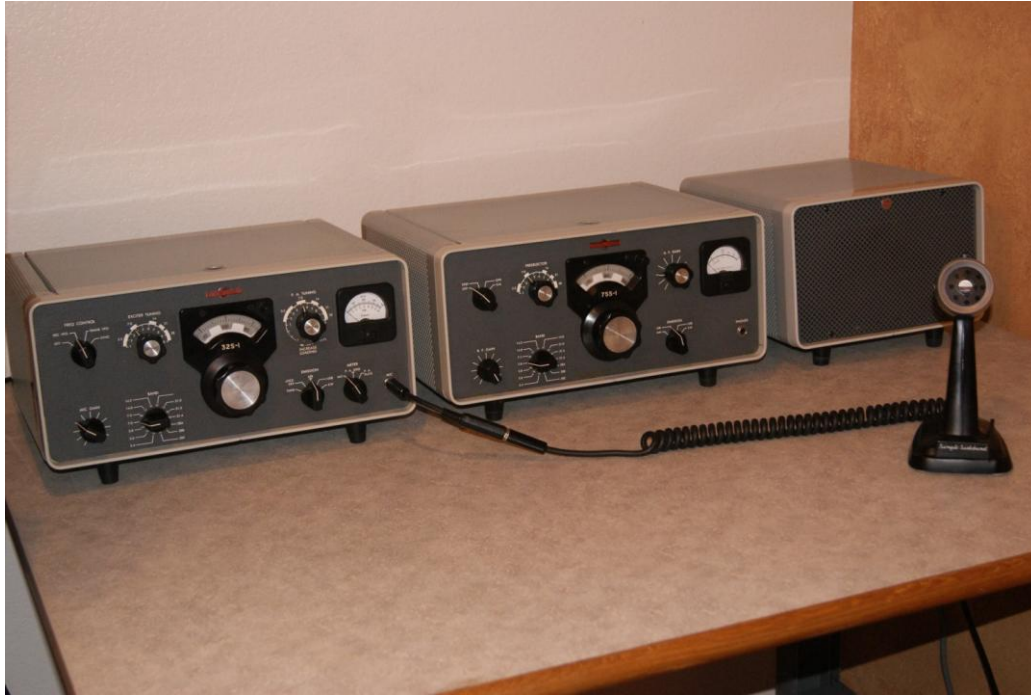
As I gain experience with my S-Line I'm sure there will be other tweaks and adjustments to be made, but that is the nature of operating equipment that is over 50 years old. Following is a picture of my handsome S-Line station made shortly after my second contact was finished.

Epilogue On 9 January 2012 cables were fabricated from RG-58 to allow the 32S-1 and 75S-1 to work together as a transceiver. On 10 January 2012 contacts were made on 40 Meters LSB. The first contact was with a local station (W5ALI – Bruce). Two other contacts were soon made with stations in Arkansas: (KA5RHK – Ken (who I chat with frequently on AM), and WX5J – Nick). Good audio reports were obtained and the S-Line performed flawlessly producing about 125 Watts of peak output power as measured on my Palstar antenna tuner's peak power meter.
