USACERL Technical Report FM-93/01

Corrosion Mitigation in Civil Works Projects:
Minimization of Cavitation Repair in Turbines

Application of Thermal Spray and Ceramic Coatings and Reinforced Epoxy for Cavitation Damage Repair of Hydroelectric Turbines and Pumps

by
Richard Ruzga
Paul Willis
Ashok Kumar

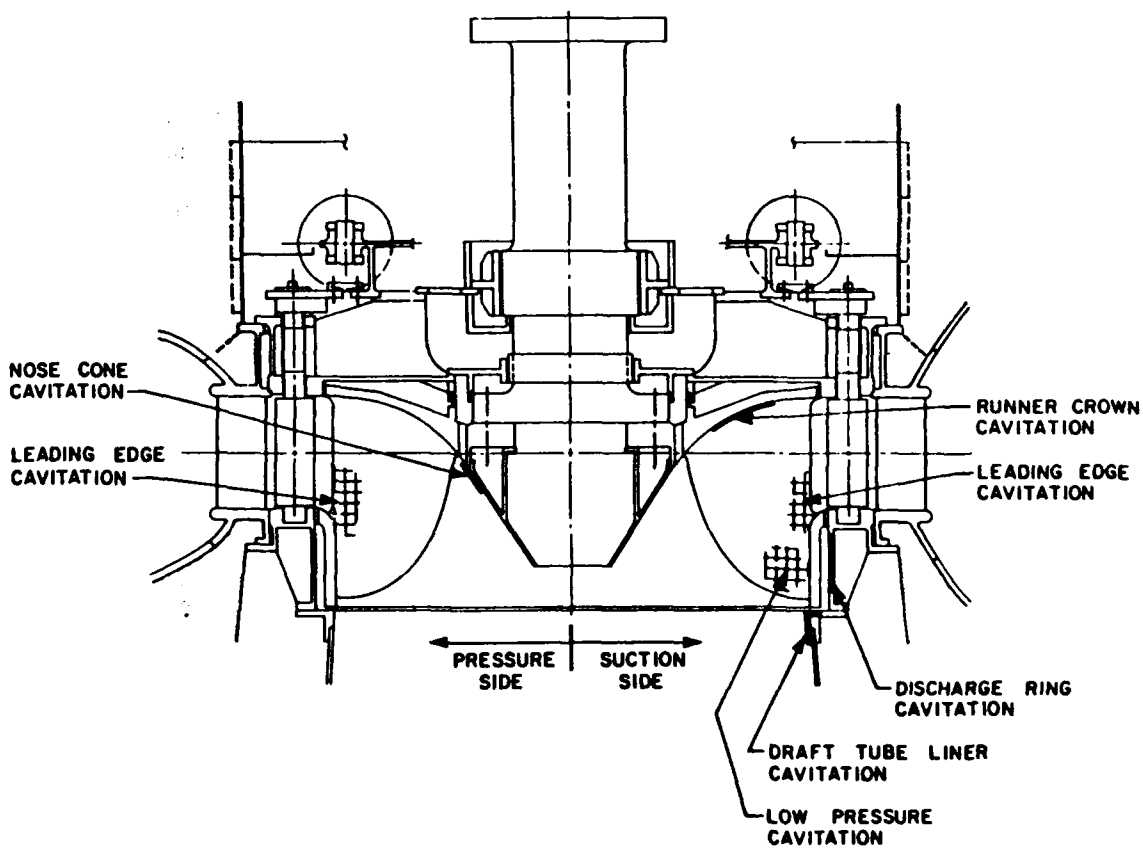
Figure 1. Typical Areas of Cavitation in Francis Turbines. (Copyright ©1986. Electric Power Research Institute. EPRI AP-4719. *Cavitation Pitting Mitigation in Hydraulic Turbines*. Reprinted with permission.)

Cavitation damage can occur to components of all reaction-type turbine equipment, including fixed-blade propeller turbine units, adjustable blade propeller turbines, and reversible Francis pump-turbines. Impulse turbines generally do not experience cavitation but are exposed to erosion. Areas on Francis units where cavitation damage can be expected to occur (Figures 1 and 2) include:

- runner blades - suction side, near band and trailing edge
- runner blades - leading edge, near the band on both the suction side and the pressure side
- runner blades - trailing edge, on suction side
- runner blades - near crown (leading edge)
- the air vents in the crown on the runner
- the discharge ring opposite the runner band
- below the band on the draft tube liner
- wicket gates sides.⁷

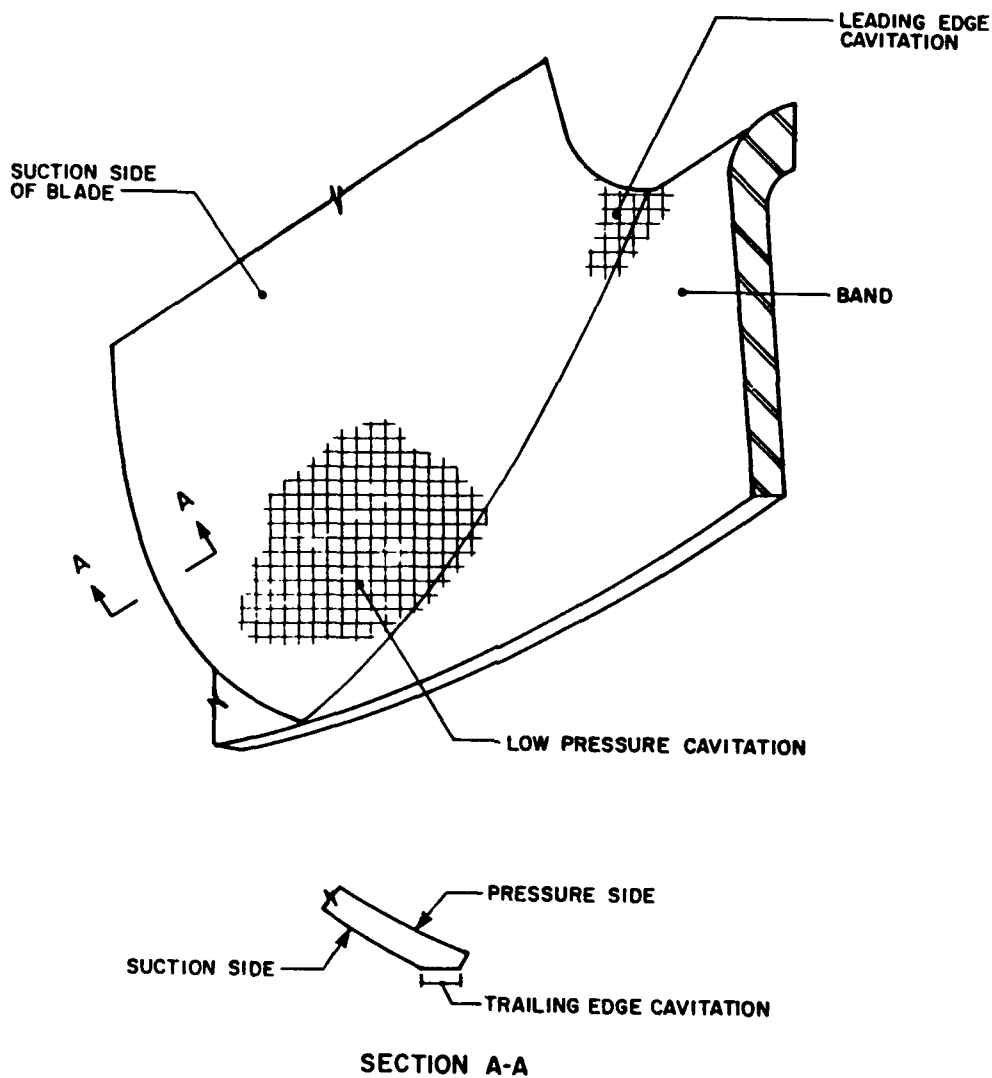
Figure 2. Areas of Cavitation on the Runner in Francis Turbines. (Copyright ©1986. Electric Power Research Institute. EPRI AP-4719. *Cavitation Pitting Mitigation in Hydraulic Turbines*. Reprinted with permission.)

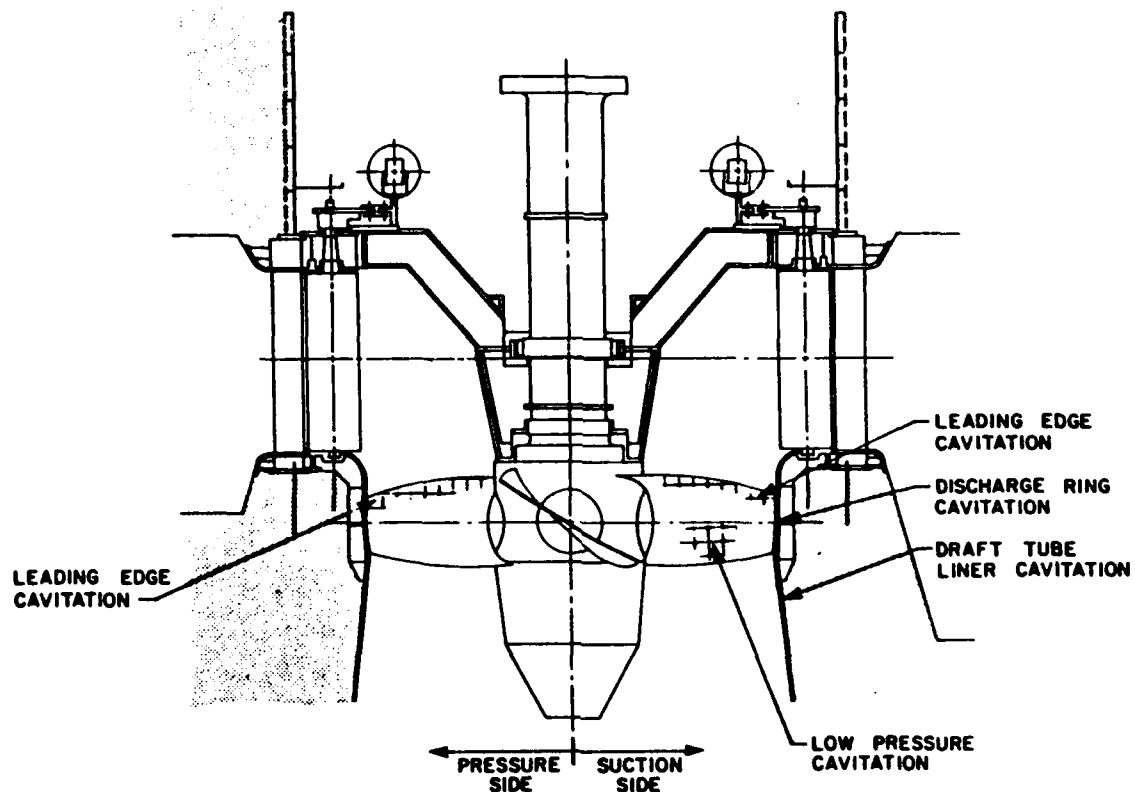
Figure 3. Typical Areas of Cavitation in Propeller Turbine. (Copyright ©1986. Electric Power Research Institute. EPRI AP-4719. *Cavitation Pitting Mitigation in Hydraulic Turbines*. Reprinted with permission.)

Areas on propeller units where cavitation damage can occur (Figures 3 and 4) include:

- runner blades - suction side from the centerline to the trailing edge
- runner blades - leading edge, both the suction side and the pressure side
- runner blades - trailing edge, pressure side
- runner blade - suction side of the peripheral edge
- near the runner periphery, suction side
- the runner hub, discharge ring, and draft tube liner.⁸

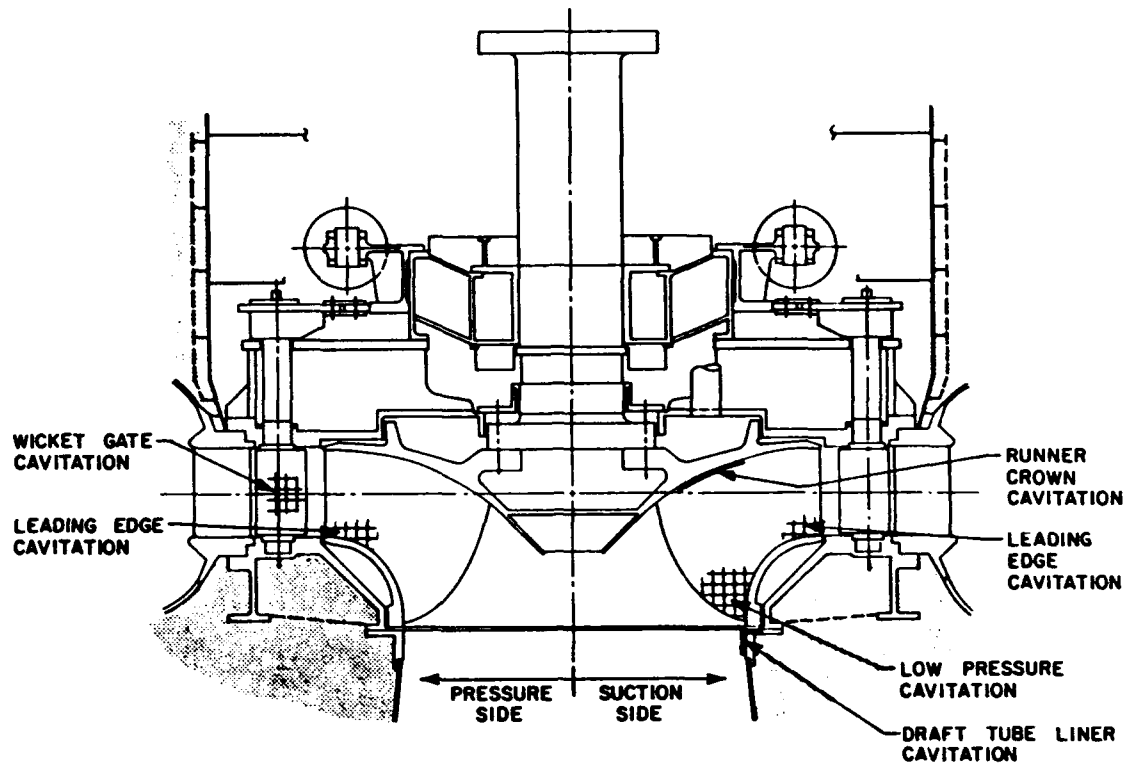
Figure 5. Typical Areas of Cavitation in Pump Turbines. (Copyright ©1986. Electric Power Research Institute. EPRI AP-4719. *Cavitation Pitting Mitigation in Hydraulic Turbines*. Reprinted with permission.)

Areas on pump-type turbines where cavitation damage can occur (Figures 5 and 6) include:

- runner blades - suction side, near and at the pump leading edge
- runner blades - pressure side, at pump leading edge
- runner blades - both the suction side and pressure side, near the band at turbine leading edge
- crown, or runner blade, turbine leading edge near crown
- the discharge ring near the runner
- under the bottom of the band on the draft tube liner
- below the band on the draft tube liner
- wicket gates sides.⁹

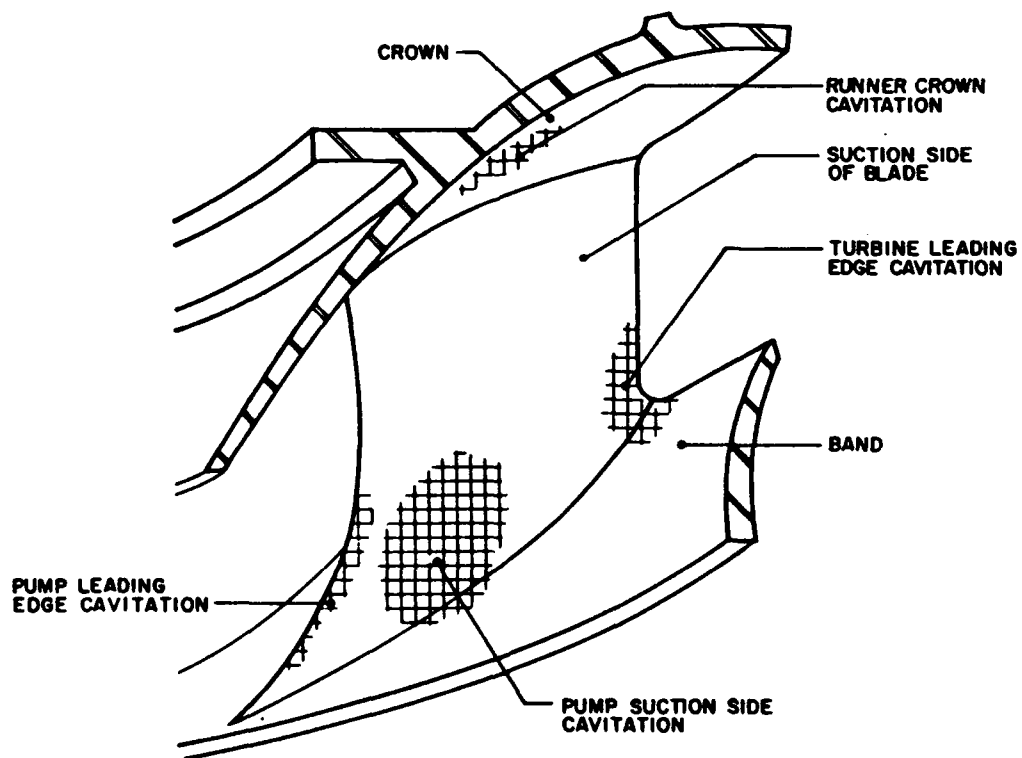
Figure 6. Areas of Cavitation on the Runner in Pump Turbines. (Copyright ©1986. Electric Power Research Institute. EPRI AP-4719. *Cavitation Pitting Mitigation in Hydraulic Turbines*. Reprinted with permission.)

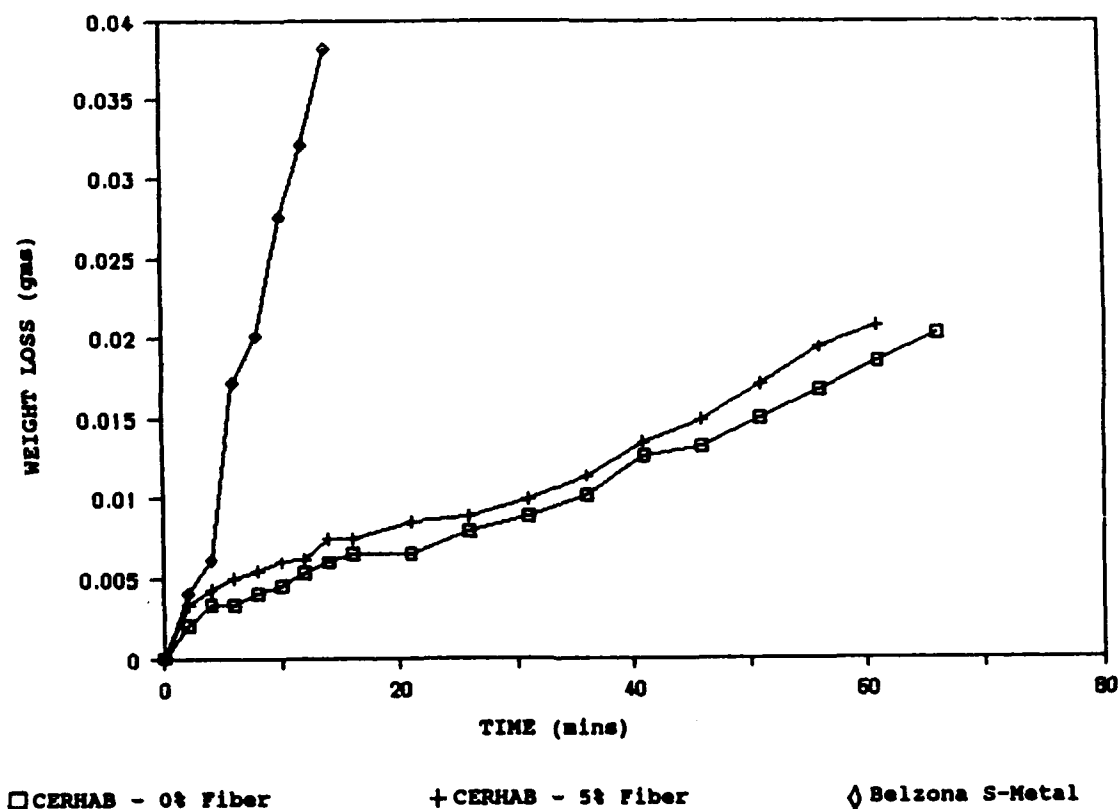
Figure 7. Vibratory Cavitation Test Results Comparing CERHAB With 0% and 5% Fiber to Epoxy.

The results of the shop-sprayed CERHAB coating were mixed. Cavitation resistance testing was performed using a vibratory cavitation unit. A commercially available reinforced epoxy was tested with formulations of CERHAB that had different weight percents of added fibers. Figures 7 through 9 contain the data of CERHAB with fiber additions of 5, 7, and 10 percent, respectively. The tests were also performed with a reinforced epoxy and CERHAB with no fiber added for baseline information. Figure 7 shows that after approximately 10 minutes of testing, the epoxy had lost more than 6 times the weight of either of the two CERHAB compositions. The CERHAB composition with no fiber reinforcing performed slightly better during the entire test. It appears that the added fracture toughness imparted to

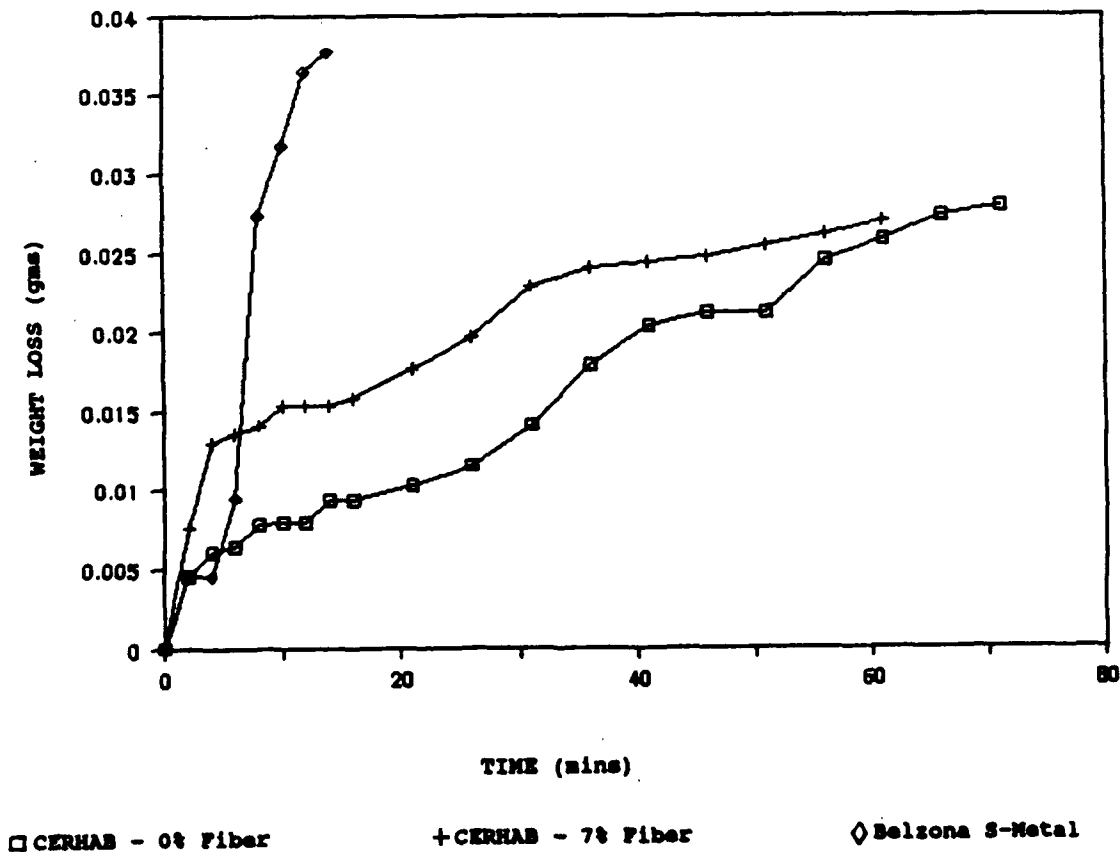
Figure 8. Vibratory Cavitation Test Results Comparing CERHAB With 0% and 7% Fiber to Epoxy.

the enamel by the fibers has little effect on the coating's cavitation resistance. Figures 8 and 9 show similar cavitation resistance behavior for the coatings. It is interesting that as the weight percent of the fiber reinforcement increases, the resistance to cavitation damage slightly decreases. It appears that there may be an optimum fiber weight percent to give maximum performance, as is true with many fiber reinforced coating systems.

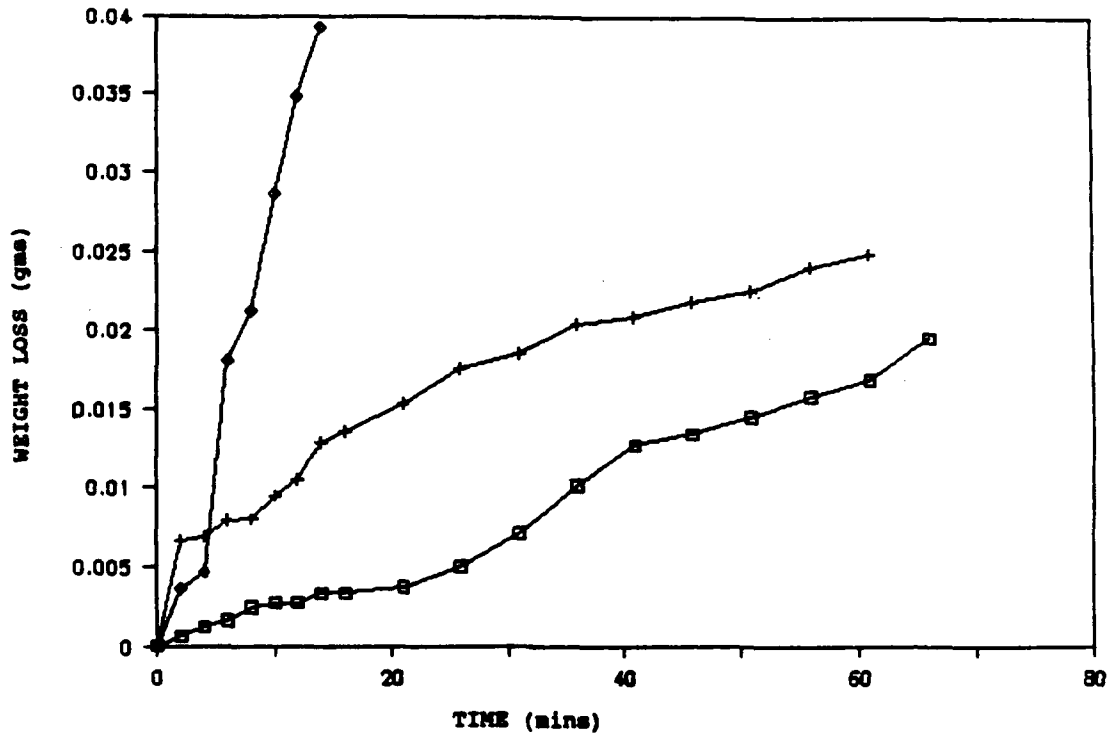
□ CERHAB - 0% Fiber + CERHAB - 10% Fiber ◇ Belzona S-Metal

Figure 9. Vibratory Cavitation Test Results Comparing CERHAB With 0% and 10% Fiber to Epoxy.

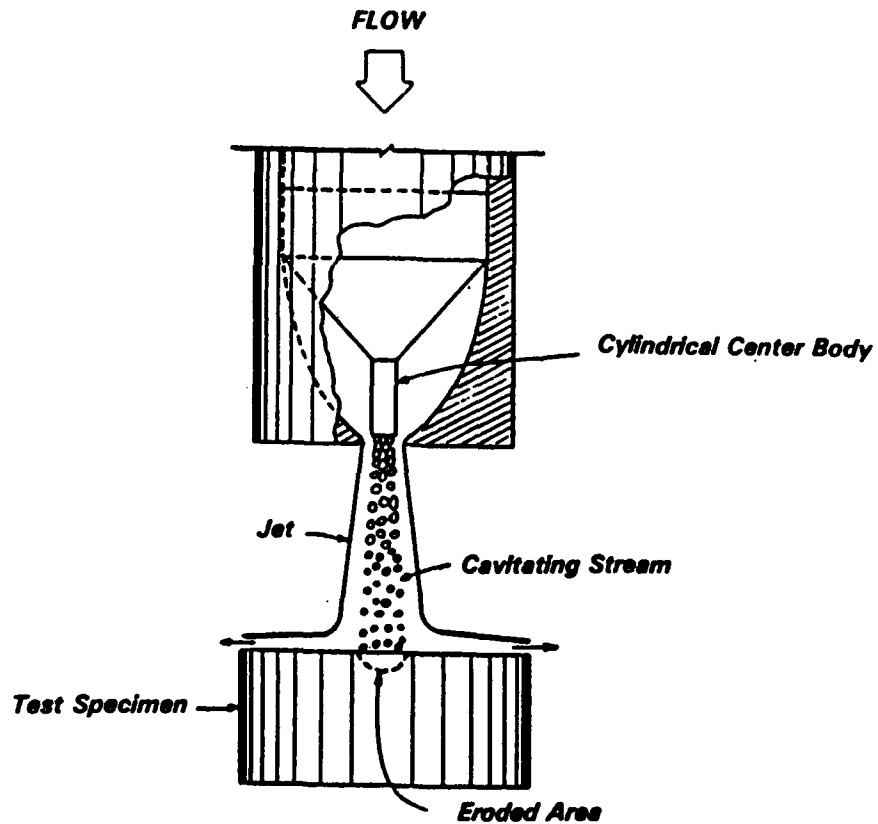
Figure 10. The Tennessee Valley Authority Cavitating Jet System.

The cavitating jet system, Figure 10, operated by the Tennessee Valley Authority's (TVA's) Engineering Laboratory consists of a cartridge-style filter, a three-plunger positive displacement pump rated for a flow of 3 gallons per minute (GPM) at 10,000 pounds per square inch (psi), and a 25 horsepower electric motor. The unit has a flow control valve, to set the operating flow and pressure, an unloading valve, to temporarily interrupt a test for specimen removal and weighing, and a bypass valve, as a safety backup and for pressure relief. Gauges monitor the inlet and discharge pressures during operation and record the accumulated operating hours for maintenance records. The test chamber is constructed of stainless steel, 18 in. x 18 in. x 18 in., and has windows for monitoring the specimens.

The TVA has conducted a limited number of tests on highly resistant materials at 10,000 and 6000 psi. A 4000 psi pressure was used as a standard for accelerated cavitation tests with base materials and weld overlays. It was found that soft coatings experienced mechanical damage, therefore they were subjected to a reduced pressure of 2000 psi. The test samples were located approximately 0.875 in. from the nozzle tip.

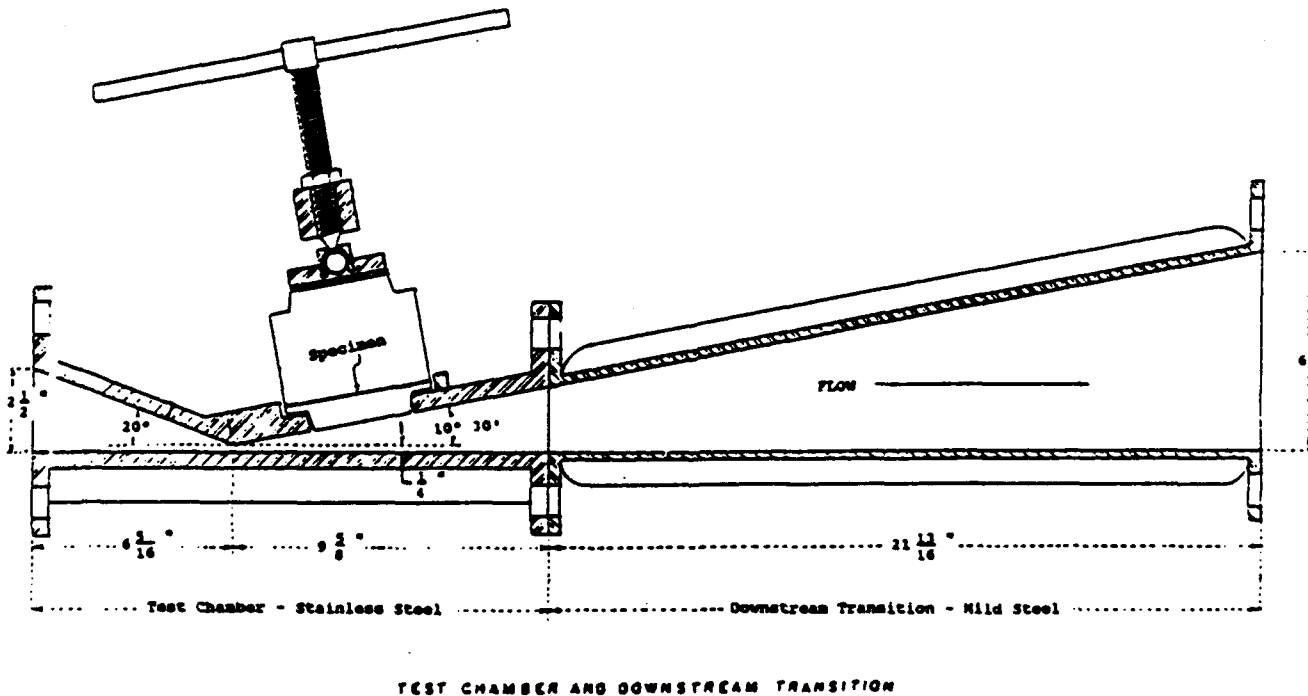
Figure 11. U.S. Bureau of Standards Venturi-Flow Cavitation Testing Unit.

The venturi-flow system, Figure 11, is capable of testing metallic coated as well as concrete specimens. The inlet pressure is controllable and directly affects the water velocity that flows through the throat. By adjusting the inlet pressure, a variety of cavitating environments may be simulated.

Two coating systems were tested in the venturi-flow testing unit. The first coating system consisted of a 1- to 2-mil thick bond coat with a composition of 20 percent-Al, 80 percent-NiAl. A second wire-fed flame spray metallized coating of 20 percent-Cr, 35 percent-Ni, 45 percent-Fe was applied with a thickness
