Project Report 873b.3(1)

Archaeological Building Recording and Watching Brief: Manor Oaks Farm, Manor Lane, Sheffield, South Yorkshire

Volume 1: Text and Illustrations

Manor Oaks Farm, Manor Lane, Sheffield, South Yorkshire

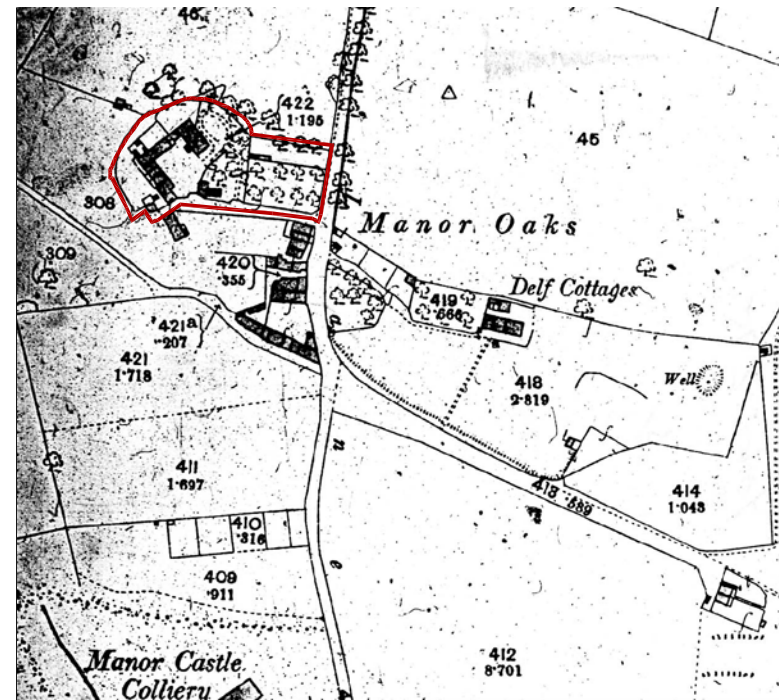
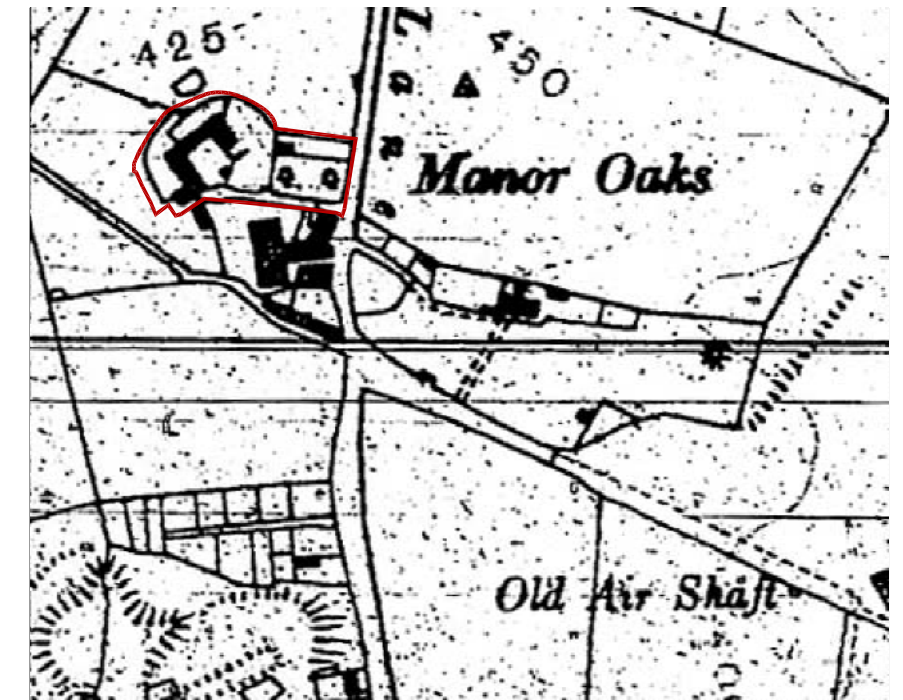
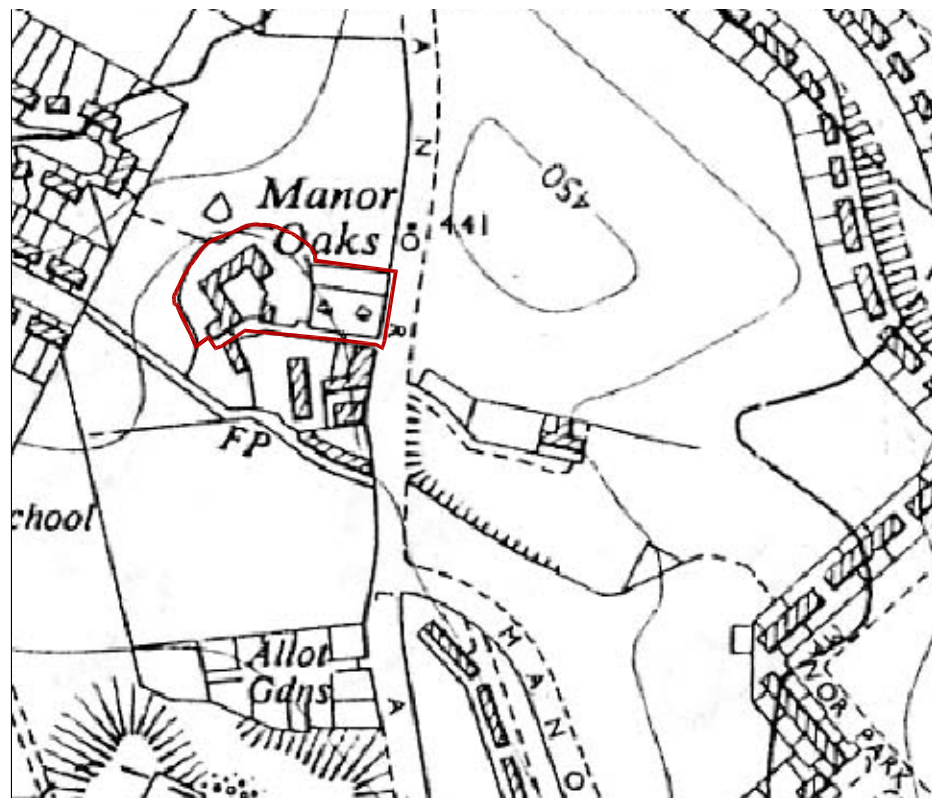
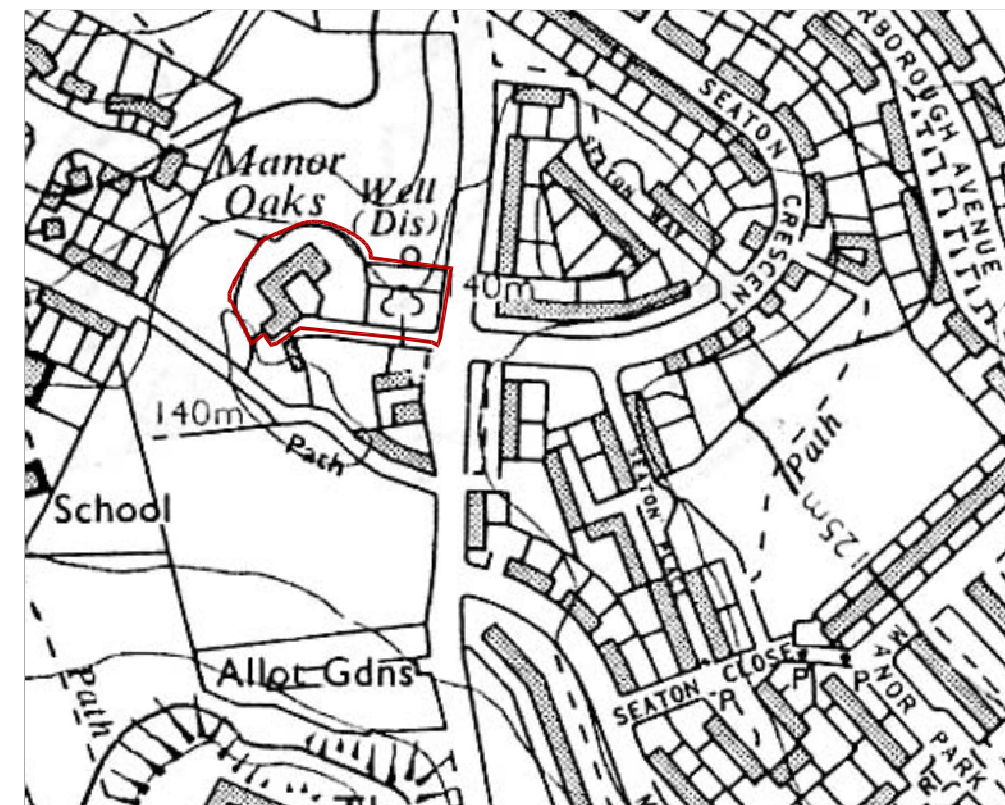
1850 First Edition Ordnance Survey Map

1892 Ordnance Survey Map

1924 Ordnance Survey Map

1956 Ordnance Survey Map

1987 Ordnance Survey Map

The demolition of the rear section of the house provided some information as to the original form of the house. The internal rear wall of the stone-built section of the house was exposed following the demolition. No traces of earlier door openings or windows were detected within this wall, however, there were traces of an early plastered finish to the walls visible at first floor level. This suggests that prior to the extension of the house in brick that the house may well have been larger. The only below ground indication of this was a substantial section of stone foundation uncovered towards the north-western end of the building and located along the line of the end of the first phase of the house. Other stone foundations were also exposed during the course of the subsequent trenching although it has been noted that the existence of stone foundations does not automatically suggest that the walls above were of stone. In this case it is possible that the foundations were part of the later brick-built phase. However, the mortar used in the construction of the foundation and the brick wall above differed, with a white mortar being employed to bond the stone and a grey mortar used for the brickwork. The cartographic evidence, dating back to 1850, shows the ground plan of the house as it appears today.

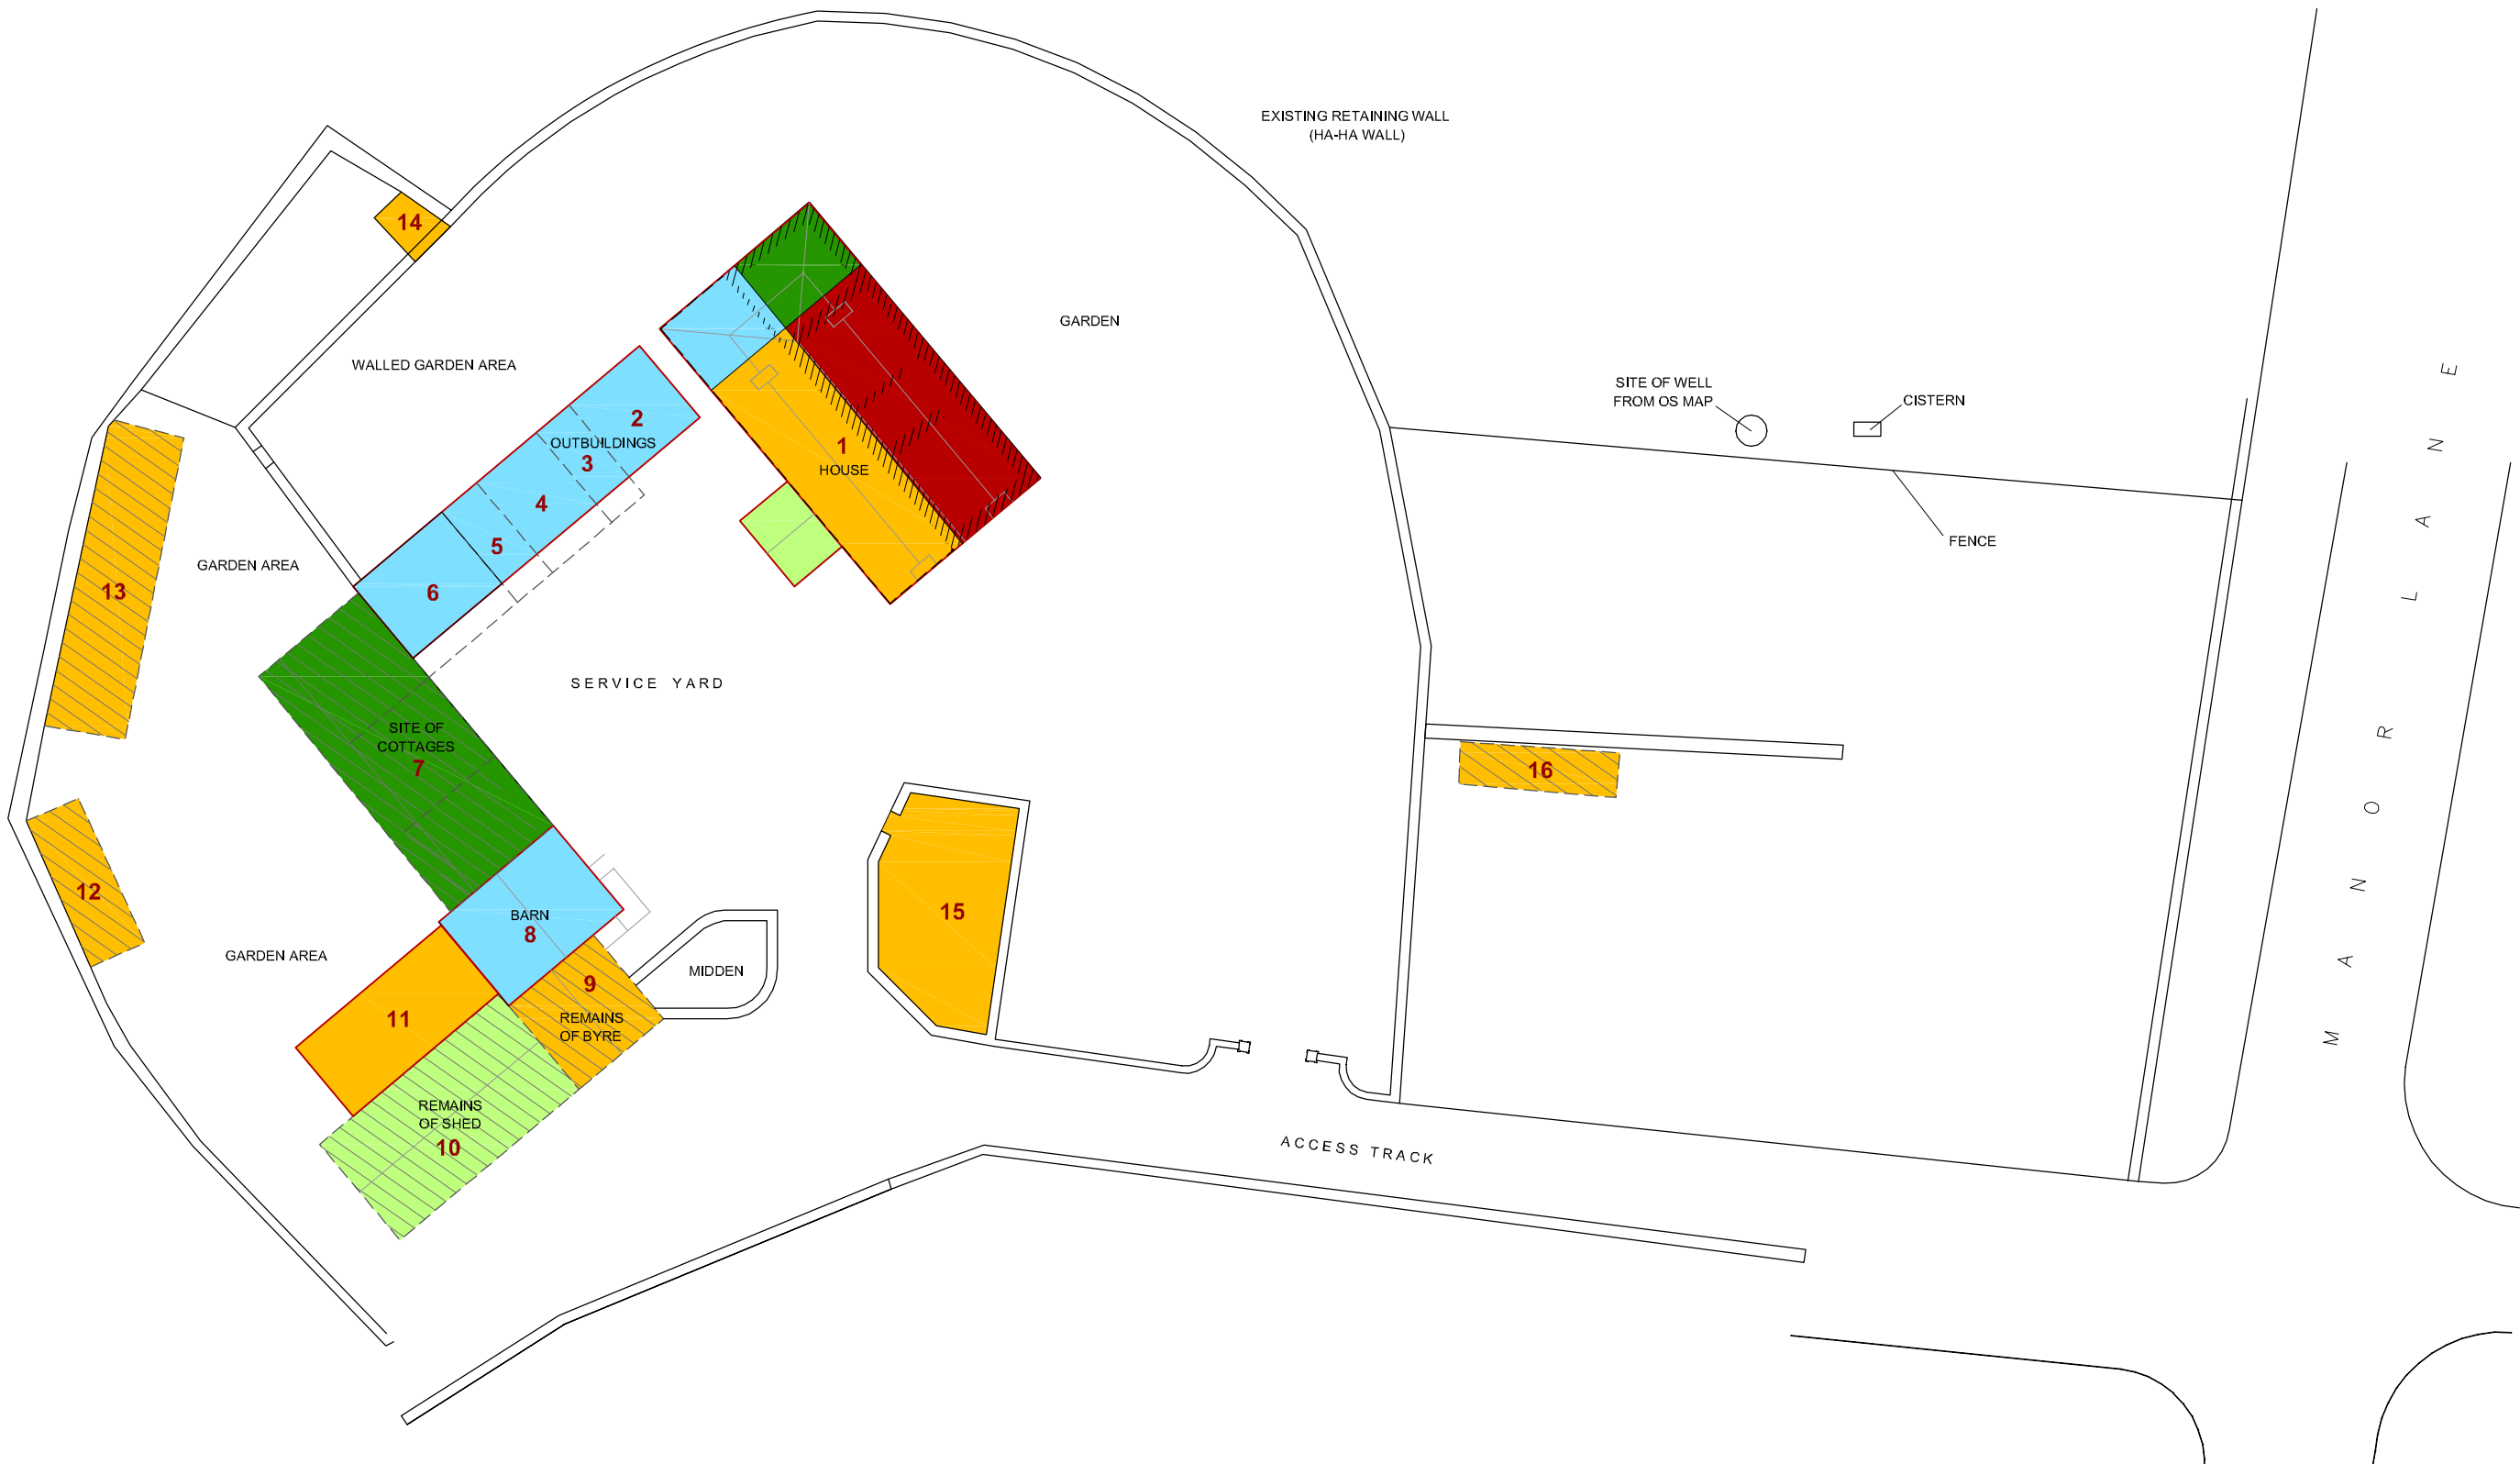
Scale	1:300	Date	June 2007
NGR	SK 3763 8685	Drawn	K.Speight
Project No.	873b.2	Illustration No.	4

- Phase 1
- Phase 2
- Phase 3
- Phase 4
- Phase 5
- Site of Former Buildings

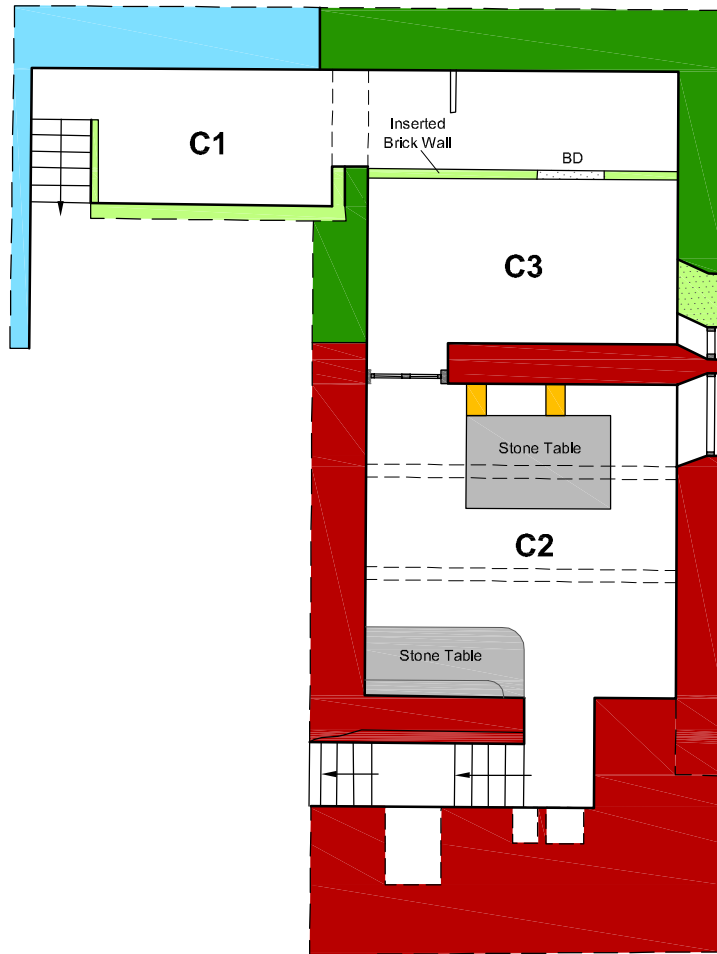
Project: Manor Oaks Farm, Sheffield	Scale	1:100	Date	June 2007
	NGR	SK 3763 8685	Drawn	K. Speight
Title: Building 1: Cellar Floor Plan	Project No.	873b.2	Illustration No.	6

Cellar

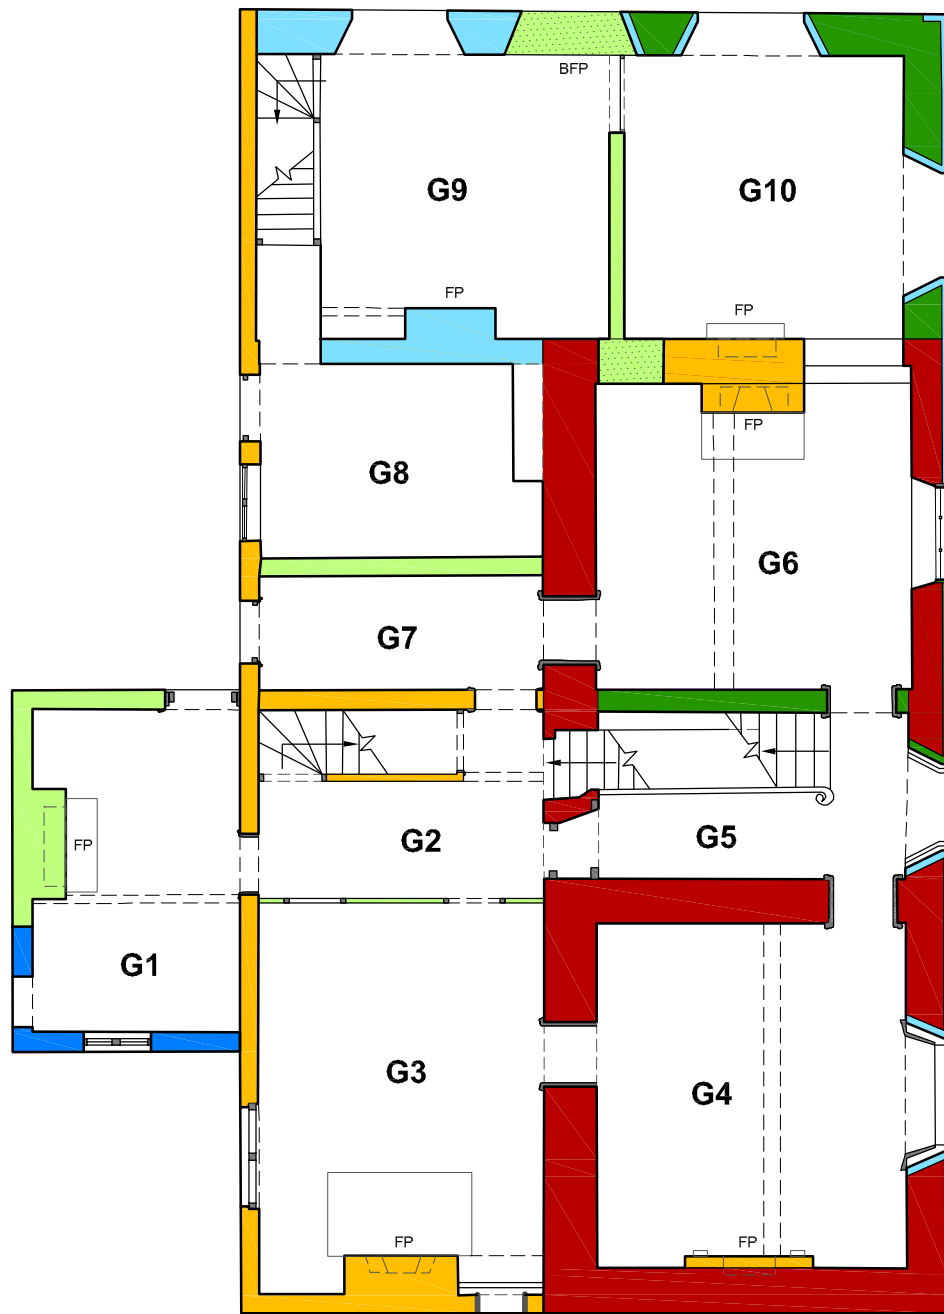
Project: Manor Oaks Farm, Sheffield	Scale 1:100	Date June 2007
Title Building 1: Ground Floor Plan	NGR SK 3763 8685	Drawn K.Speight
	Project No. 873b.2	Illustration No. 7

Ground Floor

Room G3 (**Plate 44**) measuring 5.16m by 3.79m, is the largest room on the southern side of the building. The floor was originally boarded (removed by the time of the survey) and the ceiling is of lath-and-plaster. It is evident that the floor itself was a later replacement and not contemporary with the initial construction of the building, as the floor joists are supported by two courses of modern machine pressed brick. There are moulded architrave surrounds to the two doorways and a moulded picture rail running around the upper section of the walls. Located on the south-east wall is a

Room G4 (**Plate 47**) is the largest ground floor space located within the earlier section of the house, measuring 4.53m by 4.10m. The floor is of 16cm boards, painted yellow and the ceiling is lath-and-plaster with a large timber beam spanning the room. The floor, as that of room G3, is a later replacement having the joists supported on two courses of modern brick. It is clear that the re-flooring of the two rooms was undertaken at the same time as one of the brick supporting walls runs beneath the connecting door in the south-west wall. There is moulded architrave to the two doors and a deep moulded skirting to the base of the walls. Running around the upper portion of the walls is a moulded picture rail above which there is a shallow moulded ceiling cove. It is evident that the picture rail is a later addition to the room as there are remnants of an earlier wall paper concealed beneath it. The walls are of stone rubble construction covered with a layer of lime based render and a thin skim of plaster.

Room G10 (**Plate 79**), which measures 3.70m by 3.68m, is also heavily modernised and latterly fire damaged, retains nothing in the way of original features. The original boarded floor is covered with chipboard and the ceiling has been recovered with sheets of shuttering plywood. Both of the windows had been removed by the time of the survey; the internal splays remain. Against the south-east wall is a modern fireplace constructed from brick and breeze block (**Plate 80**).

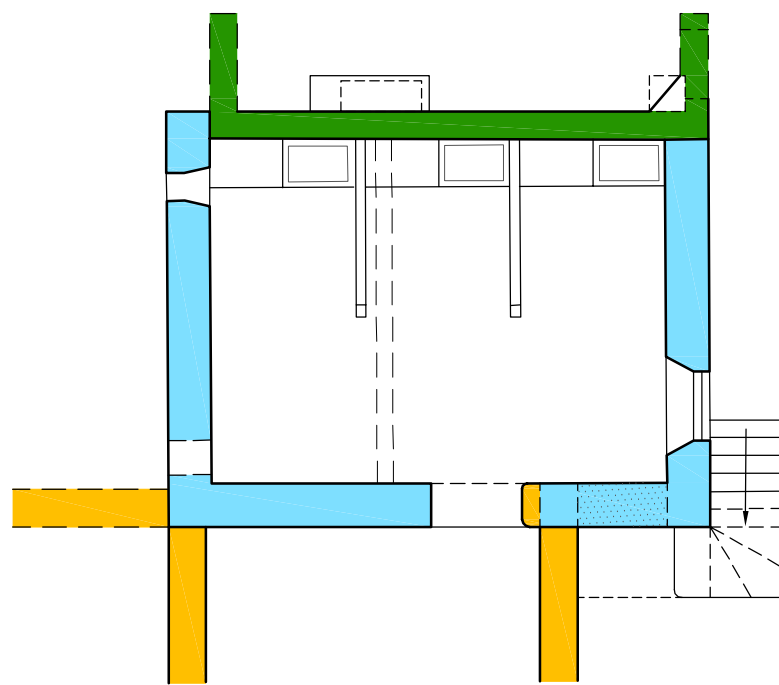
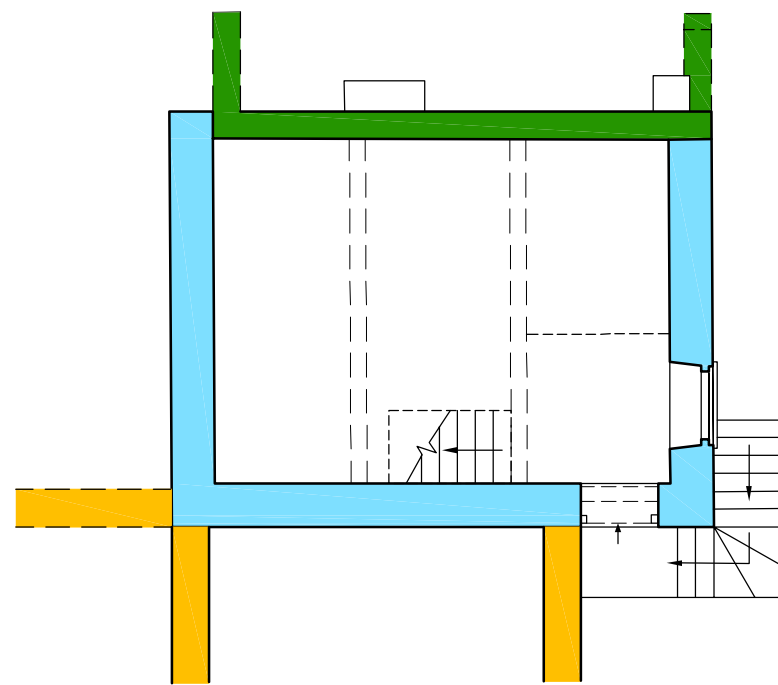
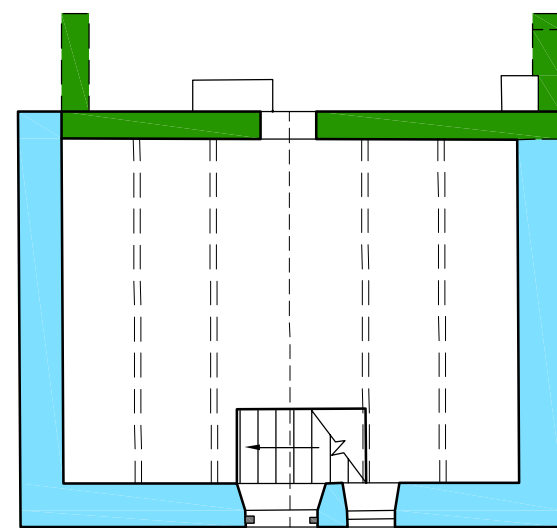
Ground Floor

First Floor

Attic
