# Artifacts in MRI

Dr Stephane BREIL – MRI Clinical Marketing Manager  
PHILIPS APAC

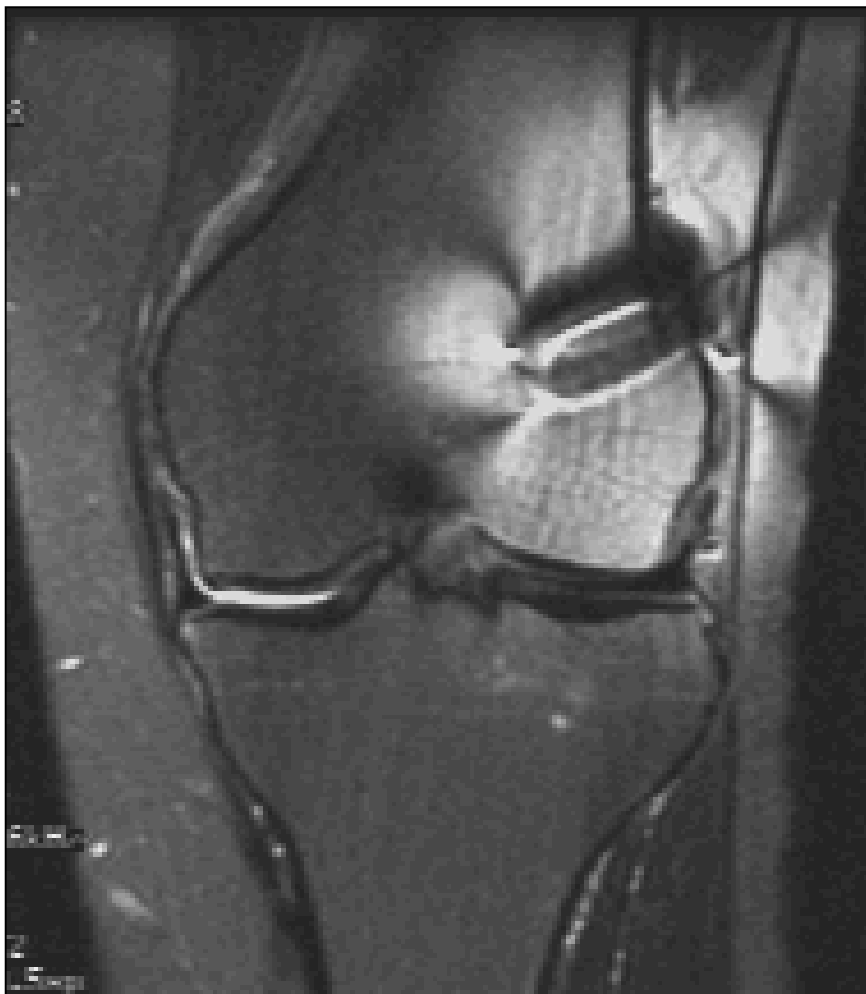
# Aliasing Artifact

Causes of the aliasing artifact:

- Tissue is outside FOV in phase direction

Recommendations :

- Increase FOV in phase direction
- Change Fold-over direction
- Oversampling

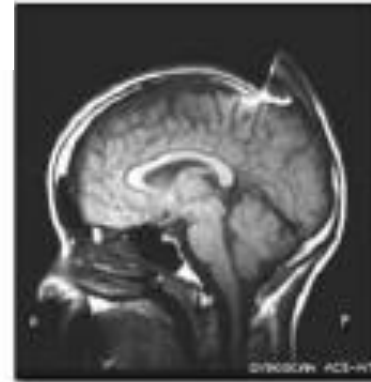
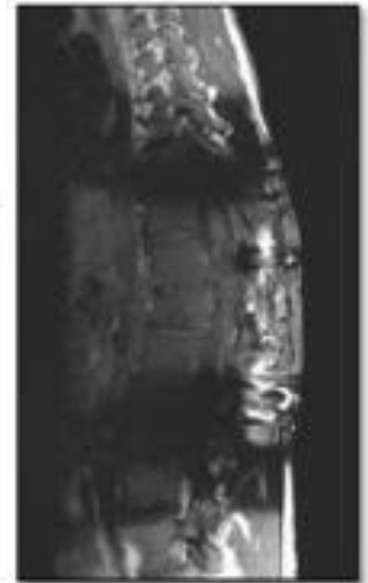
# Examples of metallic artifacts origins

- Internal
  - Surgical clips, staples, shunts
  - Dental implants and appliances
- External
  - Jewelry, buckles
  - Piercings
  - Metallic stitching in clothing
  - Hairpins, some hairpieces, wigs
  - Make-up, tattoo

Warning: these items may also cause a burn risk

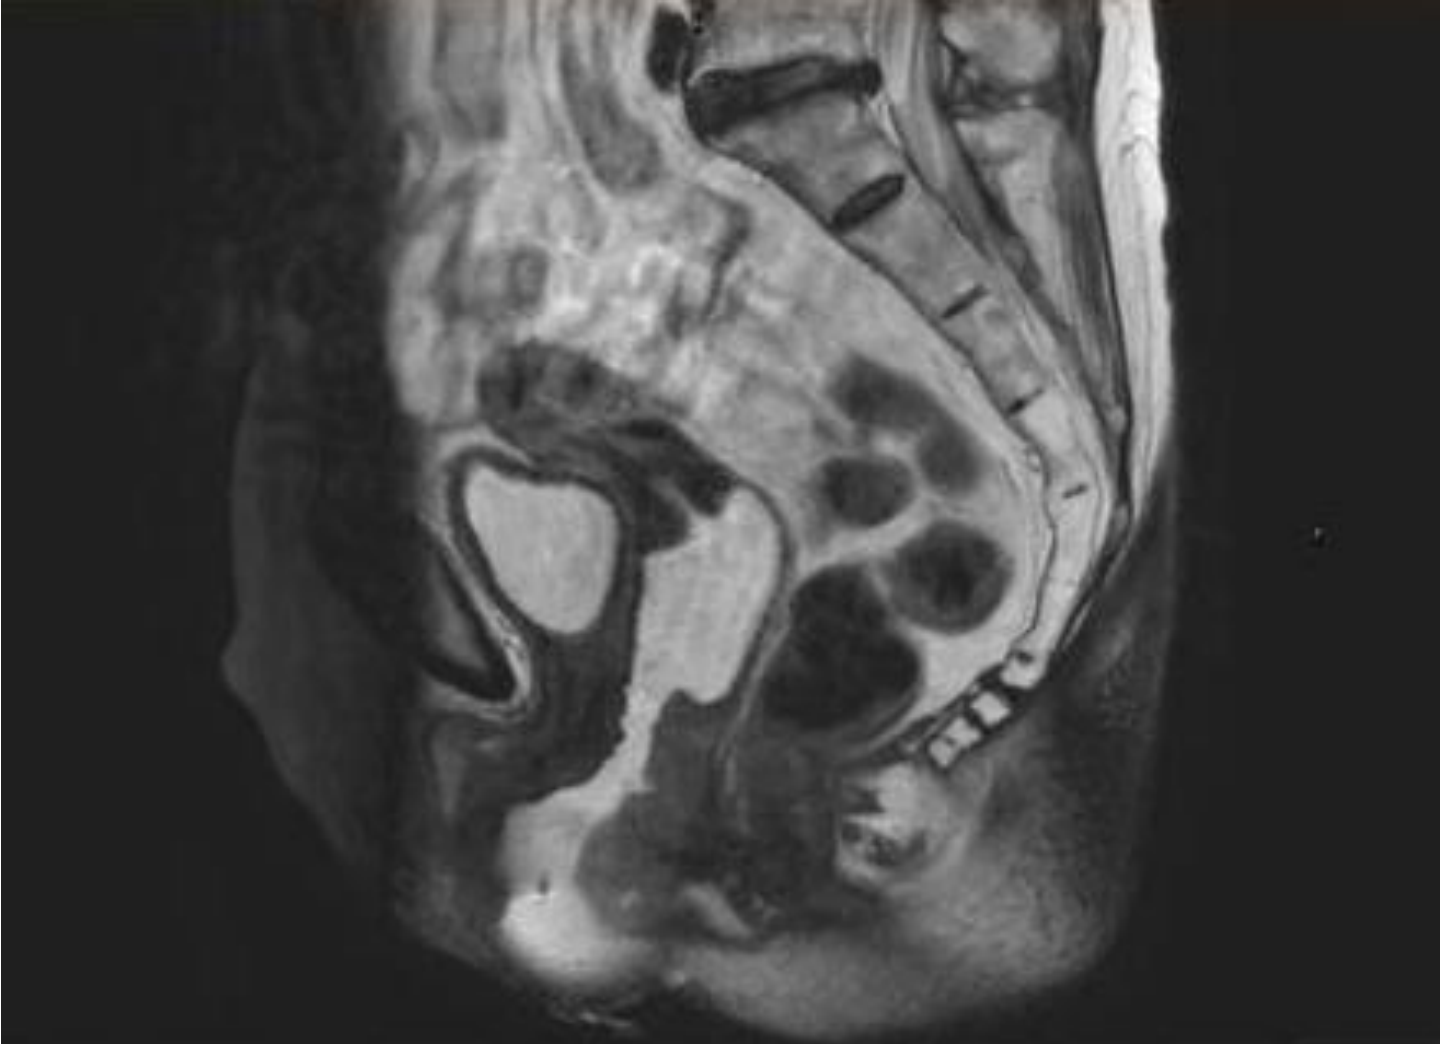
# Respiratory Motion Artifacts

Solution for Respiratory motion artifacts:

- Respiratory triggering
- Breath hold
- Navigator

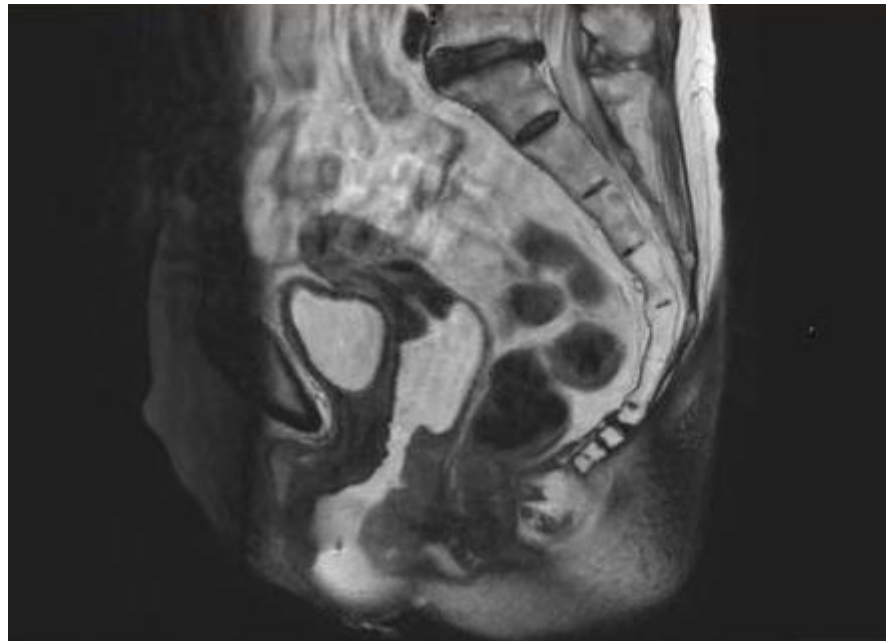
# Peristalsis Motion Artifacts

Solution for Peristalsis motion artifacts:

- Give an Anti-peristaltic drug (prescribed by referring physician)
- Patient preparation (NPO, Nothing Per Orem)
- Strap the patient tight
- MultiVane

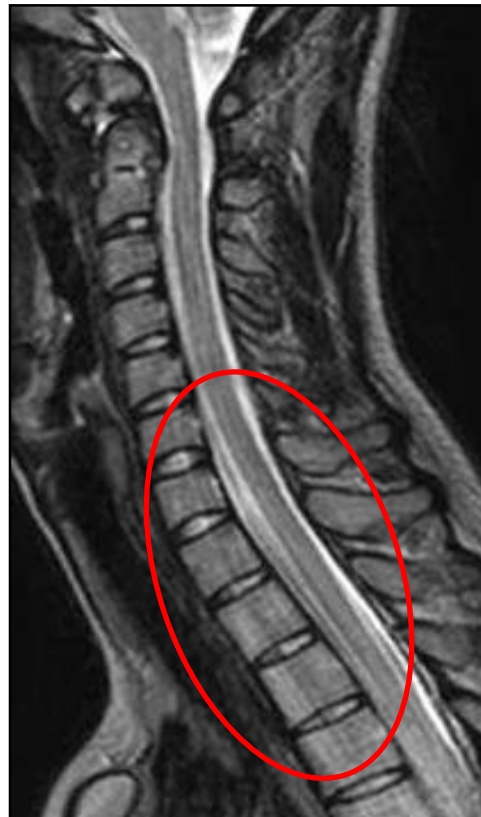
# CSF Pulsation Motion Artifacts

Solution for CSF pulsation motion artifacts:

- Flow compensation
- Cardiac synchronization
- b-FFE

flow com : no

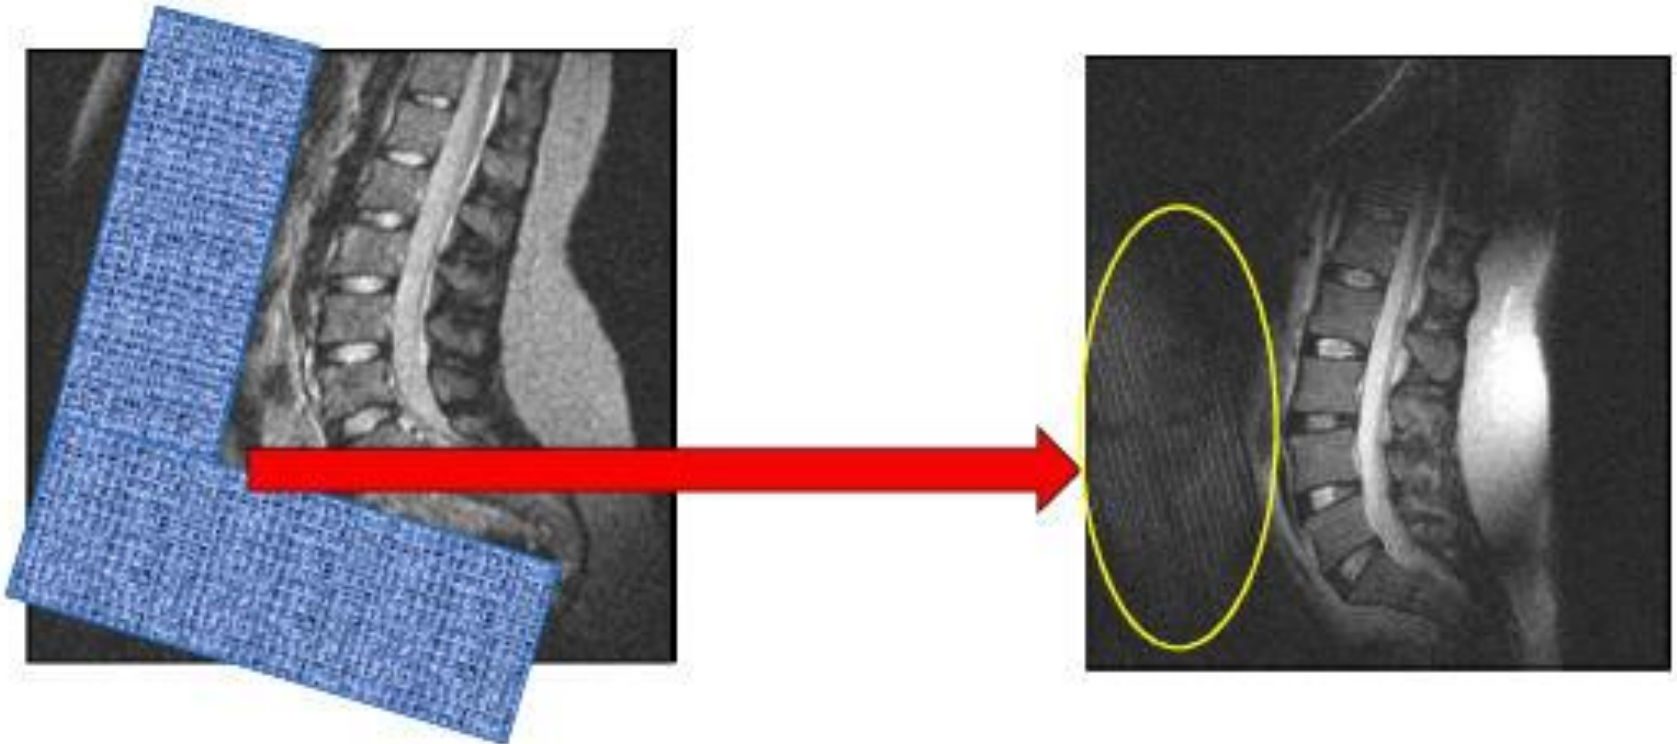
# REST Artifact

Causes of the REST artifact:

- Two or more REST slabs intersect each other.

Recommendations :

- Apply REST slabs so that they do not overlap.

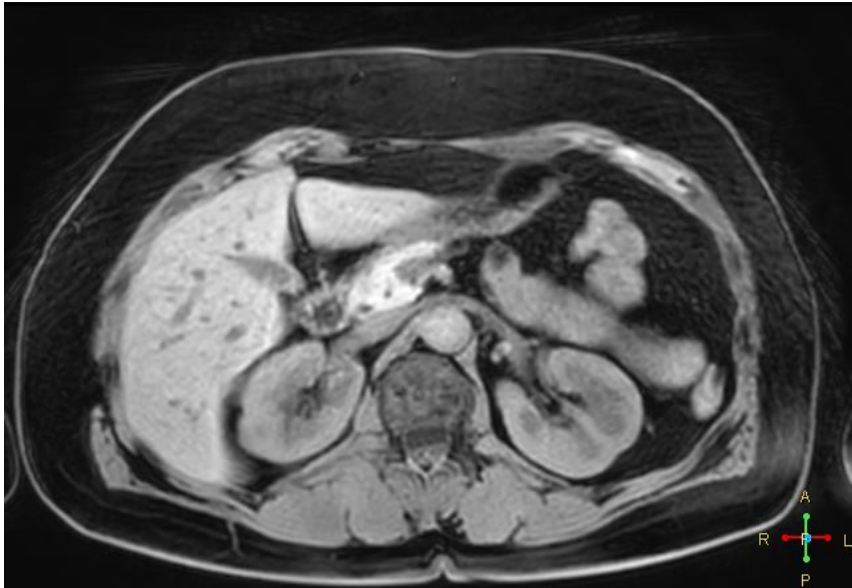
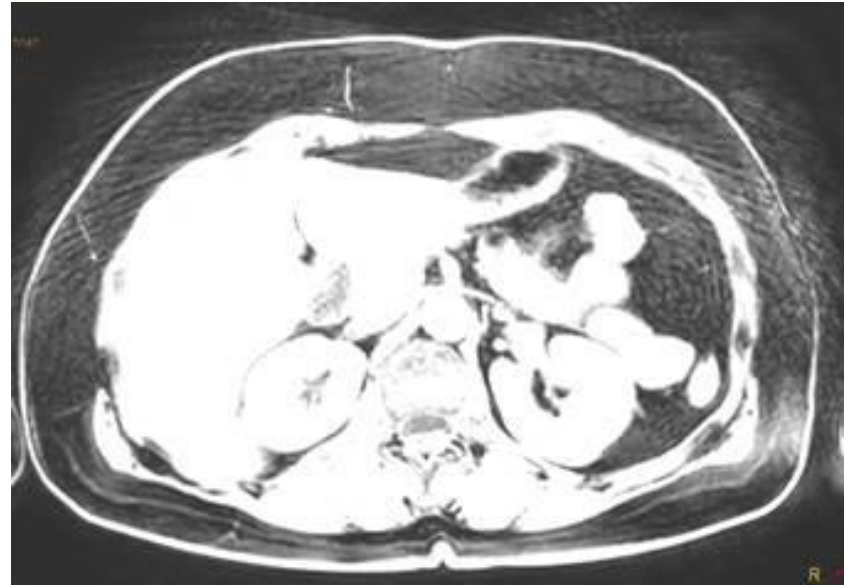
# Low MultiVane percentage

- Causes streaking artifacts

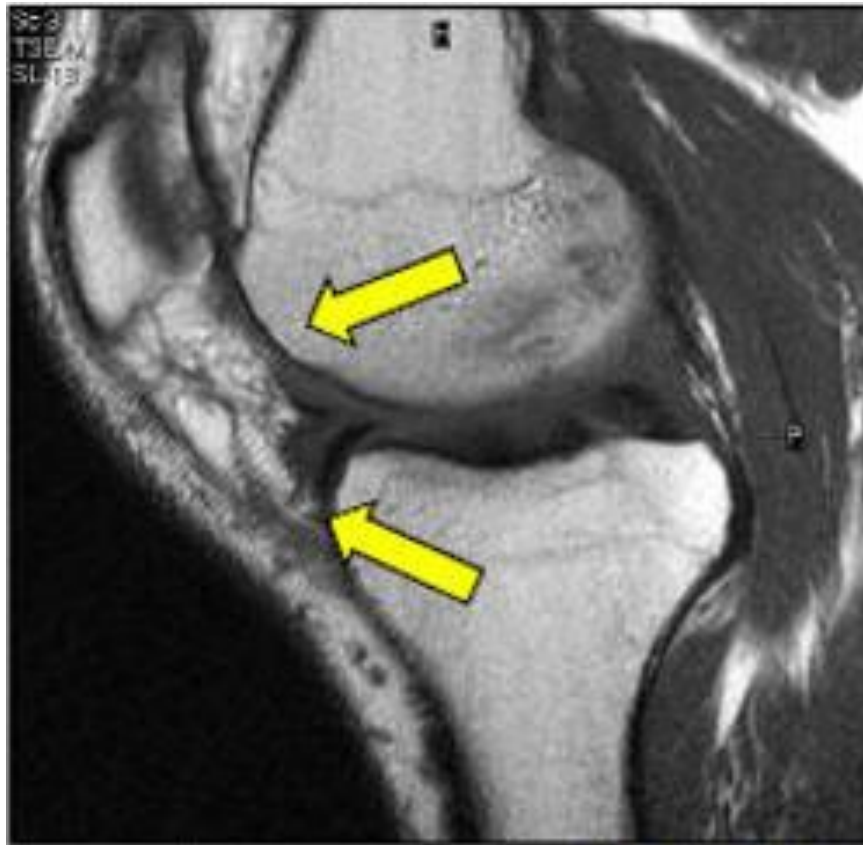
## Blur artifact (high turbo factor)

- Tends to happen when an operator attempts to increase the spatial resolution of a single shot scan.

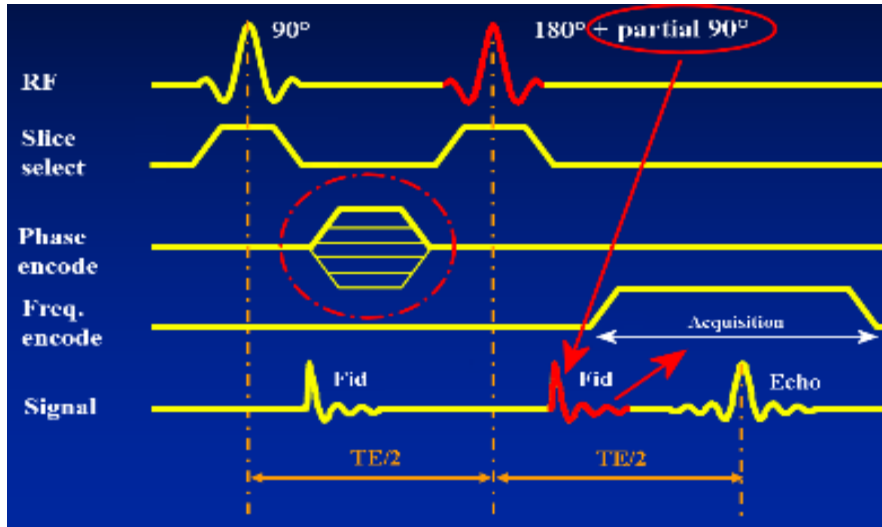
## FID artifact (or stimulated echoes):

- Can be reduced by:
  - **NSA** minimum of **2**
  - **Flow compensation** is set to **yes**
  - **FID reduction** (gradient crusher) set to **strong**

Do not combine flow compensation and FID reduction.  
Only use flow compensation if FID reduction parameter is not available.  
(Because flow compensation will reduce SNR)

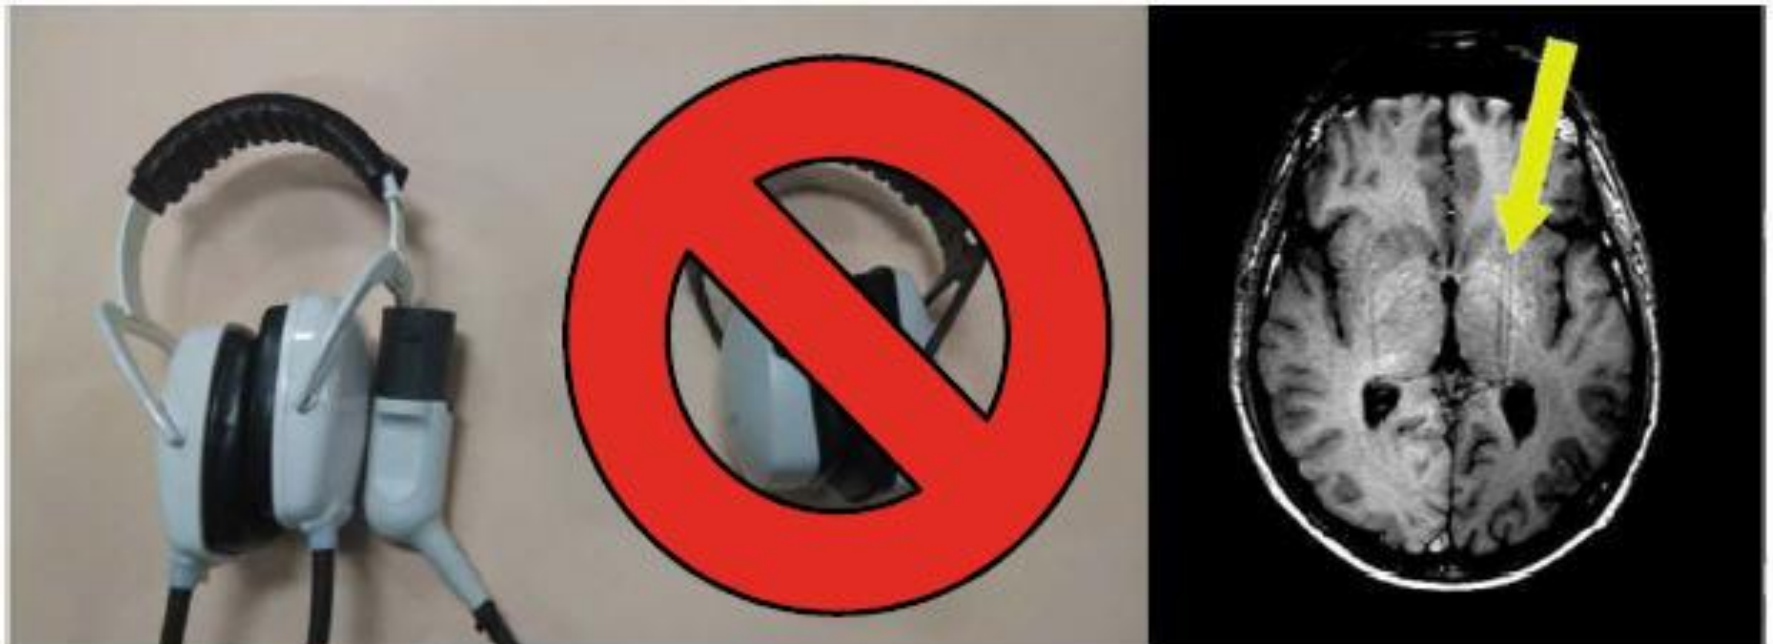
# Proton signal in passive headset

- Advice has always been to use only the patient headset that connects to system.
- Can fold into brain when SENSE is applied.

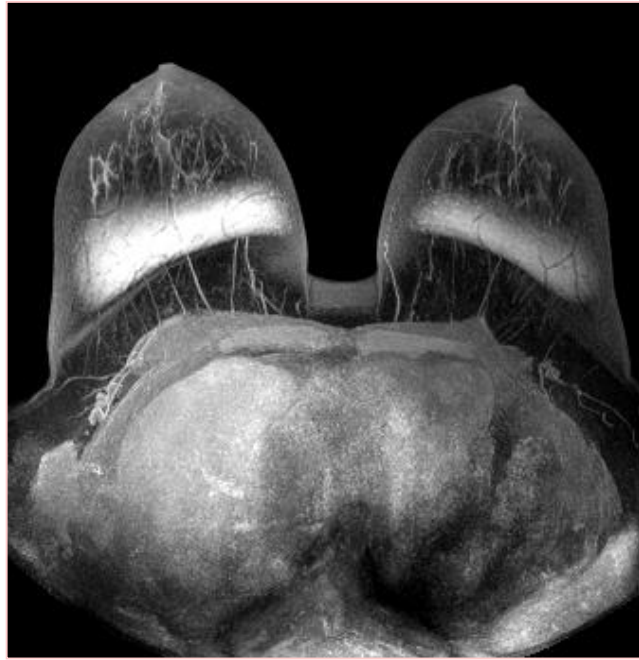
# Coil movement

The reference-scan provides coil sensitivities if the coils have not moved between the ref and clinical scans.

Split-line artifact

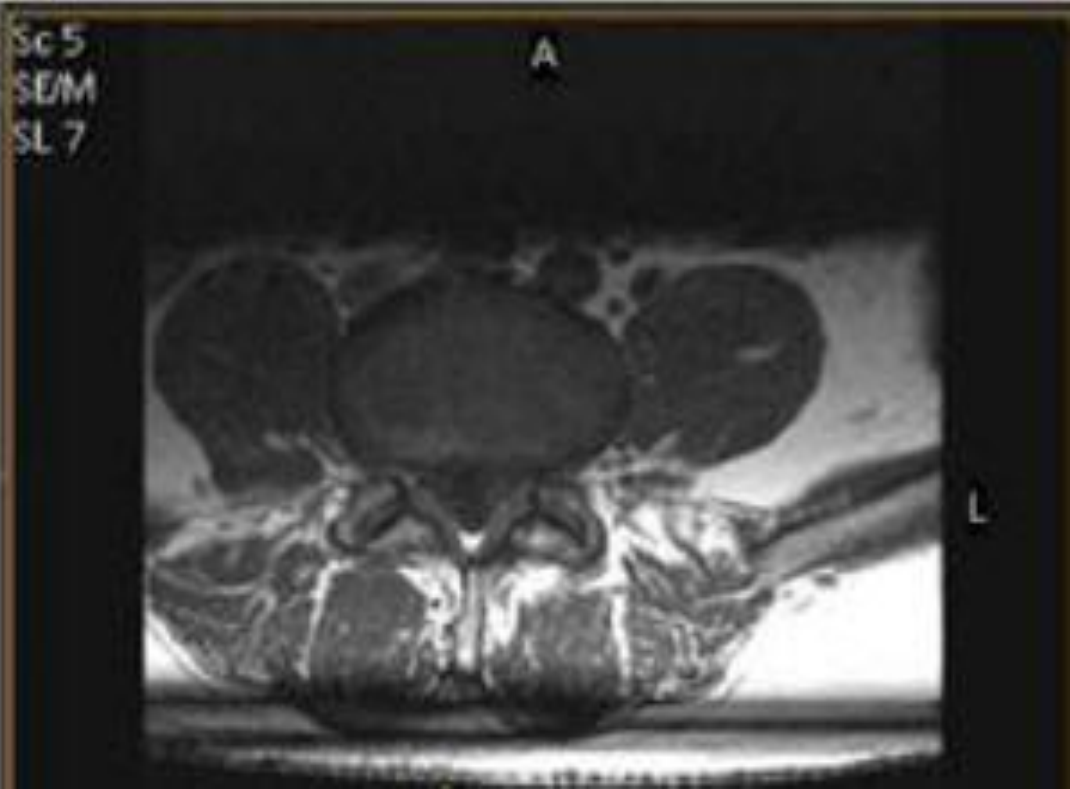
# Cross-talk artifact (multi-stack sequences)

Can be prevented by setting scan parameter stacks as packages to yes.

Note: This will increase scan time

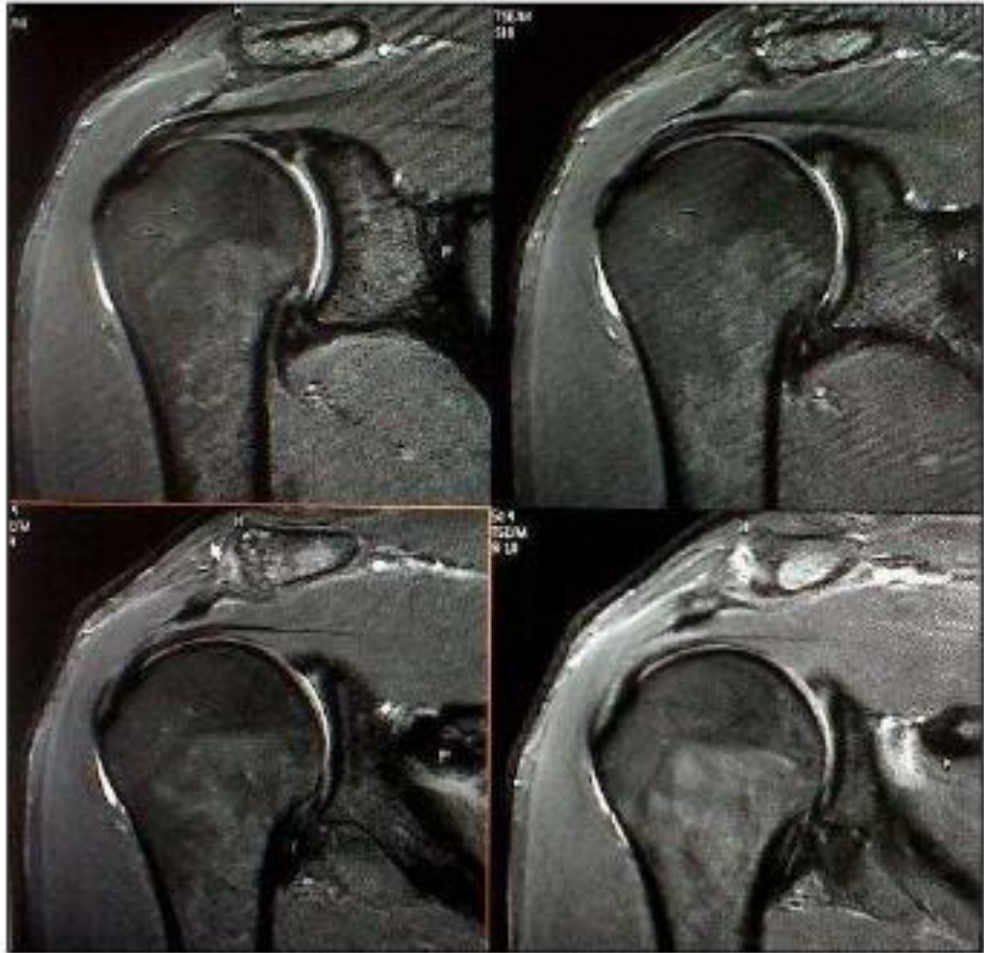
# Spikes

Many sources possible

In this case, caused by a loose pin in coil.

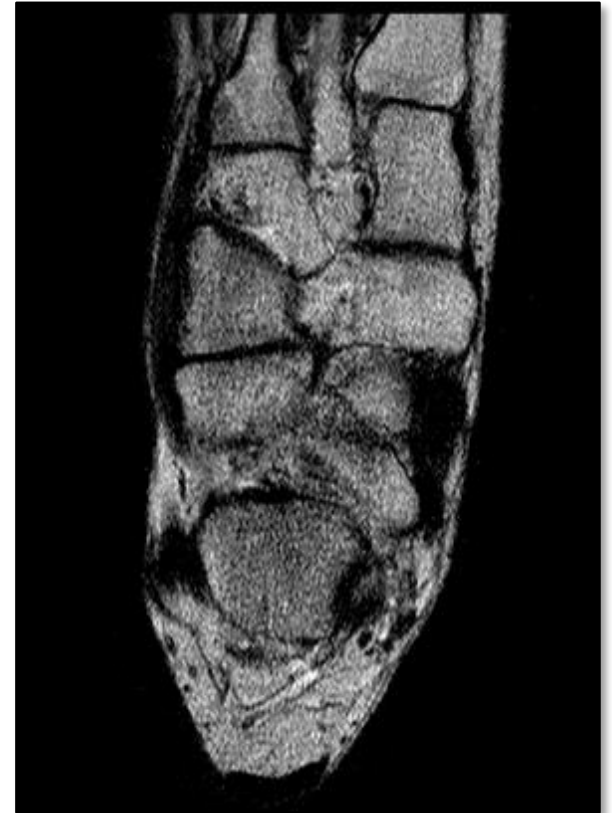
Spikes are caused by a 'bad' data point in k-space, due to hardware or environmental influences, leading to:

- Zebra stripes
- Noise
- Data point artifact

In this example, spikes from gradient coil →

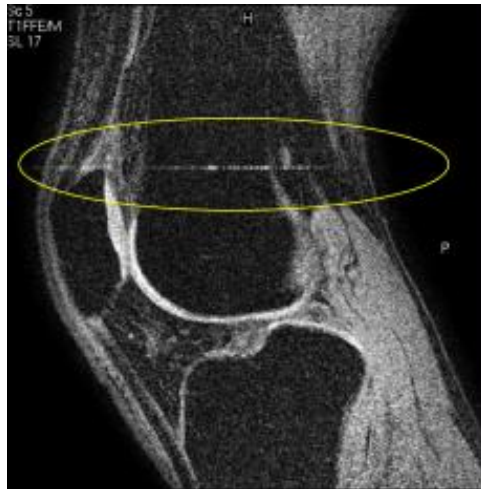
# RF Interference

- RF disturbance in the scan room can cause:
  - Single dots
  - Line artifacts

- RF door open
- Poor integrity of RF room
- 3<sup>rd</sup> party equipment
- Broken light bulb

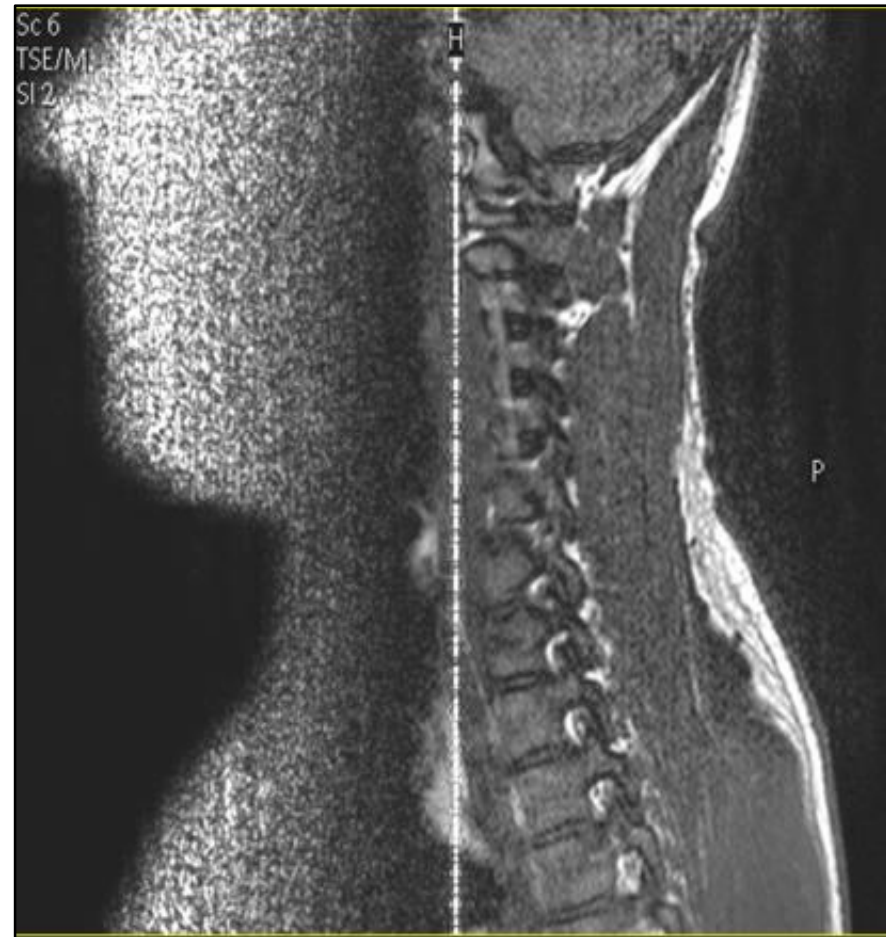
- Appeared as line artefact
- Occurred with all coils
- Affected one slice
- Intermittent occurrence

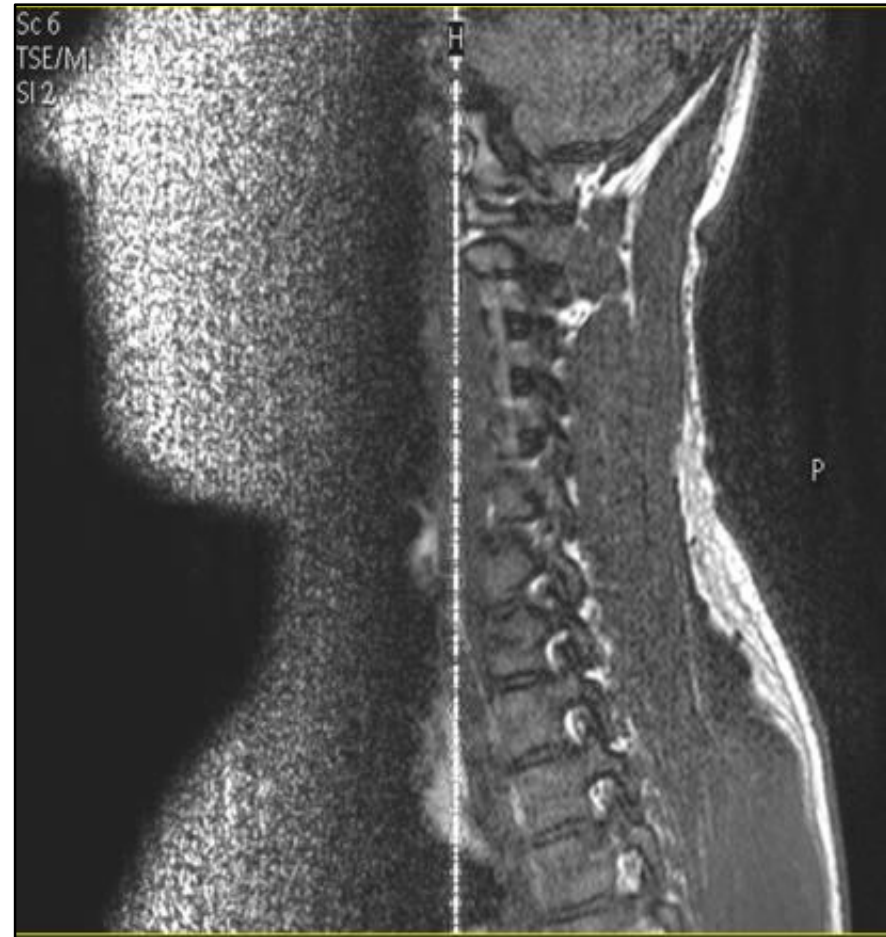
# RF Interference

- Defective filter in gradient cables

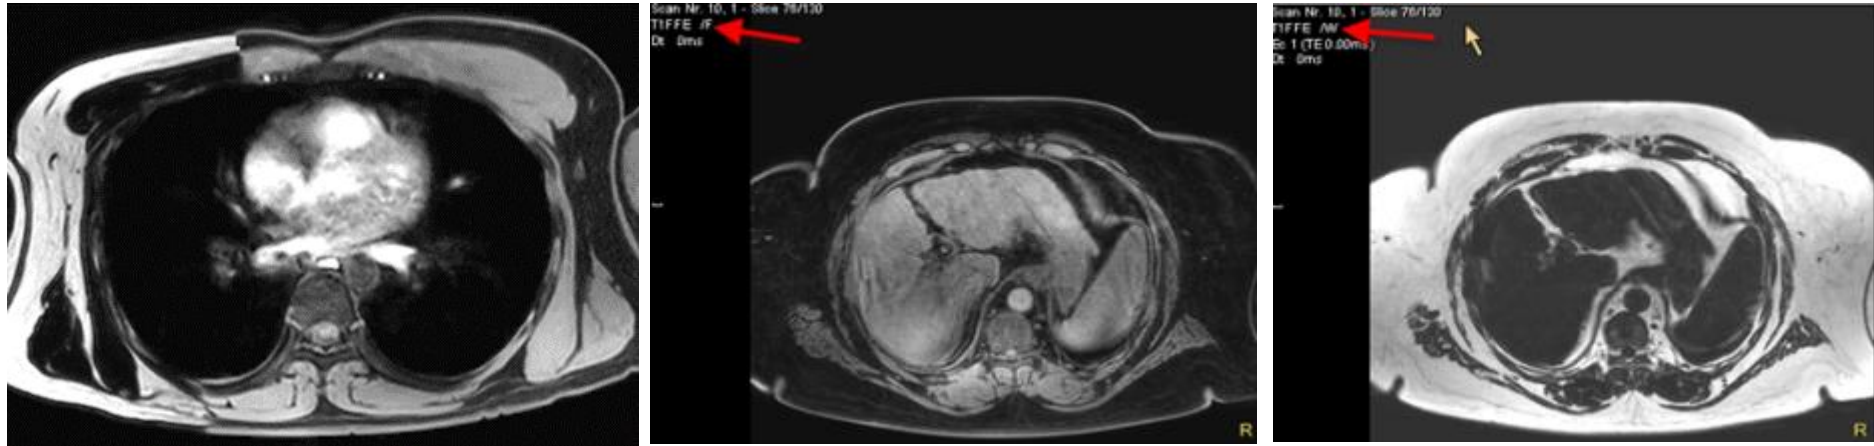
# Reconstruction artifact

Swap artifact in mDIXON-FFE caused by incorrect calculation of Water and Fat reconstructions

- mDIXON\_XD solve this problem, using 7 point fat modeling for better fat determination
