BROTHER® HL-2230 • 2240 • 2270 • 2280 • DR420 • 450 OPC DRUM CARTRIDGE REMANUFACTURING INSTRUCTIONS

REMANUFACTURING THE BROTHER HL-2280/DR420 OPC DRUM CARTRIDGE (DR2200 EUROPE/DR2225 ASIA)

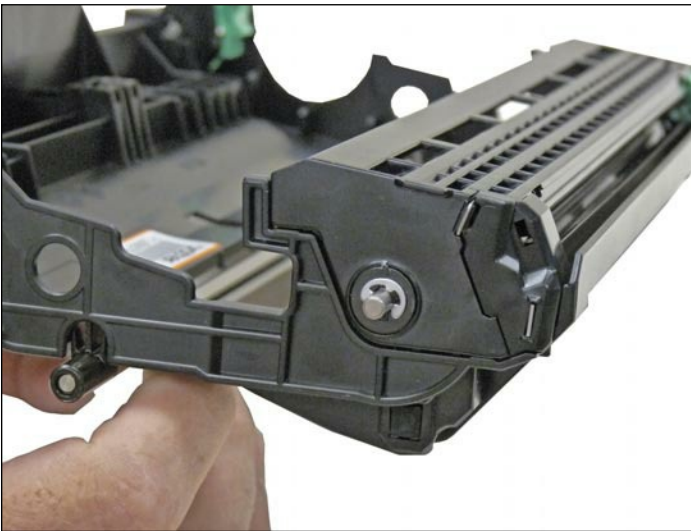
1. Remove the E-ring from the non-gear side of the drum axle shaft.

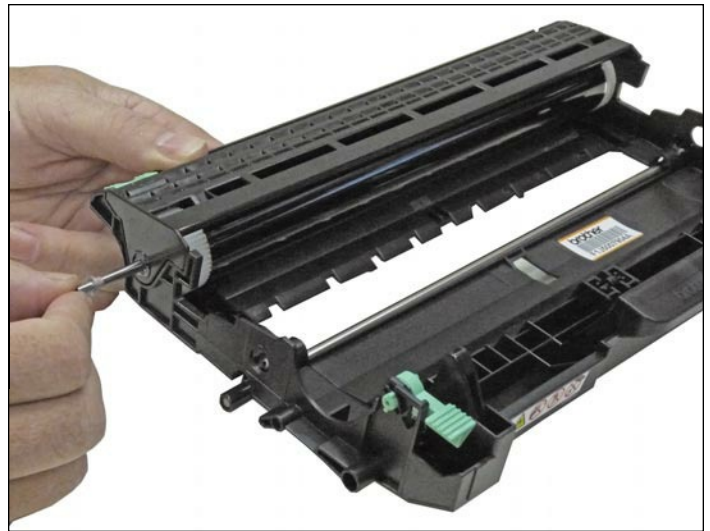
2. Remove the drum axle from the non-gear side of the drum. If you try to pull it out from the gear side, the shaft will jam up on the drum's ground contact, and damage the contact.

Solid black pages: Caused by a bad drum ground contact, probably from the drum axle shaft to the contact gear, inside the drum.

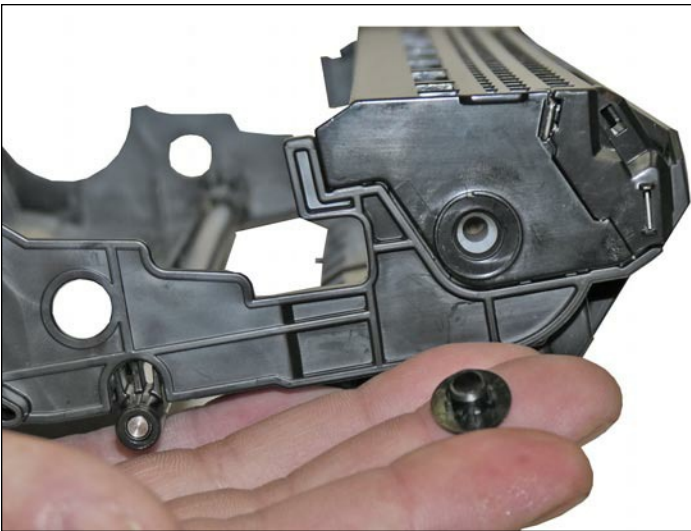
3. Be careful not to lose the round drum bushing, from the non-gear side of the cover!

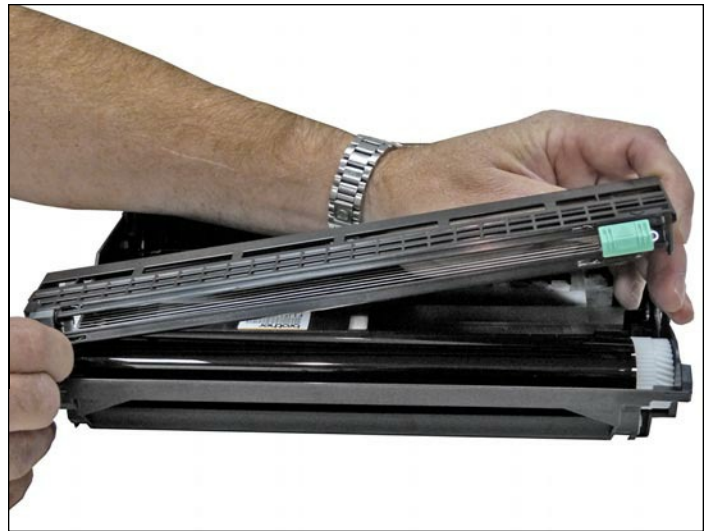
4. Carefully pry up and lift off the top cover/corona wire assembly from the cartridge.

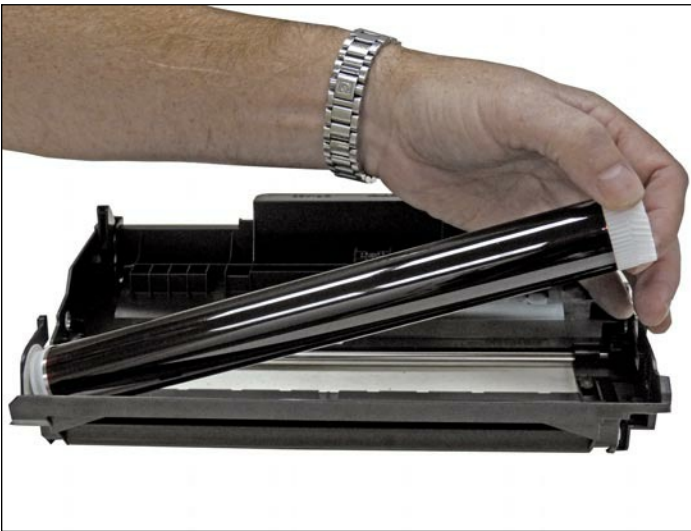
5. Carefully remove the drum.

Note that there is a one-piece drive gear, not two, as in previous Brother drum units.

The hub side is also spring loaded, and is not easily removable.

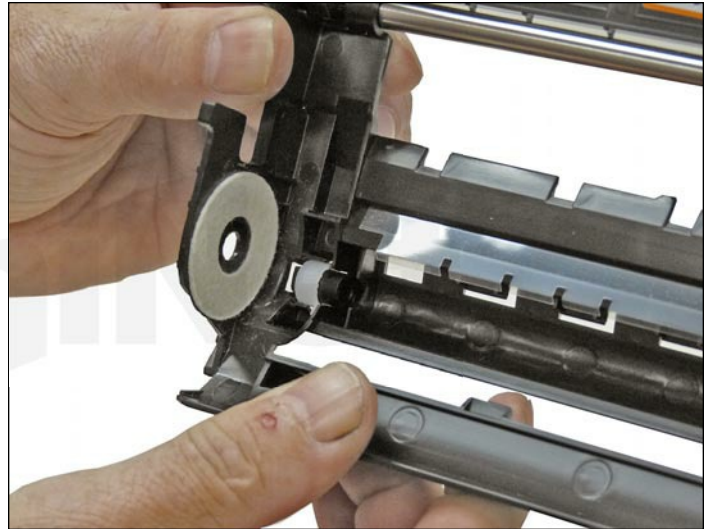
7. **IMPORTANT:** Note that there will be a small white bushing with an internal black plastic spacer left in the cartridge. This spacer keeps the transfer roller touching the electrical contacts on the left side of the cartridge. Be very careful not to lose this spacer! The cartridge will either print very light, or half pages, if it is missing. It is best to remove this spacer and bushing while cleaning the cartridge. With compressed air, blow off the transfer roller. Unless you have a statically grounded vacuum, do not vacuum this roller.

Light or half-page prints: This is caused by a missing transfer roller spacer. The spacer is a small piece of black plastic that sits next to the right end of the transfer roller. This piece keeps the transfer roller touching the electrical contact on the opposite side of the roller. If missing, the roller will move and can cause light or half-page prints.

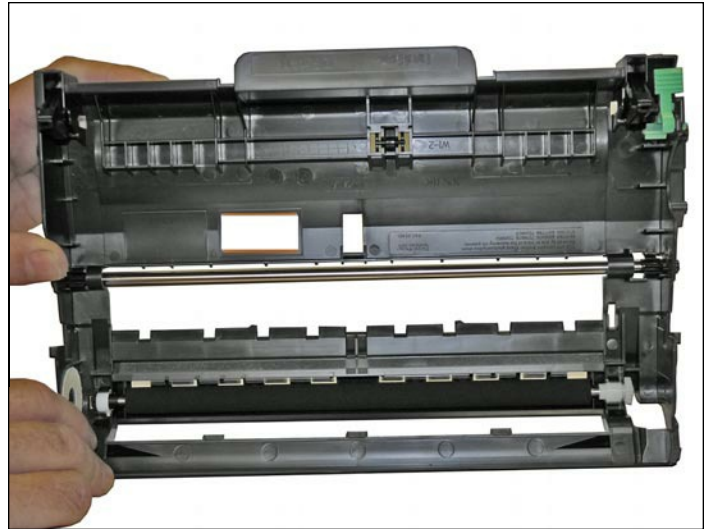
9. Install the transfer roller.

Make sure that both the white plastic bushings are clean.

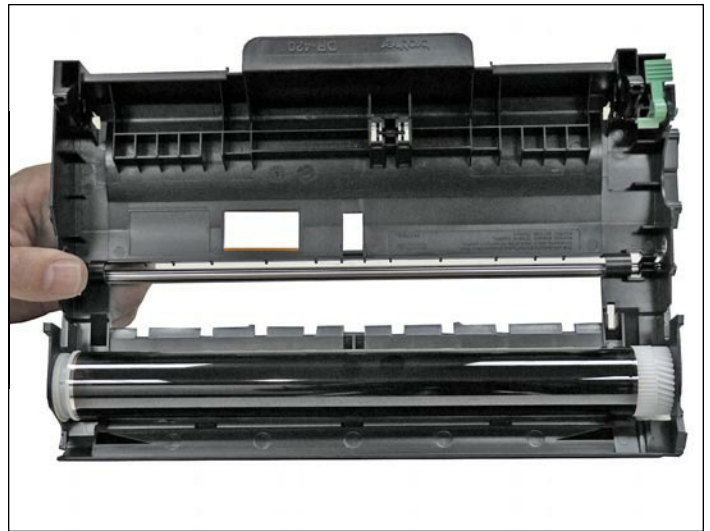
11. Install the drum, hub side first. You will have to compress the hub spring slightly for the drum to fit properly.

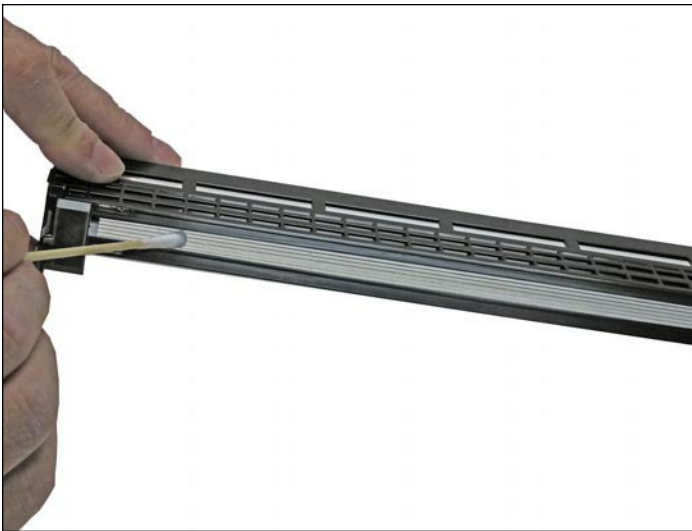
12. Clean the primary corona wire and grid with a cotton swab and alcohol.

Dark black vertical streaks: This is normally caused by either a dirty primary corona wire, or that the blue corona wire cleaner is not in its "home" position on the left side of the cartridge.

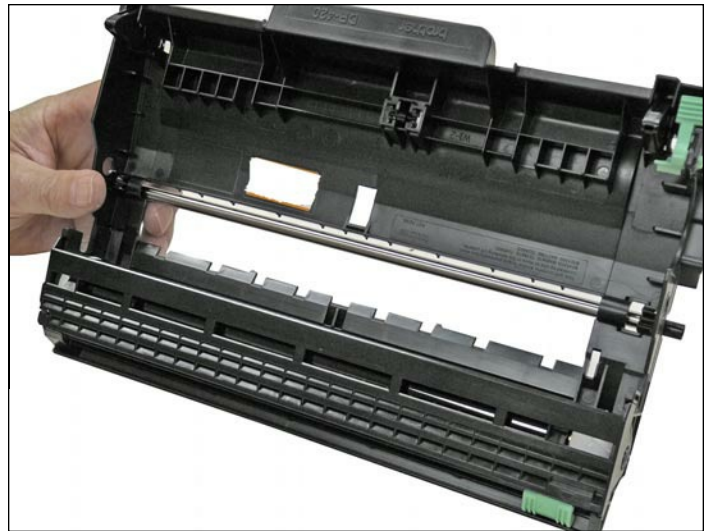
13. Install the top cover, pressing down so it snaps in place.

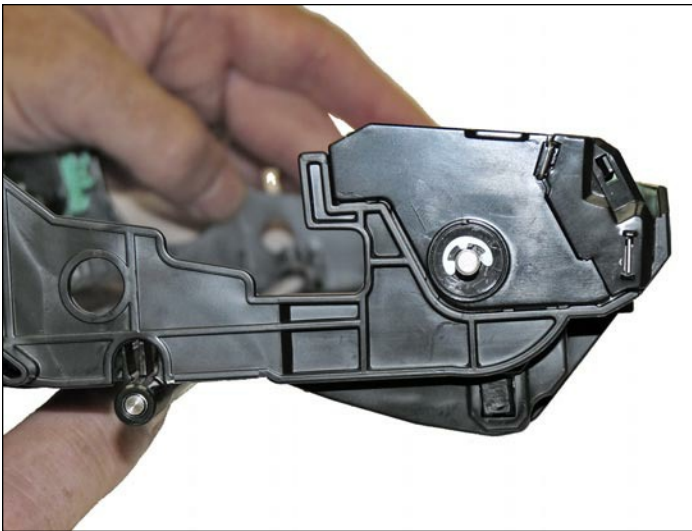
16. Install the E-ring on non-gear side of the drum axle shaft. Press the axle bushing in slightly so that the e-ring slot is accessible.
