CHAPTER D9. TURKANA: SUB-PROJECT OF INTRODUCTION OF SOLAR POWER SYSTEM IN WATER PUMP FACILITIES IN LODWAR WATER AND SANITATION COMPANY

D9.1 Outline of the Sub-project

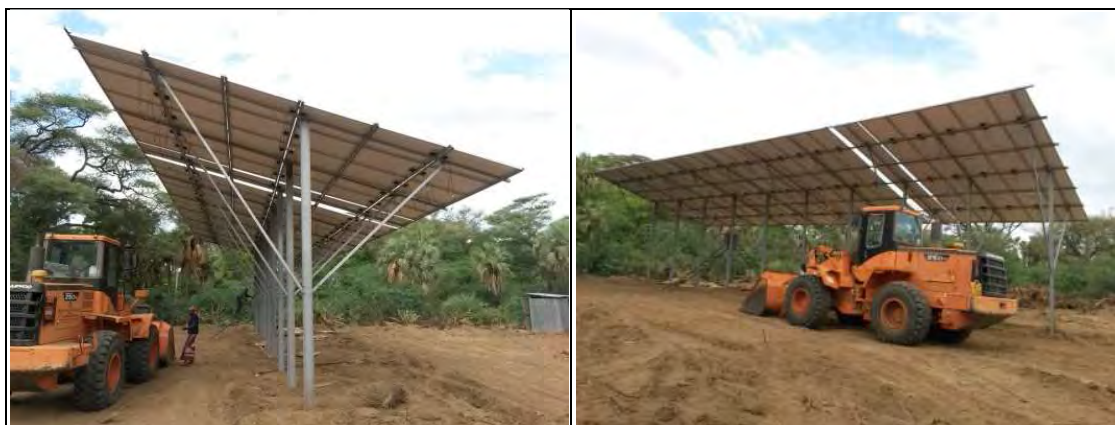
Figure AD9.1.3 Photos of Solar System in LOWASCO

- a. Transport of equipment to the site,
- b. Lifting of the existing pump from the borehole
- c. Reinstalling the pump with the existing pipes
- d. Erection of the 4 m support tower for the solar panels and positioning of the solar modules on the structure.
- e. Cable connections between existing pump controller, manual changeover switch and the solar modules (within an assumed distance of 20 m from the pump house)
- f. Commissioning and testing with water delivered to the surface

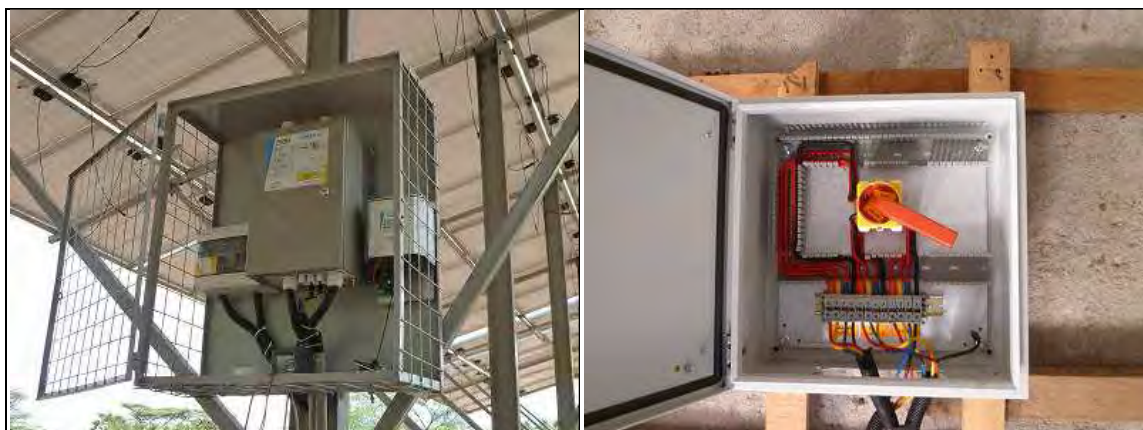
Figure D9.1.4 Inverter System and Control Unit

The controllers Lorentz PS15K2 is used for converting the DC power from the solar panels into the 3-phase AC power required to run the pump. It has an integrated MPPT (Maximum Power Point Tracking) which maximizes power use from PV modules. The unit is to be housed in a damp proof stainless steel enclosure. The controller is fitted with PS Data Modules which provides real-time and stored information on key pump metrics. The data module can be used with a bluetooth connection for contactless pump control, data monitoring and extraction to a Pump Scanner Android Application.

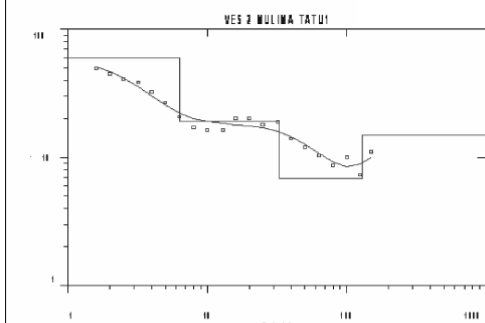
N1-2 Kaabilikeret

VES 2: Co-ordinates Degrees 035° 28' 36.1"E; 04° 12' 45.5"N, Alt 692m ASL

MODEL: VES 2 MULLIMA TATU1				
LAYER	RESISTIVITY	THICKNESS	DEPTH	
1	59.9	6.3	6.3	
2	19.0	26.7	33.0	
3	6.0	97.0	130.0	
4	15.0

No	Site Code	Village name	Location	Depth to Expected Formation (m)	True Resistivity in Ohms (Ω)	Expected formation	Remarks
1	N1-2	Kaabileret	Milimatatu	0 – 6.3 6.3 – 33.0 33 – 130 Below 130.0	59.9 19.0 6.8 15.0	Loam soils Fractured volcanics Highly weathered/fractured volcanics (aquiferous) Weathered to fresh volcanics	· Well defined aquifer 40-120m · Good recharge · Groundwater potential medium to high
2	N2-2	Lokwaket	Milimatatu	0 – 2.3 2.3 – 8.1 8.1 – 21.0 21 – 120 Below 120.0	162.1 23.7 14.0 20.0 9.9	Sandy top soils Alluvial sands Weathered volcanics Highly weathered volcanics Weathered volcanics/ clays	· Well defined aquifer 40-80m & 100m · Good recharge · Groundwater potential medium to high
3	N3-2	Ngaukon	Kangakipur	0 – 3.3 3.3 – 16.1 16.1 – 82.0 Below 82.0	213.0 5.3 1.5 5.2	Dry top soils Compact sub soils Weathered volcanics Fractured volcanics	· Deep weathering · Well defined aquifers 40-80m & 100-120m · Groundwater potential medium to high

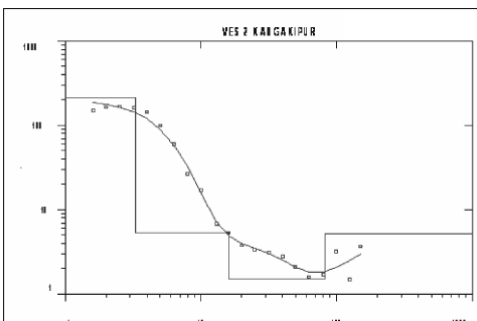
N3-2 Ngaukon

VES 2: Co-ordinates Degrees 035° 31' 53.5"E; 04° 03' 35.0"N, Alt 738m ASL

MODEL: VES 2 KANGAKIPUR				
LAYER	RESISTIVITY	THICKNESS	DEPTH	
1	213.0	3.3	3.3	
2	5.3	12.0	16.1	
3	1.5	65.9	82.0	
4	5.2

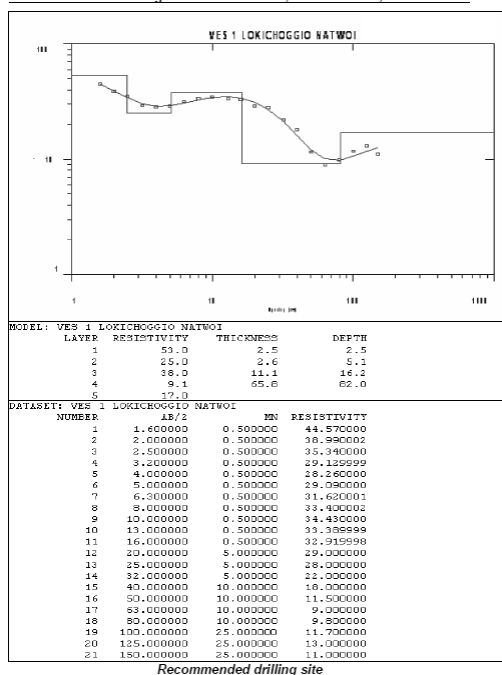
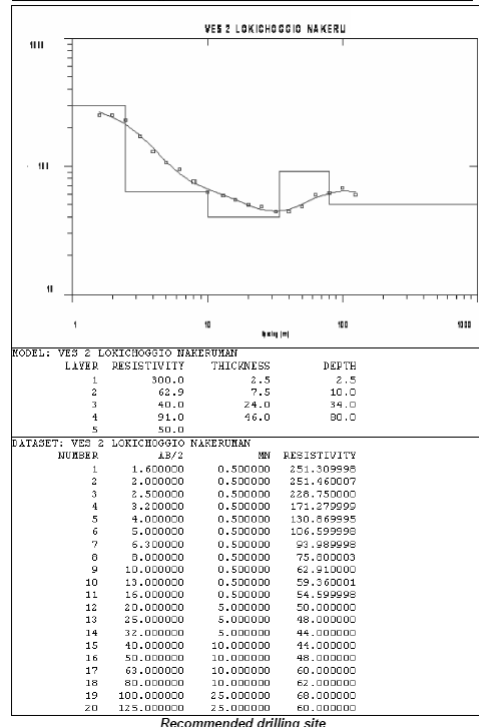
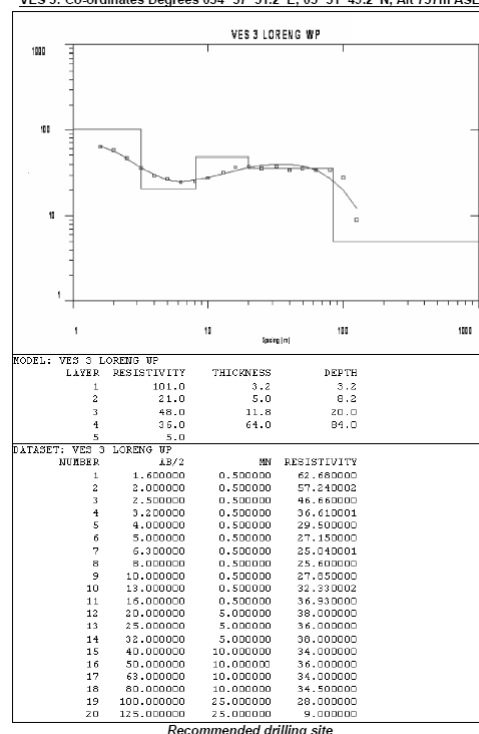
Figure BD6.2.3 VES Curves (2)

VES 1: Co-ordinates Degrees 034° 17' 20.5"E; 04° 06' 59.6"N, Alt 713m ASL

VES 2: Co-ordinates Degrees 034° 18' 34.9"E; 04° 19' 19.1"N, Alt 696m ASL

VES 1: Co-ordinates Degrees 034° 26' 39.6"E; 03° 47' 02.2"N, Alt 783m ASL

VES 3: Co-ordinates Degrees 034° 37' 51.2"E; 03° 31' 49.2"N, Alt 737m ASL

7	W3-1	Oropoi	Oropoi	0 – 3.3 3.3 – 20.0 20 – 110 Below 110.0	570.0 45.0 92.0 240.0	Sandy top soils Loose sediments Alluvial sands Weathered to fresh basement	· Deep weathering · Good recharge · Ground water potential medium-high
8	W4-3	Loreng	Kakuma	0 – 3.2 3.2 – 8.2 8.2 – 20.0 20 – 84.0 Below 84.0	101.0 21.0 48.0 36.0 5.0	Sandy soils Weathered sediments Compact sediments Alluvial sands Decomposed volcanics/clays	· Deep weathering · good recharge · stable formation · Groundwater potential medium-high
9	W5-1	Nakoros	Kakuma	0 – 2.4 2.4 – 12.0 12 – 101.0 Below 101.0	30.0 68.0 9.0 18.0	Loam soils Compact sediments Saturated sediments Weathered to fresh volcanics	· Deep weathering · Good recharge · Ground water potential medium-high
10	W6-4	Kokurio	Loriti/Oropoi	0 – 2.5 2.5 – 5.1 5.1 – 33.0 33 – 125.0 Below 125.0	49.0 120.0 9.9 21.0 34.0	Sandy over burden Compact sediments Weathered sediments Saturated sediments Weathered to fresh volcanics	· Deep weathering · Shallow aquifer 25-40m · Deep aquifer 60-110, · Good recharge · Groundwater potential medium-high
